# Manhole Inspection Report

Date:	<b>03/27/2018</b>	Weather:		Coding:	<b>RZMACP</b>
MH#:	<b>M-308-020</b>	Owner:	<b>NA</b>	Len. Surveyed:	<b>10.7</b>
P.O.#:		Surveyor:	<b>John Kuglmaier</b>	Rim to Invert:	<b>11.1</b>
Customer:		Cert. #:	<b>U-1215-07002349</b>	Wall Material:	<b>Concrete (reinforced)</b>

Street:	<b>Diamond Dr. 213' Southeast of Color</b>	Project:	<b>Hobart, IN</b>
City:	<b>Hobart, IN</b>	GPS Northing:	<b>0.0</b>
Location:		GPS Easting:	<b>0.0</b>
Drain Area:	<b>Southwest</b>	GPS Accuracy:	<b>Nearest Meter</b>
Cover Shape:	<b>Circular</b>	Evidence of Surcharge:	<b>No</b>
Cover Size:	<b>22.5</b>	Potential for Runoff:	<b>None</b>
Comments:

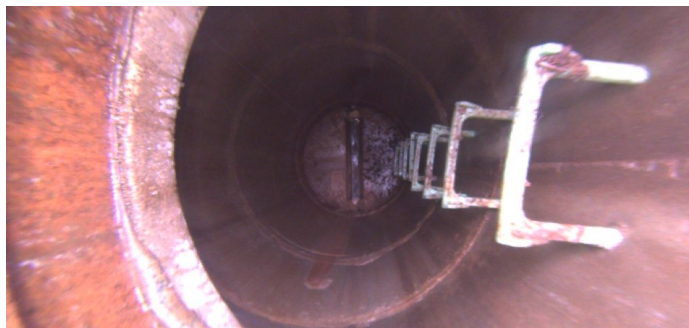
Code: **MGP**  
Description: **General Photo**

Distance (ft): **.0**  
Structural Grade: **0**  
O&M Grade: **0**  
Clock Start/From:  
Clock To:  
1st Value:  
2nd Value:  
Value Percent:  
Step: **NO**  
Remarks:

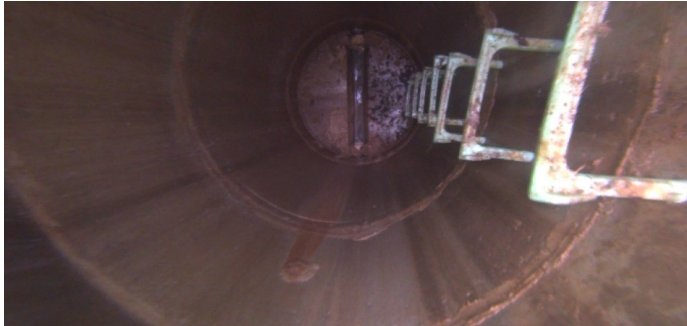
Code: **IS**  
Description: **Infil Stain**

Distance (ft): **1.5**  
Structural Grade: **0**  
O&M Grade: **0**  
Clock Start/From: **6**  
Clock To:  
1st Value:  
2nd Value:  
Value Percent:  
Step: **NO**  
Remarks:

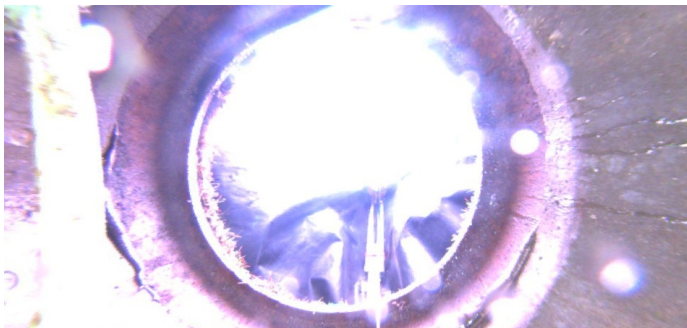
Code: **MGP**  
Description: **General Photo**

Distance (ft): **2.3**  
Structural Grade: **0**  
O&M Grade: **0**  
Clock Start/From:  
Clock To:  
1st Value:  
2nd Value:  
Value Percent:  
Step: **NO**  
Remarks:

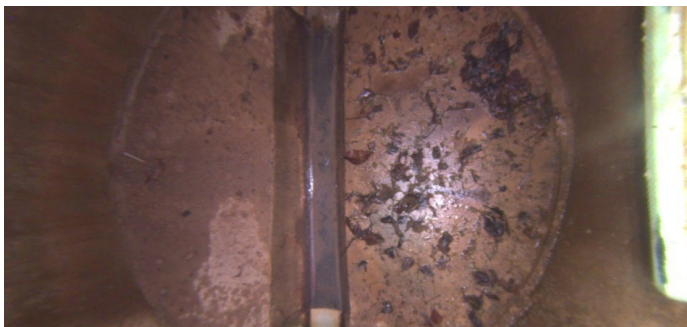
Code: **MGO**  
Description: **General Observation**

Distance (ft): **8.7**  
Structural Grade: **0**  
O&M Grade: **0**  
Clock Start/From:  
Clock To:  
1st Value:  
2nd Value:  
Value Percent:  
Step: **NO**  
Remarks: **Ins. Comp.**
