Manhole Inspection Report

Date:	03/26/2018	Weather:		Coding:	RZMACP
MH#:	M-308-021	Owner:	NA	Len. Surveyed:	1.8
P.O.#:		Surveyor:	John Kuglmaier	Rim to Invert:	11.1
Customer:		Cert. #:	U-1215-07002349	Wall Material:	Concrete (reinforced)

Street:	Colorado St. Diamond Dr. to the Nor	Project:	Hobart, IN
City:	Hobart, IN	GPS Northing:	0.0
Location:		GPS Easting:	0.0
Drain Area:	Southwest	GPS Accuracy:	Nearest Meter
Cover Shape:	Circular	Evidence of Surcharge:	No
Cover Size:	22.5	Potential for Runoff:	None
Comments:

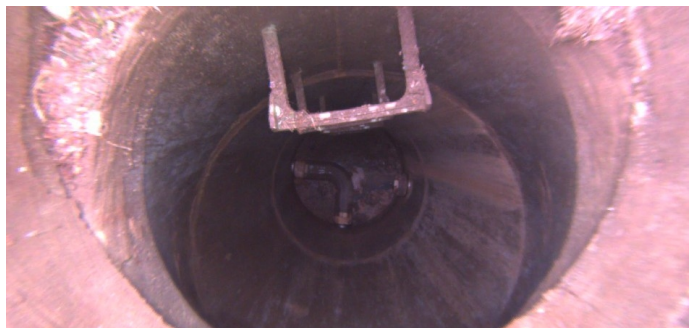
Code: **MGP**
Description: **General Photo**

Distance (ft): **.0**
Structural Grade: **0**
O&M Grade: **0**
Clock Start/From:
Clock To:
1st Value:
2nd Value:
Value Percent:
Step: **NO**
Remarks:

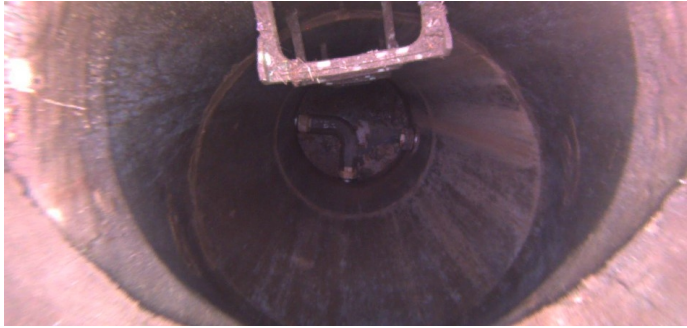
Code: **IS**
Description: **Infil Stain**

Distance (ft): **.3**
Structural Grade: **0**
O&M Grade: **0**
Clock Start/From: **1**
Clock To: **4**
1st Value:
2nd Value:
Value Percent:
Step: **NO**
Remarks:

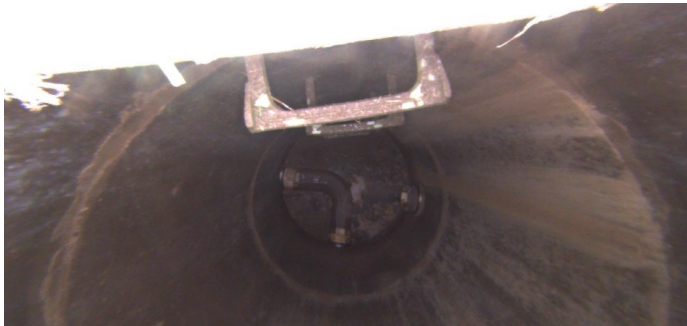
Code: **MGO**
Description: **General Observation**

Distance (ft): **1.8**
Structural Grade: **0**
O&M Grade: **0**
Clock Start/From:
Clock To:
1st Value:
2nd Value:
Value Percent:
Step: **NO**
Remarks: **Ins. Comp.**
