Manhole Inspection Report

Date:	03/27/2018	Weather:		Coding:	RZMACP
MH#:	M-308-022	Owner:	NA	Len. Surveyed:	7.5
P.O.#:		Surveyor:	John Kuglmaier	Rim to Invert:	8.2
Customer:		Cert. #:	U-1215-07002349	Wall Material:	Concrete (reinforced)

Street:	Colorado St. 141' Northeast of Diam	Project:	Hobart, IN
City:	Hobart, IN	GPS Northing:	0.0
Location:		GPS Easting:	0.0
Drain Area:	Southwest	GPS Accuracy:	Nearest Meter
Cover Shape:	Circular	Evidence of Surcharge:	Yes
Cover Size:	22.5	Potential for Runoff:	None
Comments:

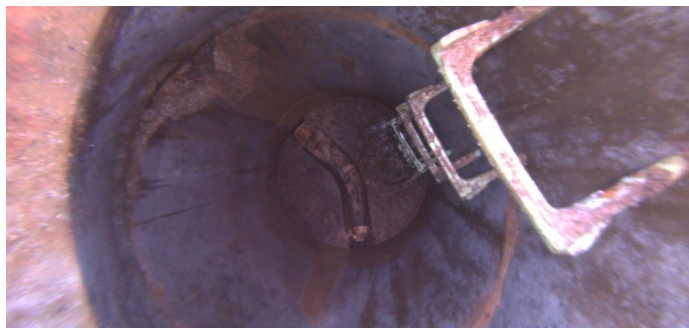
Code: **MGP**
Description: **General Photo**

Distance (ft): **.0**
Structural Grade: **0**
O&M Grade: **0**
Clock Start/From:
Clock To:
1st Value:
2nd Value:
Value Percent:
Step: **NO**
Remarks:

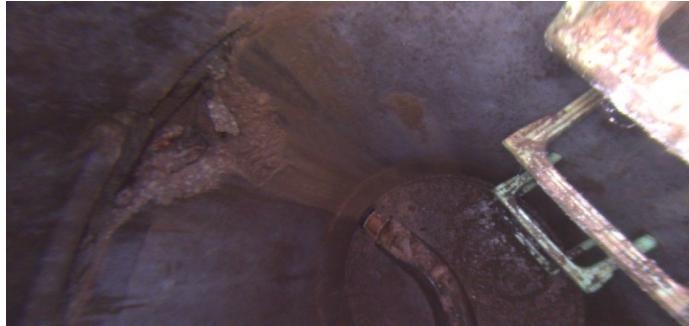
Code: **HSV**
Description: **Hole Soil Visible**

Distance (ft): **1.9**
Structural Grade: **5**
O&M Grade: **0**
Clock Start/From: **10**
Clock To:
1st Value:
2nd Value:
Value Percent:
Step: **NO**
Remarks:

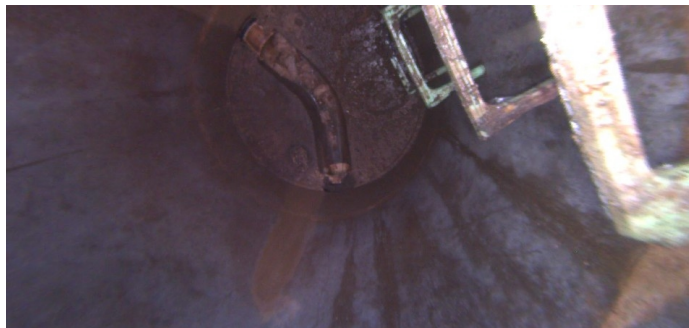
Code: **IS**
Description: **Infil Stain**

Distance (ft): **1.9**
Structural Grade: **0**
O&M Grade: **0**
Clock Start/From: **7**
Clock To:
1st Value:
2nd Value:
Value Percent:
Step: **NO**
Remarks:

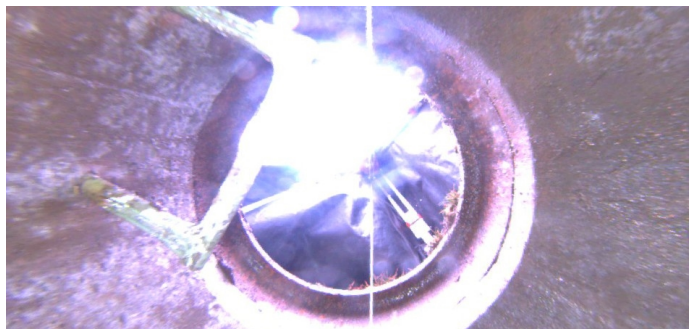
Code: **MGP**
Description: **General Photo**

Distance (ft): **2.6**
Structural Grade: **0**
O&M Grade: **0**
Clock Start/From:
Clock To:
1st Value:
2nd Value:
Value Percent:
Step: **NO**
Remarks:

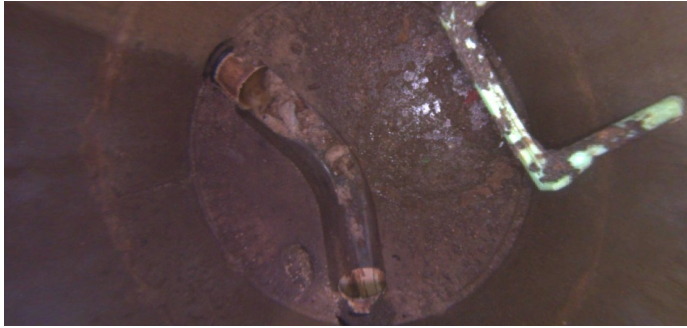
Code:	DSF
Description:	Deposits Settled Fine
Distance (ft):	4.6
Structural Grade:	0
O&M Grade:	2
Clock Start/From:	12
Clock To:	12
1st Value:	
2nd Value:	
Value Percent:	5.000
Step:	NO
Remarks:

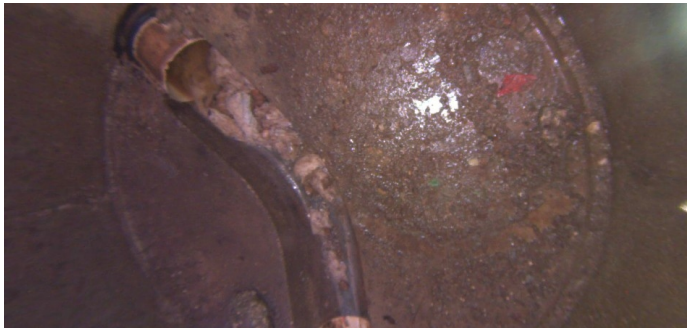
Code:	MGO
Description:	General Observation
Distance (ft):	5.8
Structural Grade:	0
O&M Grade:	0
Clock Start/From:	
Clock To:	
1st Value:	
2nd Value:	
Value Percent:	
Step:	NO
Remarks:	Ins. Comp.
