Manhole Inspection Report

Date:	03/27/2018	Weather:		Coding:	RZMACP
MH#:	M-308-024	Owner:	NA	Len. Surveyed:	5.9
P.O.#:		Surveyor:	John Kuglmaier	Rim to Invert:	6.7
Customer:		Cert. #:	U-1215-07002349	Wall Material:	Concrete (reinforced)

Street:	Emerald Dr. Colorado St.	Project:	Hobart, IN
City:	Hobart, IN	GPS Northing:	0.0
Location:		GPS Easting:	0.0
Drain Area:	Southwest	GPS Accuracy:	Nearest Meter
Cover Shape:	Circular	Evidence of Surcharge:	No
Cover Size:	22.5	Potential for Runoff:	None
Comments:

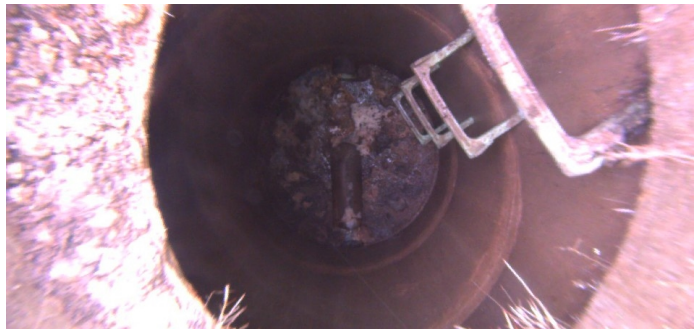
Code: **MGP**
Description: **General Photo**

Distance (ft): **.0**
Structural Grade: **0**
O&M Grade: **0**
Clock Start/From:
Clock To:
1st Value:
2nd Value:
Value Percent:
Step: **NO**
Remarks:

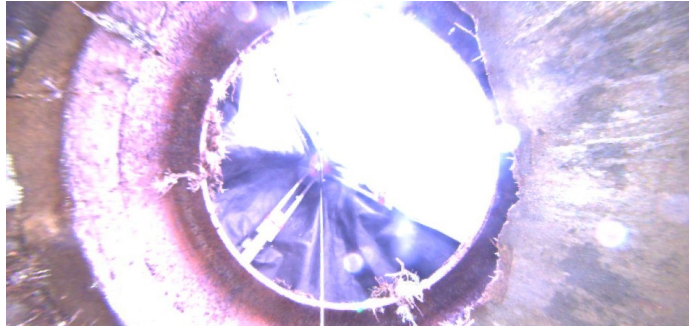
Code: **MGP**
Description: **General Photo**

Distance (ft): **2.2**
Structural Grade: **0**
O&M Grade: **0**
Clock Start/From:
Clock To:
1st Value:
2nd Value:
Value Percent:
Step: **NO**
Remarks:

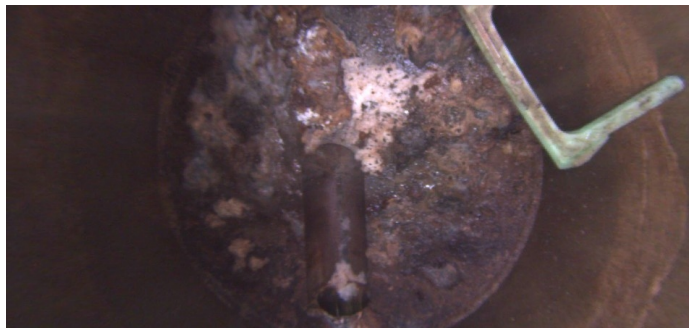
Code: **DAZ**
Description: **Deposits Attached Other**

Distance (ft): **3.4**
Structural Grade: **0**
O&M Grade: **2**
Clock Start/From: **12**
Clock To: **12**
1st Value:
2nd Value:
Value Percent: **10.000**
Step: **NO**
Remarks: **Mixed materials**

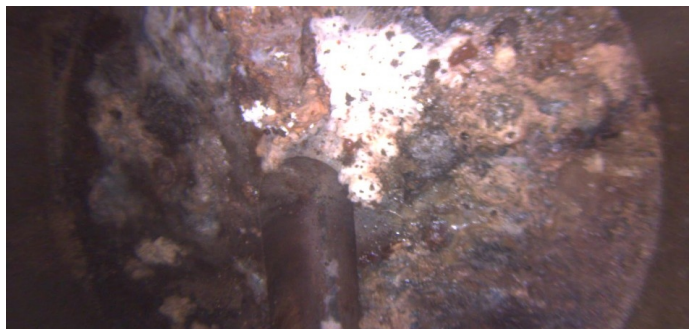
Code: **MGO**
Description: **General Observation**

Distance (ft): **4.6**
Structural Grade: **0**
O&M Grade: **0**
Clock Start/From:
Clock To:
1st Value:
2nd Value:
Value Percent:
Step: **NO**
Remarks: **Ins. Comp.**
