# Manhole Inspection Report

Date:	03/26/2018	Weather:		Coding:	RZMACP
MH#:	M-308-025	Owner:	NA	Len. Surveyed:	6.0
P.O.#:		Surveyor:	John Kuglmaier	Rim to Invert:	6.6
Customer:		Cert. #:	U-1215-07002349	Wall Material:	Concrete (reinforced)

Street:	Colorado St. 224' North of Topaz Dr.	Project:	Hobart, IN
City:	Hobart, IN	GPS Northing:	0.0
Location:		GPS Easting:	0.0
Drain Area:	Southwest	GPS Accuracy:	Nearest Meter
Cover Shape:	Circular	Evidence of Surcharge:	No
Cover Size:	22.5	Potential for Runoff:	None
Comments:

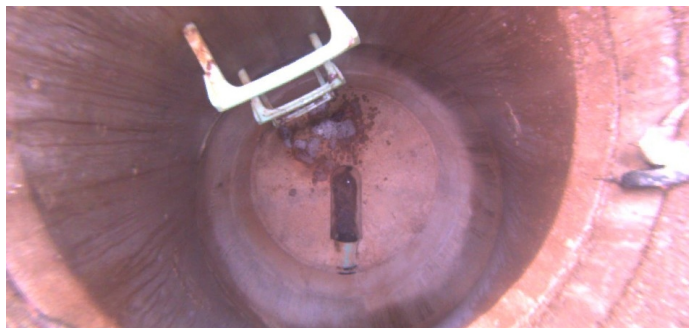
Code: **MGP**  
 Description: **General Photo**

Distance (ft): **.0**  
 Structural Grade: **0**  
 O&M Grade: **0**  
 Clock Start/From:  
 Clock To:  
 1st Value:  
 2nd Value:  
 Value Percent:  
 Step: **NO**  
 Remarks:

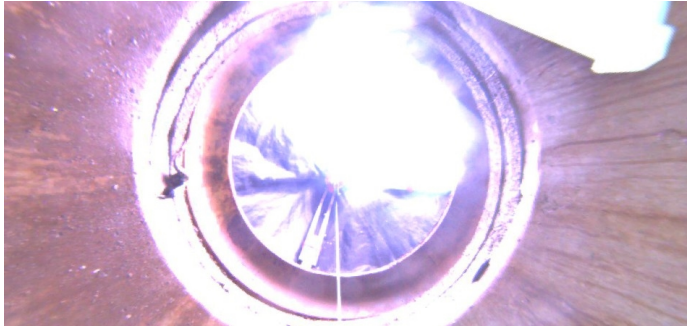
Code: **MGP**  
Description: **General Photo**

Distance (ft): **2.6**  
Structural Grade: **0**  
O&M Grade: **0**  
Clock Start/From:  
Clock To:  
1st Value:  
2nd Value:  
Value Percent:  
Step: **NO**  
Remarks:

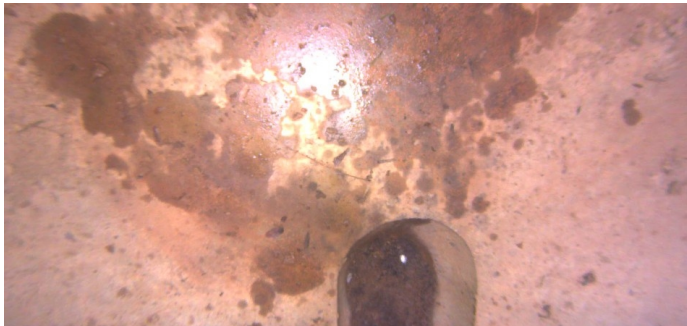
Code: **MGO**  
Description: **General Observation**

Distance (ft): **5.1**  
Structural Grade: **0**  
O&M Grade: **0**  
Clock Start/From:  
Clock To:  
1st Value:  
2nd Value:  
Value Percent:  
Step: **NO**  
Remarks: **Ins. Comp.**
