Manhole Inspection Report

Date:	03/26/2018	Weather:		Coding:	RZMACP
MH#:	M-308-026	Owner:	NA	Len. Surveyed:	9.1
P.O.#:		Surveyor:	John Kuglmaier	Rim to Invert:	9.6
Customer:		Cert. #:	U-1215-07002349	Wall Material:	Concrete (reinforced)

Street:	Colorado St. and Sapphire Ct.	Project:	Hobart, IN
City:	Hobart, IN	GPS Northing:	0.0
Location:		GPS Easting:	0.0
Drain Area:	Southwest	GPS Accuracy:	Nearest Meter
Cover Shape:	Circular	Evidence of Surcharge:	No
Cover Size:	22.5	Potential for Runoff:	None
Comments:

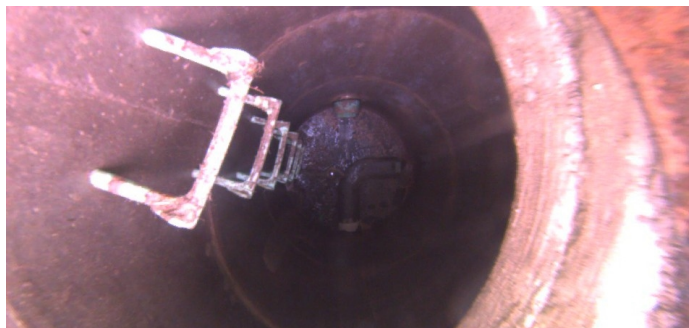
Code: **MGP**
Description: **General Photo**

Distance (ft): **.0**
Structural Grade: **0**
O&M Grade: **0**
Clock Start/From:
Clock To:
1st Value:
2nd Value:
Value Percent:
Step: **NO**
Remarks:

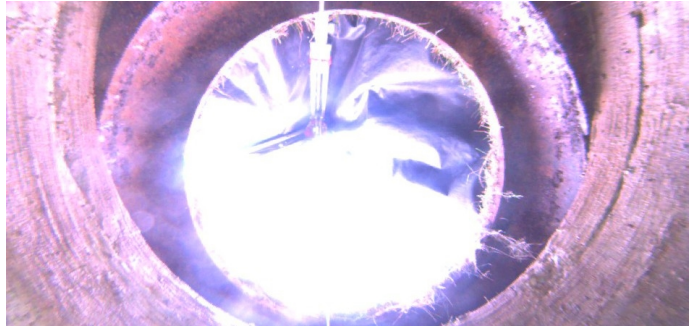
Code: **MGP**
Description: **General Photo**

Distance (ft): **1.9**
Structural Grade: **0**
O&M Grade: **0**
Clock Start/From:
Clock To:
1st Value:
2nd Value:
Value Percent:
Step: **NO**
Remarks:

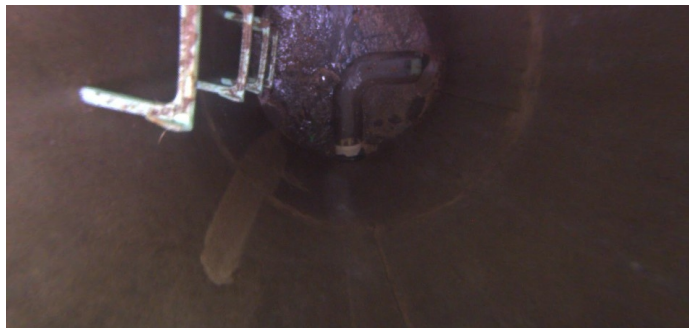
Code: **IS**
Description: **Infil Stain**

Distance (ft): **2.6**
Structural Grade: **0**
O&M Grade: **0**
Clock Start/From: **7**
Clock To:
1st Value:
2nd Value:
Value Percent:
Step: **NO**
Remarks:

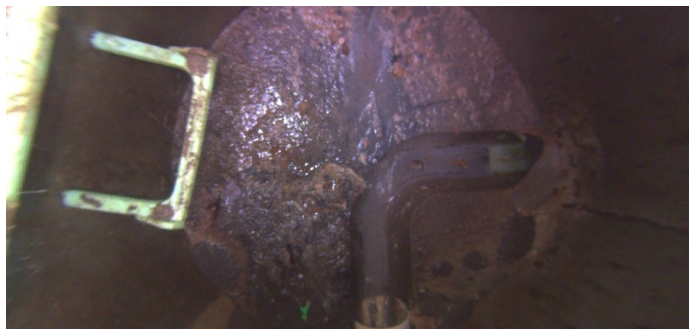
Code: **DAZ**
Description: **Deposits Attached Other**

Distance (ft): **6.3**
Structural Grade: **0**
O&M Grade: **2**
Clock Start/From: **12**
Clock To: **12**
1st Value:
2nd Value:
Value Percent: **5.000**
Step: **NO**
Remarks: **Mixed materials**

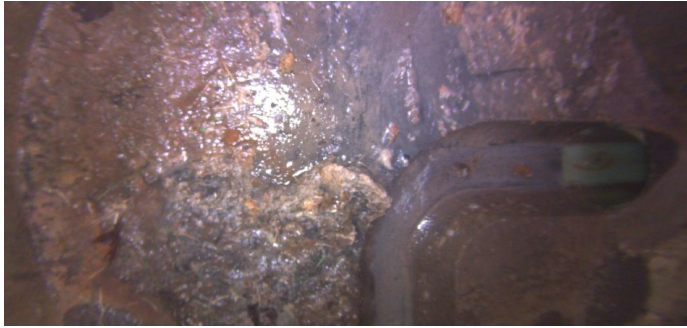
Code:	MGO
Description:	General Observation
Distance (ft):	7.7
Structural Grade:	0
O&M Grade:	0
Clock Start/From:	
Clock To:	
1st Value:	
2nd Value:	
Value Percent:	
Step:	NO
Remarks:	Ins. Comp.
