Manhole Inspection Report

Date:	03/26/2018	Weather:		Coding:	RZMACP
MH#:	M-308-028	Owner:	NA	Len. Surveyed:	8.5
P.O.#:		Surveyor:	John Kuglmaier	Rim to Invert:	9.1
Customer:		Cert. #:	U-1215-07002349	Wall Material:	Concrete (reinforced)

Street:	Sapphire Ct. 196' Northwest of Colo	Project:	Hobart, IN
City:	Hobart, IN	GPS Northing:	0.0
Location:		GPS Easting:	0.0
Drain Area:	Southwest	GPS Accuracy:	Nearest Meter
Cover Shape:	Circular	Evidence of Surcharge:	No
Cover Size:	22.5	Potential for Runoff:	None
Comments:

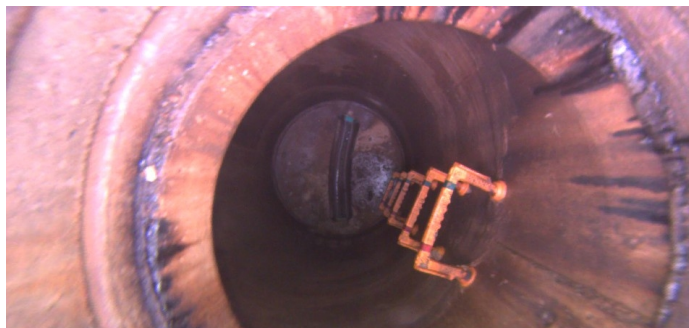
Code: **MGP**
Description: **General Photo**

Distance (ft): **.0**
Structural Grade: **0**
O&M Grade: **0**
Clock Start/From:
Clock To:
1st Value:
2nd Value:
Value Percent:
Step: **NO**
Remarks:

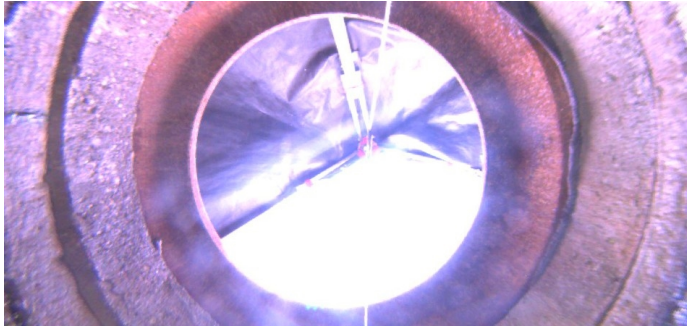
Code: **MGP**
Description: **General Photo**

Distance (ft): **2.0**
Structural Grade: **0**
O&M Grade: **0**
Clock Start/From:
Clock To:
1st Value:
2nd Value:
Value Percent:
Step: **NO**
Remarks:

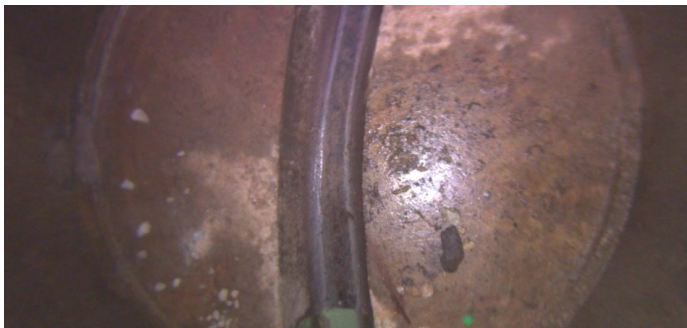
Code: **MGO**
Description: **General Observation**

Distance (ft): **6.7**
Structural Grade: **0**
O&M Grade: **0**
Clock Start/From:
Clock To:
1st Value:
2nd Value:
Value Percent:
Step: **NO**
Remarks: **Ins. Comp.**
