Manhole Inspection Report

Date:	03/23/2018	Weather:		Coding:	RZMACP
MH#:	M-308-032	Owner:	NA	Len. Surveyed:	15.1
P.O.#:		Surveyor:	John Kuglmaier	Rim to Invert:	18.3
Customer:		Cert. #:	U-1215-07002349	Wall Material:	Concrete (reinforced)

Street:	61st Ave. 316' West of Amber St.	Project:	Hobart, IN
City:	Hobart, IN	GPS Northing:	0.0
Location:		GPS Easting:	0.0
Drain Area:	Southwest	GPS Accuracy:	Nearest Meter
Cover Shape:	Circular	Evidence of Surcharge:	Yes
Cover Size:	22.5	Potential for Runoff:	None
Comments:

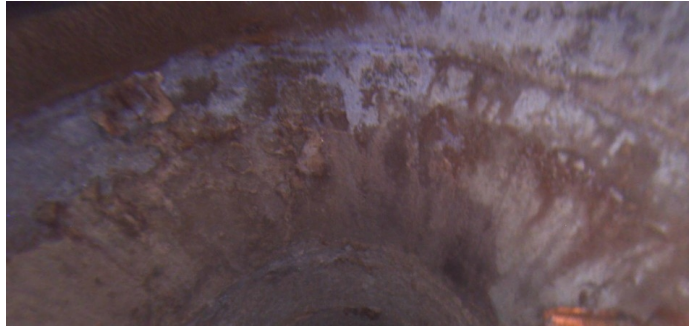
Code:	DAZ
Description:	Deposits Attached Other
Distance (ft):	.0
Structural Grade:	0
O&M Grade:	2
Clock Start/From:	12
Clock To:	12
1st Value:	
2nd Value:	
Value Percent:	10.000
Step:	NO
Remarks:	Mixed materials

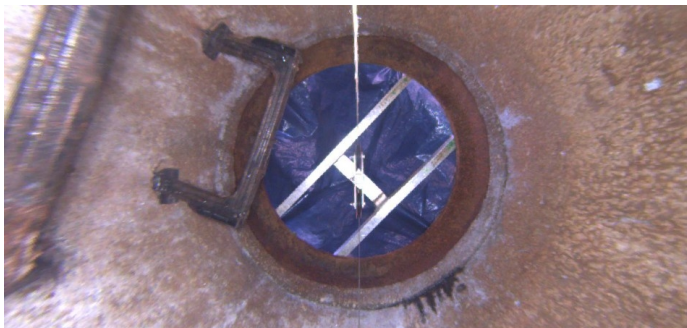
Code:	MGP
Description:	General Photo
Distance (ft):	.8
Structural Grade:	0
O&M Grade:	0
Clock Start/From:	
Clock To:	
1st Value:	
2nd Value:	
Value Percent:	
Step:	NO
Remarks:

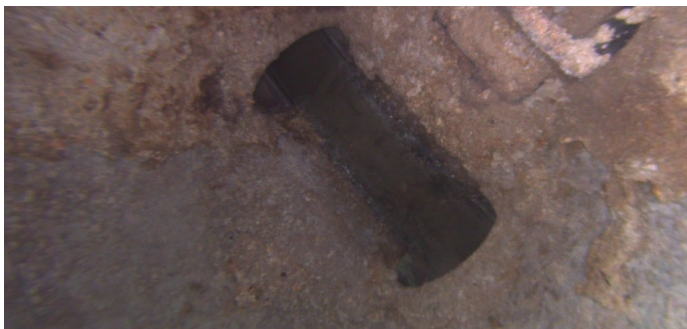
Code:	DAZ
Description:	Deposits Attached Other
Distance (ft):	11.9
Structural Grade:	0
O&M Grade:	3
Clock Start/From:	12
Clock To:	
1st Value:	
2nd Value:	
Value Percent:	15.000
Step:	NO
Remarks:	Mixed materials

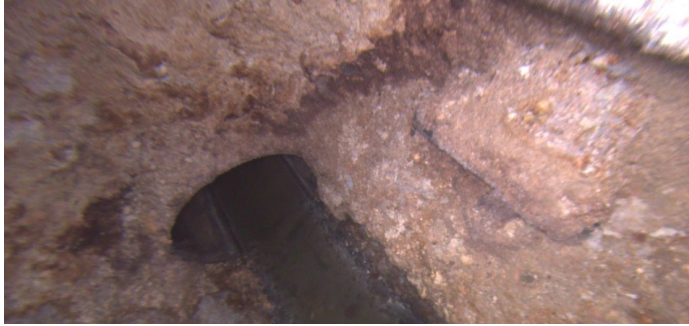
Code:	DAZ
Description:	Deposits Attached Other
Distance (ft):	13.0
Structural Grade:	0
O&M Grade:	2
Clock Start/From:	12
Clock To:	12
1st Value:	
2nd Value:	
Value Percent:	10.000
Step:	NO
Remarks:	Mixed materials

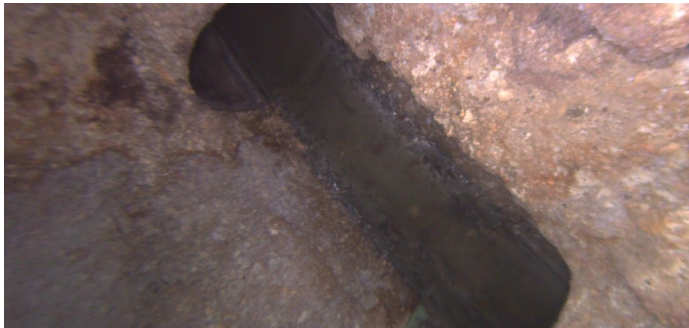
Code:	MGO
Description:	General Observation
Distance (ft):	13.3
Structural Grade:	0
O&M Grade:	0
Clock Start/From:	
Clock To:	
1st Value:	
2nd Value:	
Value Percent:	
Step:	NO
Remarks:	Ins. Comp.
