Manhole Inspection Report

Date:	03/23/2018	Weather:		Coding:	RZMACP
MH#:	M-308-033	Owner:	NA	Len. Surveyed:	4.8
P.O.#:		Surveyor:	John Kuglmaier	Rim to Invert:	5.7
Customer:		Cert. #:	U-1215-07002349	Wall Material:	Concrete (reinforced)

Street:	North of 61st Ave. 87' West of Amb	Project:	Hobart, IN
City:	Hobart, IN	GPS Northing:	0.0
Location:		GPS Easting:	0.0
Drain Area:	Southwest	GPS Accuracy:	Nearest Meter
Cover Shape:	Circular	Evidence of Surcharge:	No
Cover Size:	22.5	Potential for Runoff:	None
Comments:

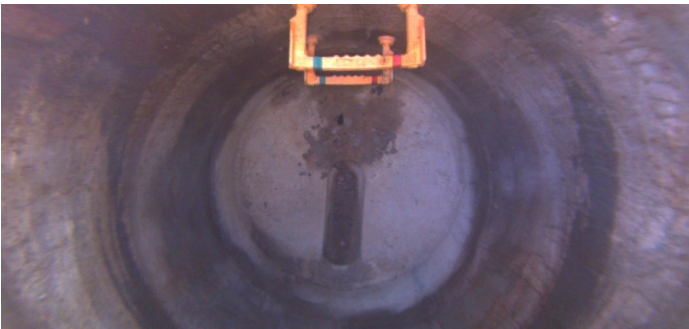
Code:

MGP

Description:

General Photo

Distance (ft):

.0

Structural Grade:

0

O&M Grade:

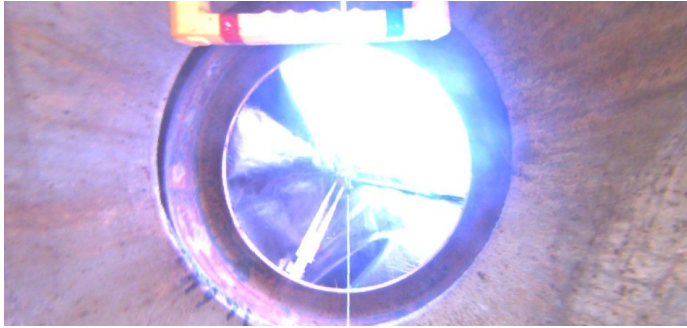
Code: **MGP**
Description: **General Photo**

Distance (ft): **2.3**
Structural Grade: **0**
O&M Grade: **0**
Clock Start/From:
Clock To:
1st Value:
2nd Value:
Value Percent:
Step: **NO**
Remarks:

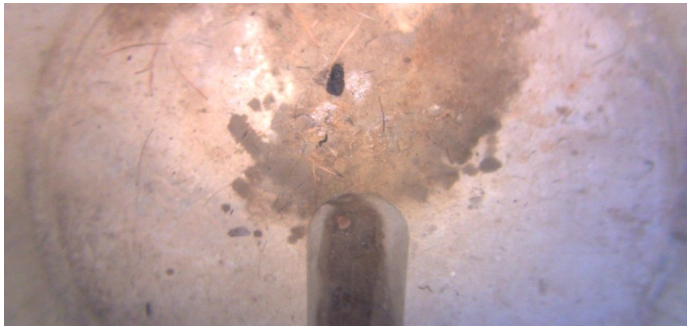
Code: **MGO**
Description: **General Observation**

Distance (ft): **3.5**
Structural Grade: **0**
O&M Grade: **0**
Clock Start/From:
Clock To:
1st Value:
2nd Value:
Value Percent:
Step: **NO**
Remarks: **Ins. Comp.**
