Manhole Inspection Report

Date:	03/23/2018	Weather:		Coding:	RZMACP
MH#:	M-308-034	Owner:	NA	Len. Surveyed:	5.2
P.O.#:		Surveyor:	John Kuglmaier	Rim to Invert:	5.9
Customer:		Cert. #:	U-1215-07002349	Wall Material:	Concrete (reinforced)

Street:	North of 61st Ave. 460' West of Am	Project:	Hobart, IN
City:	Hobart, IN	GPS Northing:	0.0
Location:		GPS Easting:	0.0
Drain Area:	Southwest	GPS Accuracy:	Nearest Meter
Cover Shape:	Circular	Evidence of Surcharge:	Yes
Cover Size:	22.5	Potential for Runoff:	None
Comments:

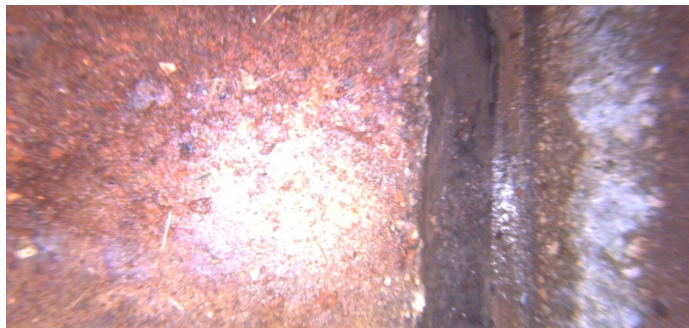
Code: **MGP**
Description: **General Photo**

Distance (ft): **1.9**
Structural Grade: **0**
O&M Grade: **0**
Clock Start/From:
Clock To:
1st Value:
2nd Value:
Value Percent:
Step: **NO**
Remarks:
