Manhole Inspection Report

Date:	04/13/2018	Weather:		Coding:	RZMACP
MH#:	M-403-001	Owner:	NA	Len. Surveyed:	7.7
P.O.#:		Surveyor:	John Kuglmaier	Rim to Invert:	8.7
Customer:		Cert. #:	U-1215-07002349	Wall Material:	Concrete (reinforced)

Street:	Gill St. 240' South of 38th Ave.	Project:	Hobart, IN
City:	Hobart, IN	GPS Northing:	0.0
Location:		GPS Easting:	0.0
Drain Area:	Northwest	GPS Accuracy:	Nearest Meter
Cover Shape:	Circular	Evidence of Surcharge:	No
Cover Size:	23.0	Potential for Runoff:	None
Comments:

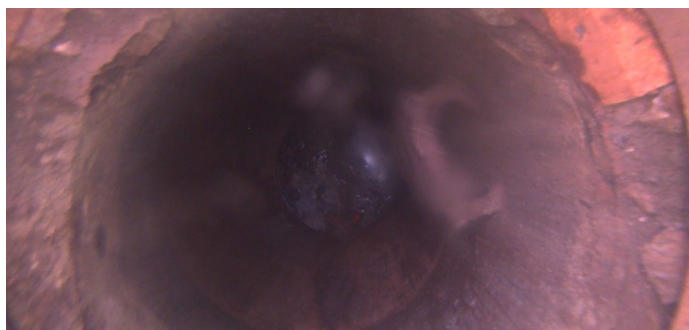
Code: **MGP**
Description: **General Photo**

Distance (ft): **.0**
Structural Grade: **0**
O&M Grade: **0**
Clock Start/From:
Clock To:
1st Value:
2nd Value:
Value Percent:
Step: **NO**
Remarks:

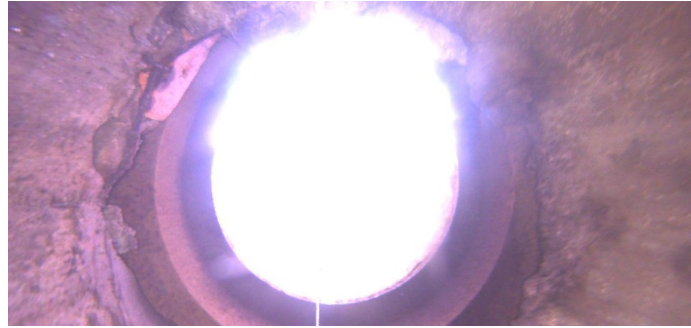
Code: **MGP**
Description: **General Photo**

Distance (ft): **2.4**
Structural Grade: **0**
O&M Grade: **0**
Clock Start/From:
Clock To:
1st Value:
2nd Value:
Value Percent:
Step: **NO**
Remarks:

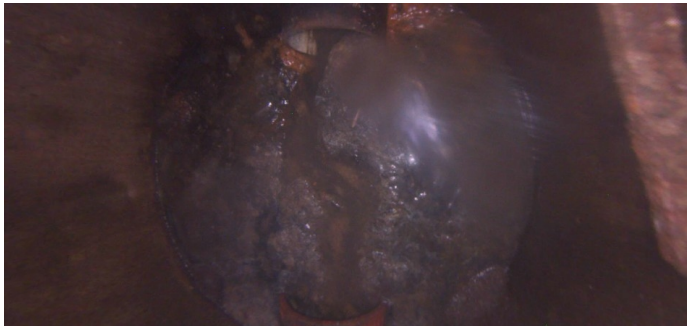
Code: **DAZ**
Description: **Deposits Attached Other**

Distance (ft): **6.0**
Structural Grade: **0**
O&M Grade: **2**
Clock Start/From: **12**
Clock To: **12**
1st Value:
2nd Value:
Value Percent: **10.000**
Step: **NO**
Remarks: **Mixed materials**

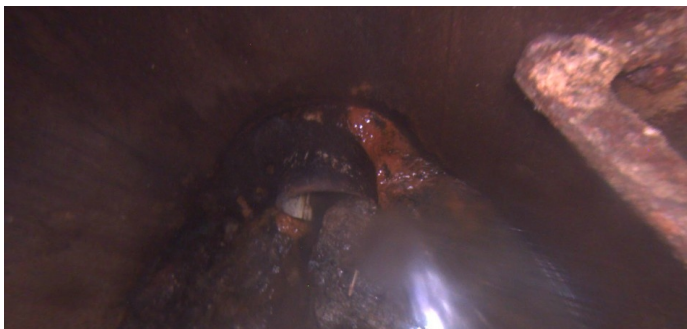
Code: **IS**
Description: **Infil Stain**

Distance (ft): **6.4**
Structural Grade: **0**
O&M Grade: **0**
Clock Start/From: **1**
Clock To:
1st Value:
2nd Value:
Value Percent:
Step: **NO**
Remarks:

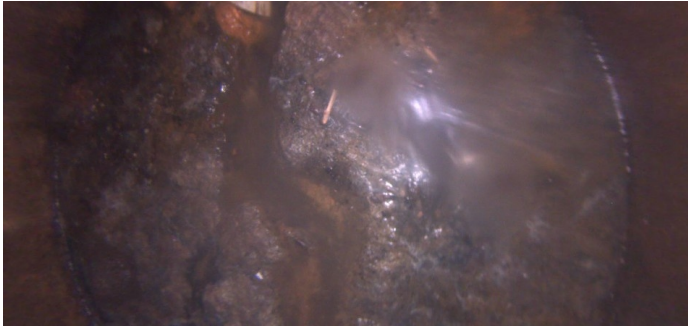
Code:	MGO
Description:	General Observation
Distance (ft):	7.0
Structural Grade:	0
O&M Grade:	0
Clock Start/From:	
Clock To:	
1st Value:	
2nd Value:	
Value Percent:	
Step:	NO
Remarks:	Ins. Comp.
