Manhole Inspection Report

Date:	09/20/2022	Weather:		Coding:	RZMACP
MH#:	M-403-004	Owner:	NA	Len. Surveyed:	7.2
P.O.#:		Surveyor:	Jen Costello	Rim to Invert:	8.0
Customer:		Cert. #:	U-907-5518	Wall Material:	Concrete (cast in place)

Street:	Gill St. 501' North of 38th Ave.	Project:	Hobart, IN
City:	Hobart, IN	GPS Northing:	2295678.558
Location:	Yard	GPS Easting:	2897044.041
Drain Area:	Northwest	GPS Accuracy:	Sub-Meter
Cover Shape:	Circular	Evidence of Surcharge:	No
Cover Size:	24.0	Potential for Runoff:	None
Comments:

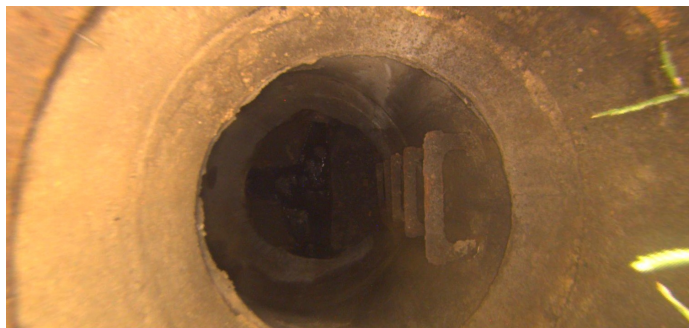
Code: **MGO**
Description: **General Observation**

Distance (ft): **.0**
Structural Grade: **0**
O&M Grade: **0**
Clock Start/From:
Clock To:
1st Value:
2nd Value:
Value Percent:
Step: **NO**
Remarks: **access mh**

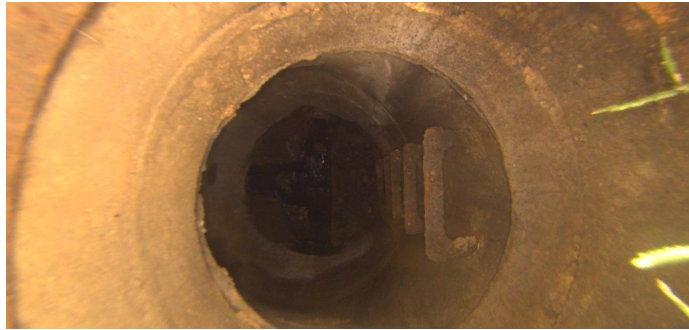
Code:	SRI
Description:	Surface Roughness Increased
Distance (ft):	.0
Structural Grade:	1
O&M Grade:	0
Clock Start/From:	12
Clock To:	12
1st Value:	
2nd Value:	
Value Percent:	
Step:	NO
Remarks:

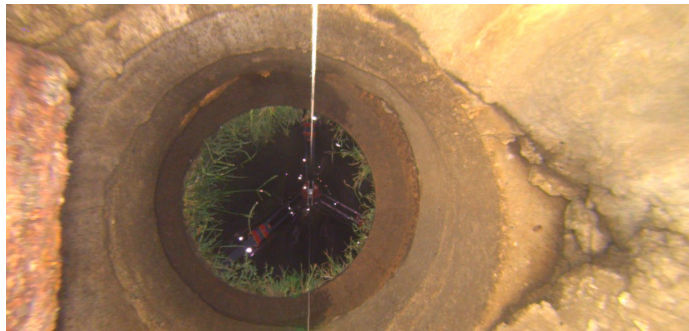
Code:	MGO
Description:	General Observation
Distance (ft):	3.1
Structural Grade:	0
O&M Grade:	0
Clock Start/From:	
Clock To:	
1st Value:	
2nd Value:	
Value Percent:	
Step:	NO
Remarks:	underside of frame

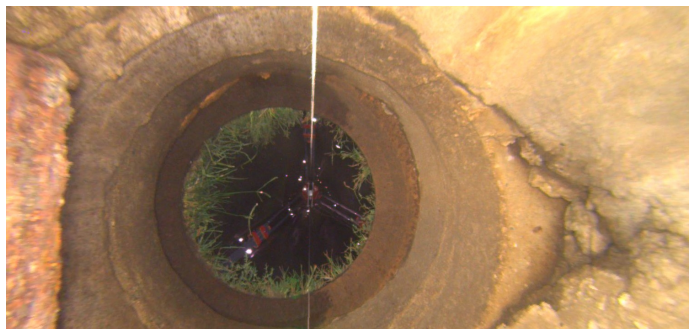
Code:	B
Description:	Broken
Distance (ft):	3.1
Structural Grade:	4
O&M Grade:	0
Clock Start/From:	8
Clock To:	9
1st Value:	
2nd Value:	
Value Percent:	
Step:	NO
Remarks:

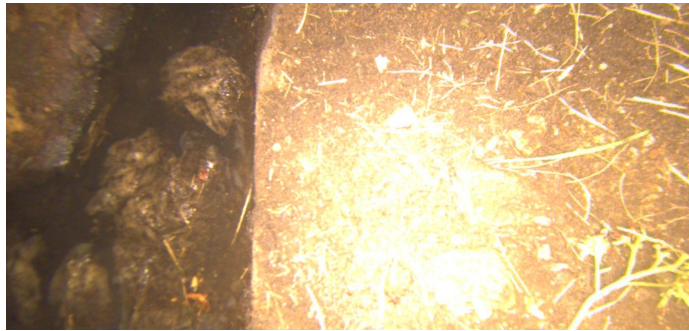
Code: **DSF**
Description: **Deposits Settled Fine**

Distance (ft): **7.2**
Structural Grade: **0**
O&M Grade: **2**
Clock Start/From: **12**
Clock To: **12**
1st Value:
2nd Value:
Value Percent: **5.000**
Step: **NO**
Remarks:

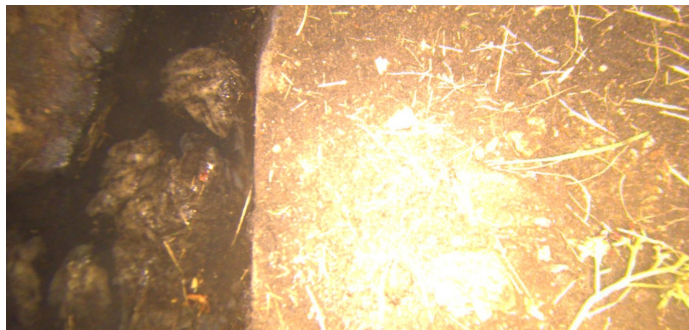
Code: **DSF**
Description: **Deposits Settled Fine**

Distance (ft): **7.2**
Structural Grade: **0**
O&M Grade: **3**
Clock Start/From: **4**
Clock To: **8**
1st Value:
2nd Value:
Value Percent: **20.000**
Step: **NO**
Remarks:

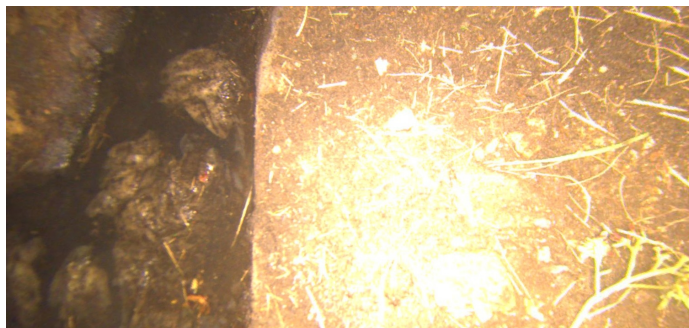
Code: **SRI**
Description: **Surface Roughness Increased**

Distance (ft): **7.2**
Structural Grade: **1**
O&M Grade: **0**
Clock Start/From: **12**
Clock To: **12**
1st Value:
2nd Value:
Value Percent:
Step: **NO**
Remarks:

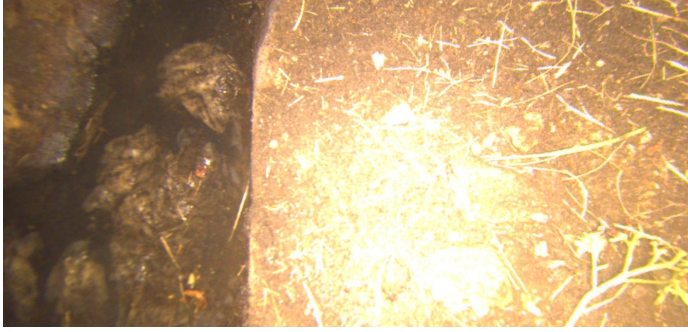
Code:	MGO
Description:	General Observation
Distance (ft):	7.2
Structural Grade:	0
O&M Grade:	0
Clock Start/From:	
Clock To:	
1st Value:	
2nd Value:	
Value Percent:	
Step:	NO
Remarks:	end of survey
