Manhole Inspection Report

Date:	05/13/2018	Weather:		Coding:	RZMACP
MH#:	M-404-001	Owner:	NA	Len. Surveyed:	12.1
P.O.#:		Surveyor:	Jen Costello	Rim to Invert:	11.9
Customer:		Cert. #:	U-907-5518	Wall Material:	Brick

Street:	Intersection of Wilson St. and Clevel	Project:	Hobart, IN
City:	Hobart, IN	GPS Northing:	41.53649902
Location:		GPS Easting:	-87.27819061
Drain Area:	West	GPS Accuracy:	Nearest Meter
Cover Shape:	Circular	Evidence of Surcharge:	No
Cover Size:	22.5	Potential for Runoff:	None
Comments:

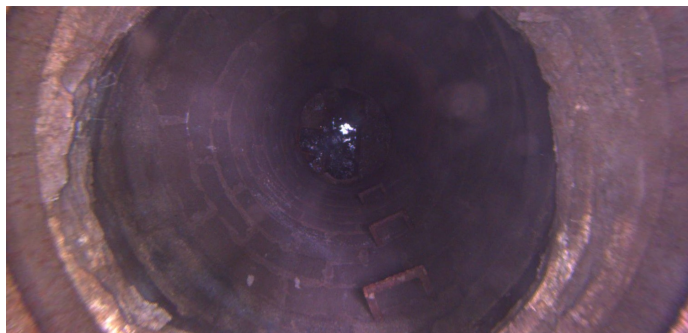
Code: **MGO**
Description: **General Observation**

Distance (ft): **.0**
Structural Grade: **0**
O&M Grade: **0**
Clock Start/From:
Clock To:
1st Value:
2nd Value:
Value Percent:
Step: **NO**
Remarks: **access mh**

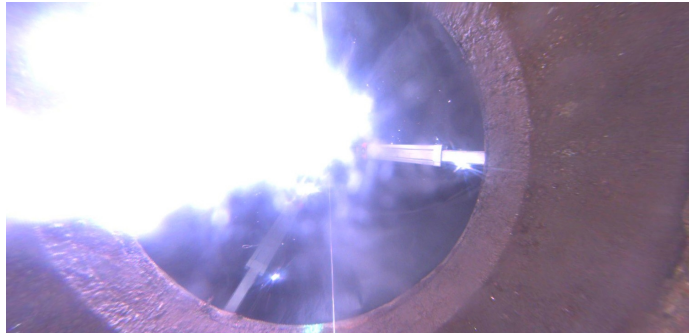
Code: **MGO**
Description: **General Observation**

Distance (ft): **1.5**
Structural Grade: **0**
O&M Grade: **0**
Clock Start/From:
Clock To:
1st Value:
2nd Value:
Value Percent:
Step: **NO**
Remarks: **underside of frame**

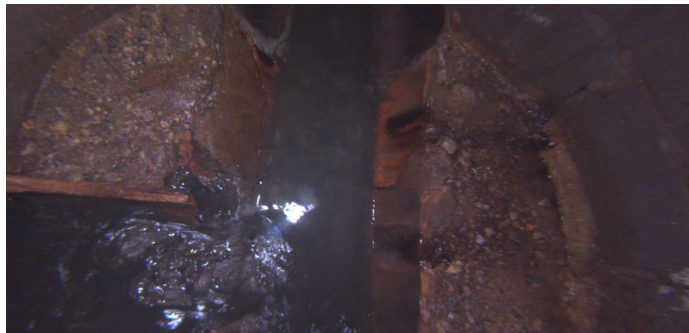
Code: **DSGV**
Description: **Deposits Settled Gravel**

Distance (ft): **10.4**
Structural Grade: **0**
O&M Grade: **2**
Clock Start/From: **12**
Clock To: **12**
1st Value:
2nd Value:
Value Percent: **5.000**
Step: **NO**
Remarks:

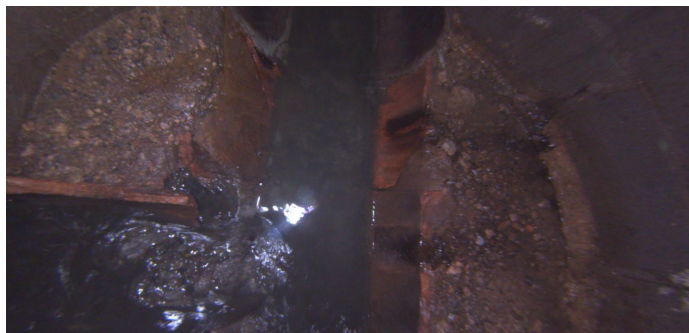
Code: **IW**
Description: **Infil Weeper**

Distance (ft): **10.4**
Structural Grade: **0**
O&M Grade: **2**
Clock Start/From: **2**
Clock To: **3**
1st Value:
2nd Value:
Value Percent:
Step: **NO**
Remarks:

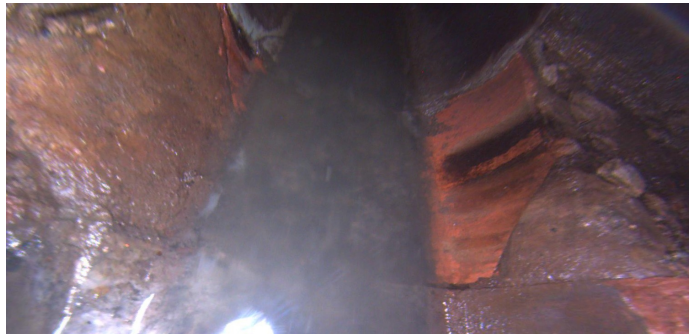
Code: **FS**
Description: **Fracture Spiral**

Distance (ft): **11.9**
Structural Grade: **3**
O&M Grade: **0**
Clock Start/From: **3**
Clock To: **5**
1st Value:
2nd Value:
Value Percent:
Step: **NO**
Remarks:

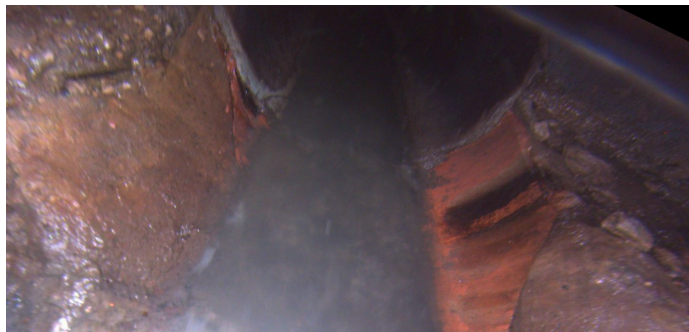
Code: **FS**
Description: **Fracture Spiral**

Distance (ft): **11.9**
Structural Grade: **3**
O&M Grade: **0**
Clock Start/From: **7**
Clock To: **9**
1st Value:
2nd Value:
Value Percent:
Step: **NO**
Remarks:

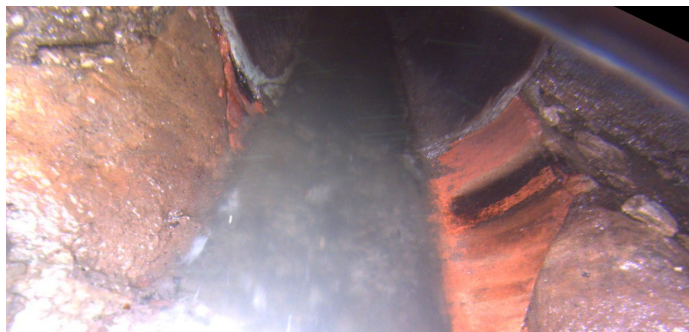
Code: **MGO**
Description: **General Observation**

Distance (ft): **12.1**
Structural Grade: **0**
O&M Grade: **0**
Clock Start/From:
Clock To:
1st Value:
2nd Value:
Value Percent:
Step: **NO**
Remarks: **end survey**
