Manhole Inspection Report

Date:	05/15/2018	Weather:		Coding:	RZMACP
MH#:	M-404-020	Owner:	NA	Len. Surveyed:	4.5
P.O.#:		Surveyor:	Jen Costello	Rim to Invert:	4.8
Customer:		Cert. #:	U-907-5518	Wall Material:	Brick

Street:	167' East of Wabash St. 273' North o	Project:	Hobart, IN
City:	Hobart, IN	GPS Northing:	41.54179382
Location:		GPS Easting:	-87.27894592
Drain Area:	Northwest	GPS Accuracy:	Nearest Meter
Cover Shape:	Circular	Evidence of Surcharge:	No
Cover Size:	22.5	Potential for Runoff:	None
Comments:

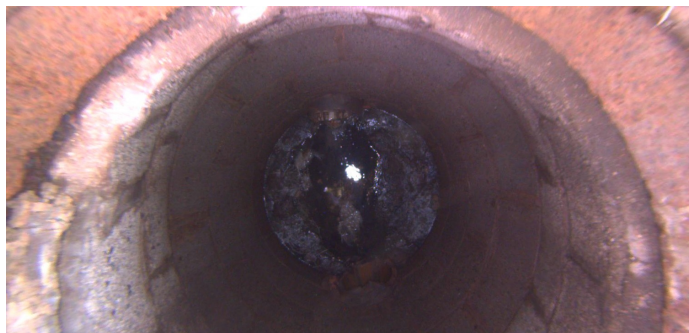
Code: **MGO**
Description: **General Observation**

Distance (ft): **.0**
Structural Grade: **0**
O&M Grade: **0**
Clock Start/From:
Clock To:
1st Value:
2nd Value:
Value Percent:
Step: **NO**
Remarks: **ACCESS MH**

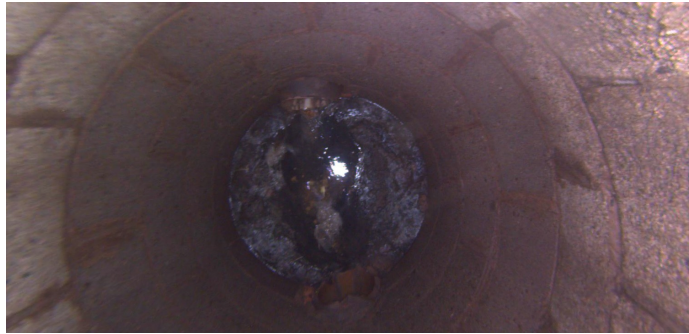
Code:	SAV
Description:	Surface Aggregate Visible
Distance (ft):	.7
Structural Grade:	3
O&M Grade:	0
Clock Start/From:	12
Clock To:	12
1st Value:	
2nd Value:	
Value Percent:	
Step:	NO
Remarks:

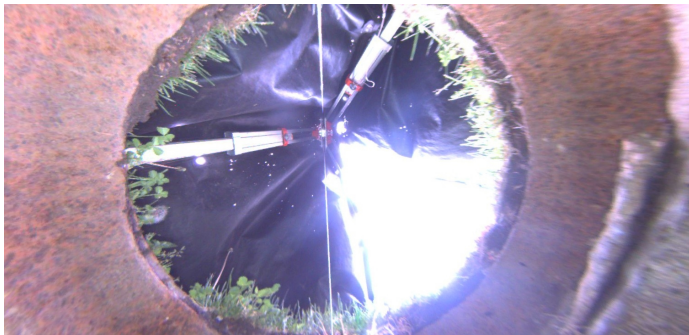
Code:	MGO
Description:	General Observation
Distance (ft):	1.6
Structural Grade:	0
O&M Grade:	0
Clock Start/From:	
Clock To:	
1st Value:	
2nd Value:	
Value Percent:	
Step:	NO
Remarks:	UNDERSIDE OF FRAME

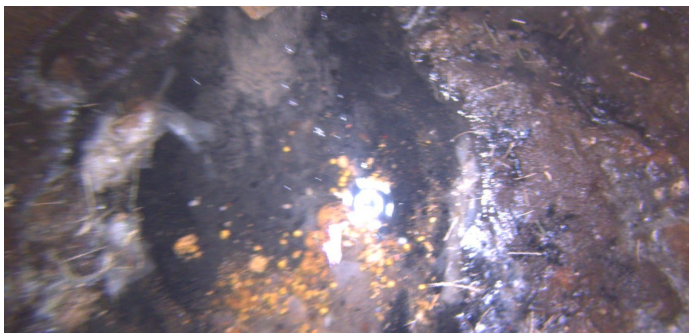
Code:	DSZ
Description:	Deposits Settled Other
Distance (ft):	4.2
Structural Grade:	0
O&M Grade:	2
Clock Start/From:	12
Clock To:	12
1st Value:	
2nd Value:	
Value Percent:	5.000
Step:	NO
Remarks:	MISC

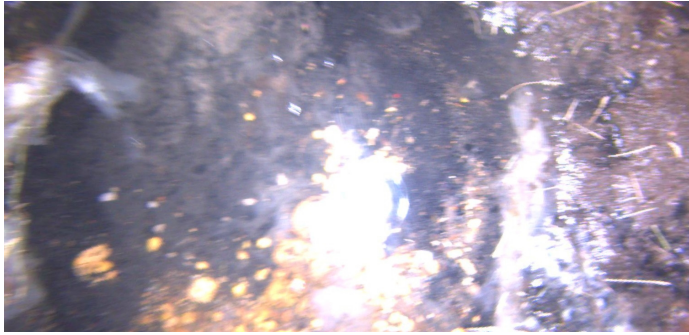
Code:	MGO
Description:	General Observation
Distance (ft):	4.5
Structural Grade:	0
O&M Grade:	0
Clock Start/From:	
Clock To:	
1st Value:	
2nd Value:	
Value Percent:	
Step:	NO
Remarks:	END SURVEY
