Manhole Inspection Report

Date:	04/10/2018	Weather:		Coding:	RZMACP
MH#:	M-404-023	Owner:	NA	Len. Surveyed:	5.4
P.O.#:		Surveyor:	John Kuglmaier	Rim to Invert:	6.5
Customer:		Cert. #:	U-1215-07002349	Wall Material:	Concrete (reinforced)

Street:	168' East of Wabash St. 145' South o	Project:	Hobart, IN
City:	Hobart, IN	GPS Northing:	2899212.892
Location:		GPS Easting:	2899212.892
Drain Area:	Northwest	GPS Accuracy:	Sub-Meter
Cover Shape:	Circular	Evidence of Surcharge:	Yes
Cover Size:	23.0	Potential for Runoff:	None
Comments:

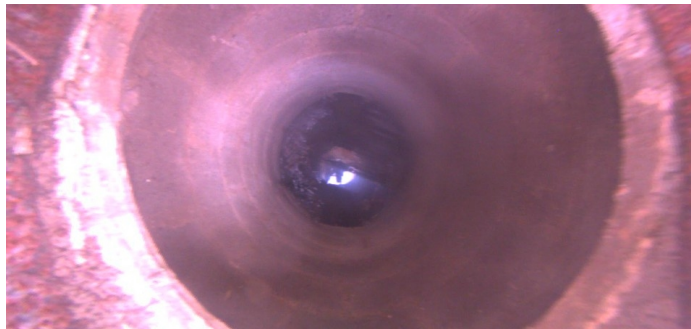
Code: **MGP**
Description: **General Photo**

Distance (ft): **.0**
Structural Grade: **0**
O&M Grade: **0**
Clock Start/From:
Clock To:
1st Value:
2nd Value:
Value Percent:
Step: **NO**
Remarks:

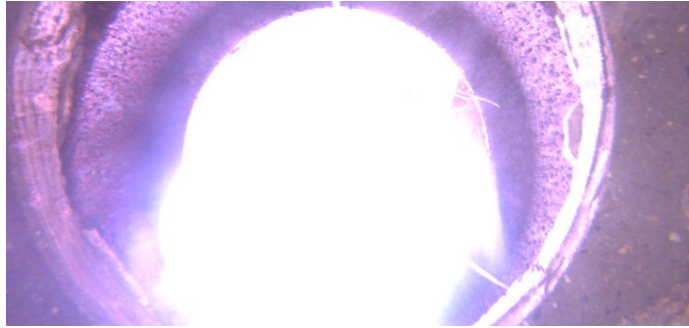
Code: **MGP**
Description: **General Photo**

Distance (ft): **1.9**
Structural Grade: **0**
O&M Grade: **0**
Clock Start/From:
Clock To:
1st Value:
2nd Value:
Value Percent:
Step: **NO**
Remarks:

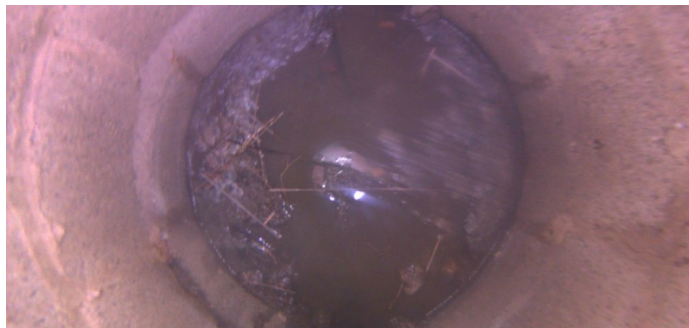
Code: **MGO**
Description: **General Observation**

Distance (ft): **3.9**
Structural Grade: **0**
O&M Grade: **0**
Clock Start/From:
Clock To:
1st Value:
2nd Value:
Value Percent:
Step: **NO**
Remarks: **Surcharge**

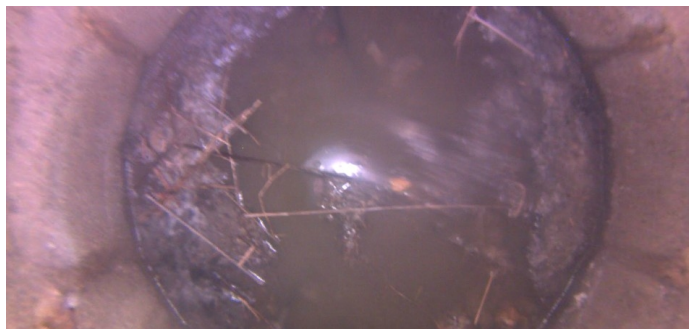
Code: **MGO**
Description: **General Observation**

Distance (ft): **4.7**
Structural Grade: **0**
O&M Grade: **0**
Clock Start/From:
Clock To:
1st Value:
2nd Value:
Value Percent:
Step: **NO**
Remarks: **Ins. Comp.**
