Manhole Inspection Report

Date:	04/10/2018	Weather:		Coding:	RZMACP
MH#:	M-404-024	Owner:	NA	Len. Surveyed:	4.8
P.O.#:		Surveyor:	John Kuglmaier	Rim to Invert:	5.8
Customer:		Cert. #:	U-1215-07002349	Wall Material:	Concrete (reinforced)

Street:	166' East of Wabash St. 41st Ave.	Project:	Hobart, IN
City:	Hobart, IN	GPS Northing:	2899217.767
Location:		GPS Easting:	2899217.767
Drain Area:	Northwest	GPS Accuracy:	Sub-Meter
Cover Shape:	Circular	Evidence of Surcharge:	No
Cover Size:	23.0	Potential for Runoff:	None
Comments:

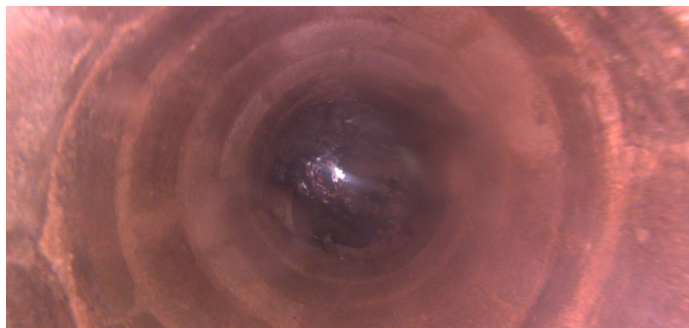
Code: **MGP**
Description: **General Photo**

Distance (ft): **.0**
Structural Grade: **0**
O&M Grade: **0**
Clock Start/From:
Clock To:
1st Value:
2nd Value:
Value Percent:
Step: **NO**
Remarks:

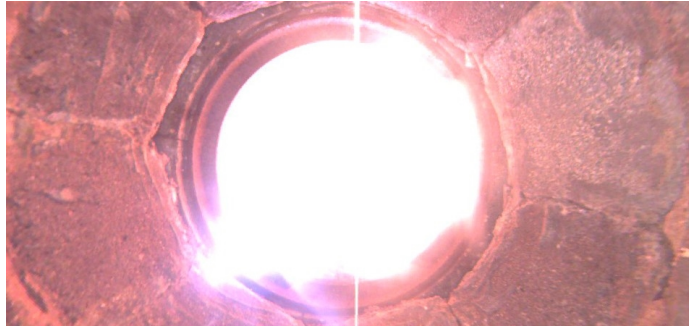
Code: **MGP**
Description: **General Photo**

Distance (ft): **2.2**
Structural Grade: **0**
O&M Grade: **0**
Clock Start/From:
Clock To:
1st Value:
2nd Value:
Value Percent:
Step: **NO**
Remarks:

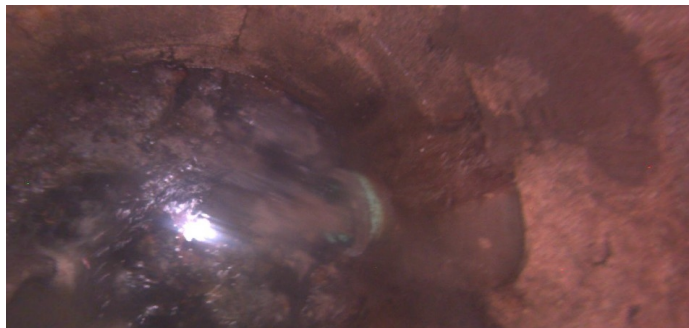
Code: **IS**
Description: **Infil Stain**

Distance (ft): **2.9**
Structural Grade: **0**
O&M Grade: **0**
Clock Start/From: **2**
Clock To:
1st Value:
2nd Value:
Value Percent:
Step: **NO**
Remarks:

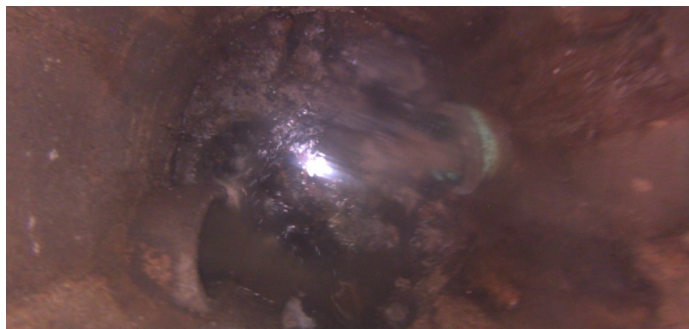
Code: **DAZ**
Description: **Deposits Attached Other**

Distance (ft): **2.9**
Structural Grade: **0**
O&M Grade: **2**
Clock Start/From: **12**
Clock To: **12**
1st Value:
2nd Value:
Value Percent: **10.000**
Step: **NO**
Remarks: **Mixed materials**

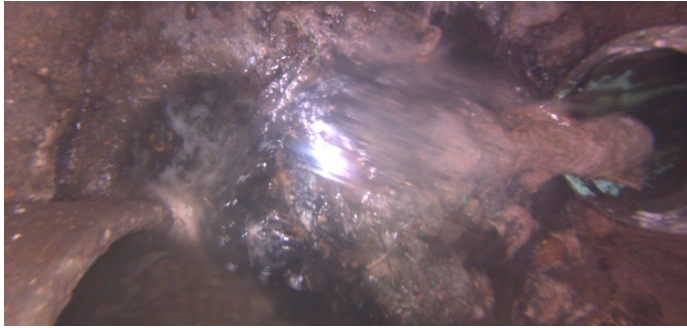
Code:	MGO
Description:	General Observation
Distance (ft):	4.1
Structural Grade:	0
O&M Grade:	0
Clock Start/From:	
Clock To:	
1st Value:	
2nd Value:	
Value Percent:	
Step:	NO
Remarks:	Ins. Comp.
