Manhole Inspection Report

Date:	05/14/2018	Weather:		Coding:	RZMACP
MH#:	M-404-026	Owner:	NA	Len. Surveyed:	5.9
P.O.#:		Surveyor:	Jen Costello	Rim to Invert:	6.5
Customer:		Cert. #:	U-907-5518	Wall Material:	Concrete (reinforced)

Street:	Dearborn St. 216' North of Ridge Rd.	Project:	Hobart, IN
City:	Hobart, IN	GPS Northing:	41.54201889
Location:		GPS Easting:	-87.28061676
Drain Area:	Northwest	GPS Accuracy:	Nearest Meter
Cover Shape:	Circular	Evidence of Surcharge:	No
Cover Size:	22.5	Potential for Runoff:	None
Comments:

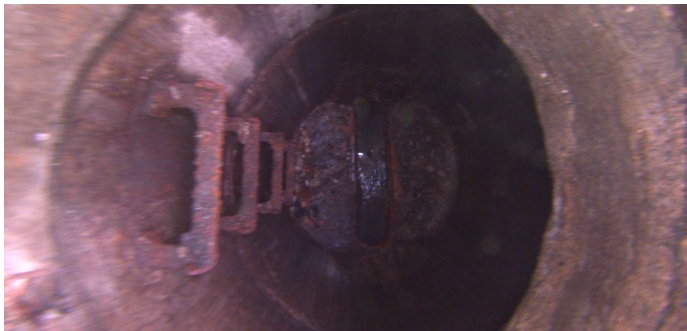
Code: **MGO**
Description: **General Observation**

Distance (ft): **.0**
Structural Grade: **0**
O&M Grade: **0**
Clock Start/From:
Clock To:
1st Value:
2nd Value:
Value Percent:
Step: **NO**
Remarks: **ACCESS MH**

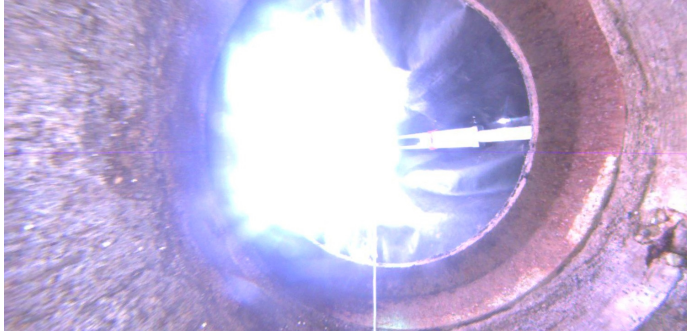
Code: **MGO**
Description: **General Observation**

Distance (ft): **2.4**
Structural Grade: **0**
O&M Grade: **0**
Clock Start/From:
Clock To:
1st Value:
2nd Value:
Value Percent:
Step: **NO**
Remarks: **UNDERSIDE OF FRAME**

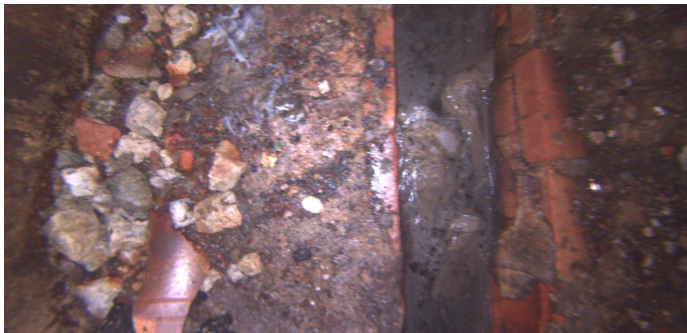
Code: **OBR**
Description: **Obstacle Rocks**

Distance (ft): **5.1**
Structural Grade: **0**
O&M Grade: **2**
Clock Start/From: **5**
Clock To:
1st Value:
2nd Value:
Value Percent: **5.000**
Step: **NO**
Remarks:

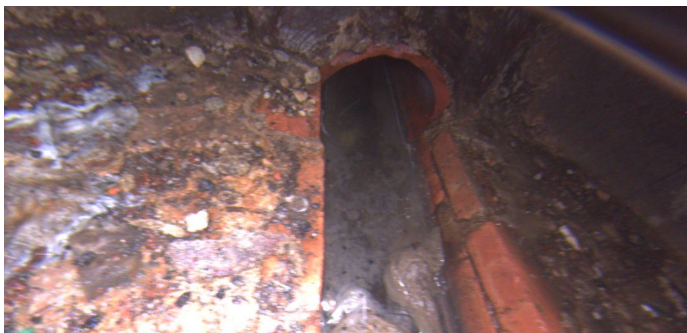
Code: **MGO**
Description: **General Observation**

Distance (ft): **5.9**
Structural Grade: **0**
O&M Grade: **0**
Clock Start/From:
Clock To:
1st Value:
2nd Value:
Value Percent:
Step: **NO**
Remarks: **END SURVEY**
