# Manhole Inspection Report

Position	Code	Observation	Video (sec)	Grade

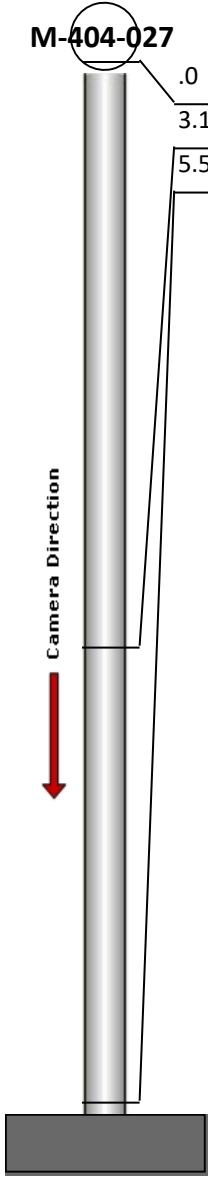
.0	MGO	General Observation	10	NA
	3.1	FC	Fracture Circumferential	28	S 2
	5.5	MGO	General Observation	45	NA

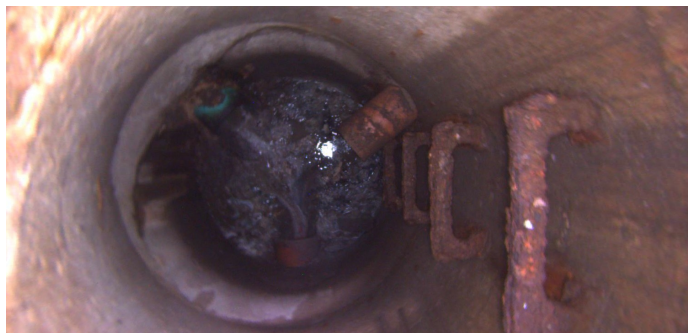
Code: **MGO**  
Description: **General Observation**

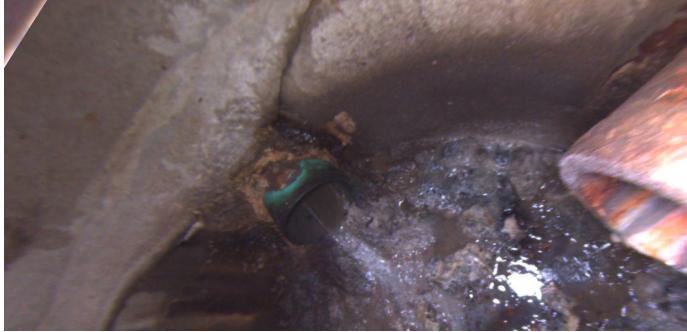
Code: **FC**  
Description: **Fracture Circumferential**
