Manhole Inspection Report

Date:	04/12/2018	Weather:		Coding:	RZMACP
MH#:	M-404-032	Owner:	NA	Len. Surveyed:	11.2
P.O.#:		Surveyor:	John Kuglmaier	Rim to Invert:	15.0
Customer:		Cert. #:	U-1215-07002349	Wall Material:	Concrete (reinforced)

Street:	Ridge Rd. 20' East of LaSalle St.	Project:	Hobart, IN
City:	Hobart, IN	GPS Northing:	2898098.202
Location:		GPS Easting:	2898098.202
Drain Area:	Northwest	GPS Accuracy:	Sub-Meter
Cover Shape:	Circular	Evidence of Surcharge:	No
Cover Size:	23.0	Potential for Runoff:	None
Comments:

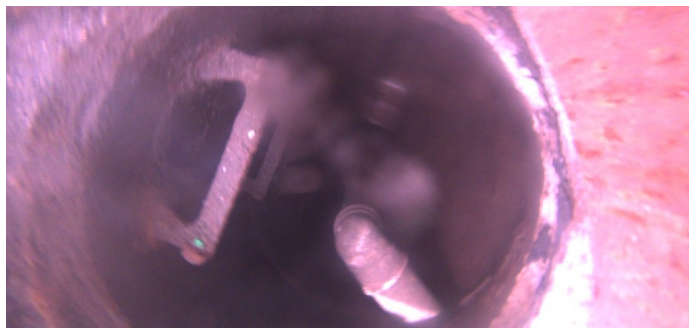
Code: **MGP**
Description: **General Photo**

Distance (ft): **.0**
Structural Grade: **0**
O&M Grade: **0**
Clock Start/From:
Clock To:
1st Value:
2nd Value:
Value Percent:
Step: **NO**
Remarks:

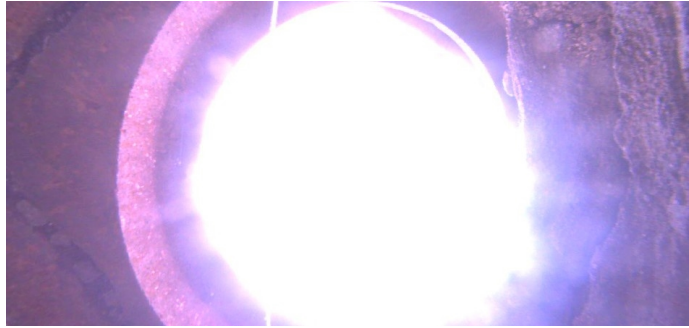
Code: **MGP**
Description: **General Photo**

Distance (ft): **1.7**
Structural Grade: **0**
O&M Grade: **0**
Clock Start/From:
Clock To:
1st Value:
2nd Value:
Value Percent:
Step: **NO**
Remarks:

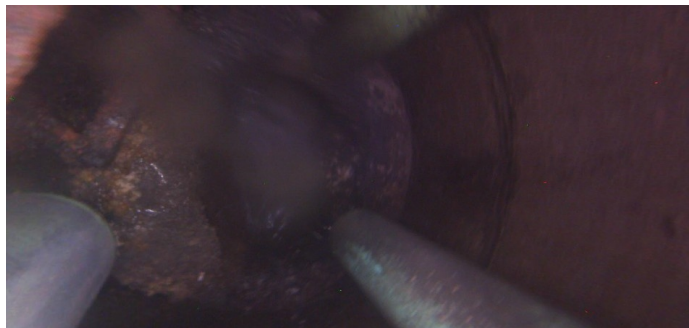
Code: **IS**
Description: **Infil Stain**

Distance (ft): **9.5**
Structural Grade: **0**
O&M Grade: **0**
Clock Start/From: **3**
Clock To:
1st Value:
2nd Value:
Value Percent:
Step: **NO**
Remarks:

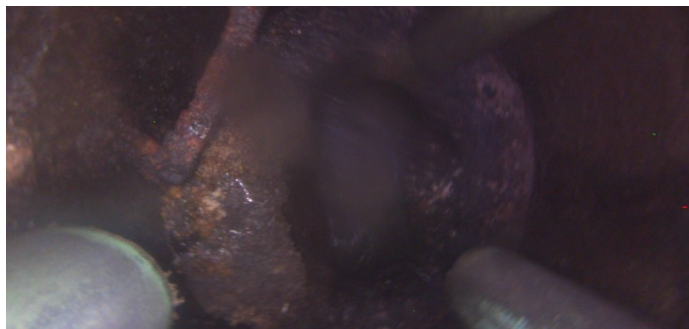
Code: **DAZ**
Description: **Deposits Attached Other**

Distance (ft): **10.2**
Structural Grade: **0**
O&M Grade: **3**
Clock Start/From: **12**
Clock To: **12**
1st Value:
2nd Value:
Value Percent: **15.000**
Step: **NO**
Remarks: **Mixed materials**

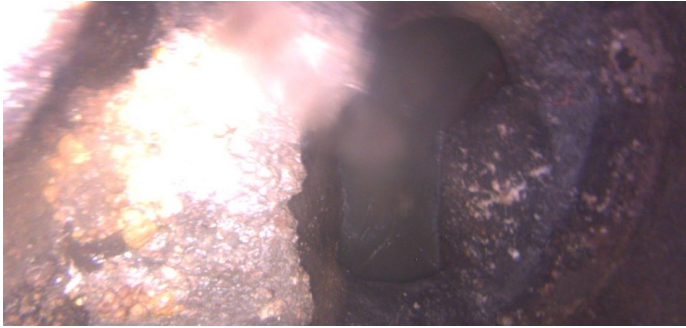
Code:	MGO
Description:	General Observation
Distance (ft):	11.2
Structural Grade:	0
O&M Grade:	0
Clock Start/From:	
Clock To:	
1st Value:	
2nd Value:	
Value Percent:	
Step:	NO
Remarks:	Ins. Comp.
