Manhole Inspection Report

Date:	05/14/2018	Weather:		Coding:	RZMACP
MH#:	M-404-036	Owner:	NA	Len. Surveyed:	4.5
P.O.#:		Surveyor:	Jen Costello	Rim to Invert:	4.7
Customer:		Cert. #:	U-907-5518	Wall Material:	Concrete (reinforced)

Street:	Dearborn St. 589' North of Old Ridg	Project:	Hobart, IN
City:	Hobart, IN	GPS Northing:	41.5430336
Location:		GPS Easting:	-87.28070831
Drain Area:	Northwest	GPS Accuracy:	Nearest Meter
Cover Shape:	Circular	Evidence of Surcharge:	No
Cover Size:	22.5	Potential for Runoff:	None
Comments:

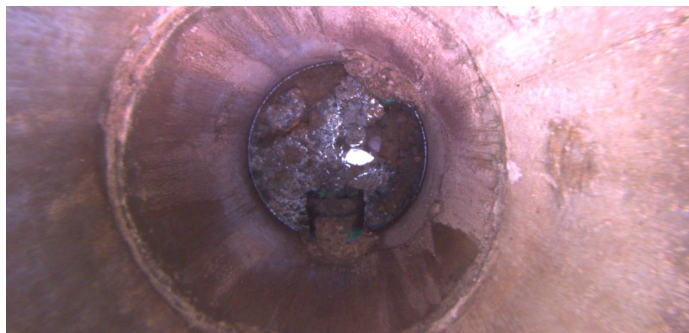
Code: **MGO**
Description: **General Observation**

Distance (ft): **.0**
Structural Grade: **0**
O&M Grade: **0**
Clock Start/From:
Clock To:
1st Value:
2nd Value:
Value Percent:
Step: **NO**
Remarks: **ACCESS MH**

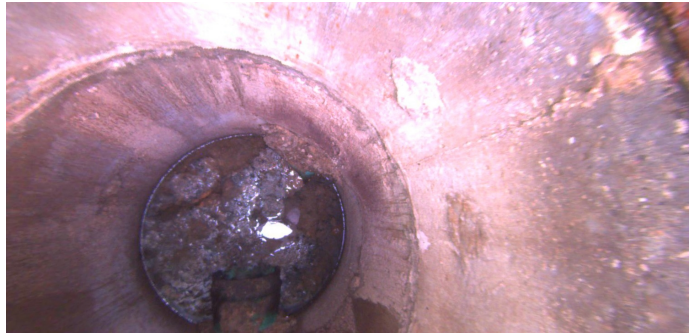
Code: **FL**
Description: **Fracture Longitudinal**

Distance (ft): **.0**
Structural Grade: **3**
O&M Grade: **0**
Clock Start/From: **2**
Clock To:
1st Value:
2nd Value:
Value Percent:
Step: **NO**
Remarks:

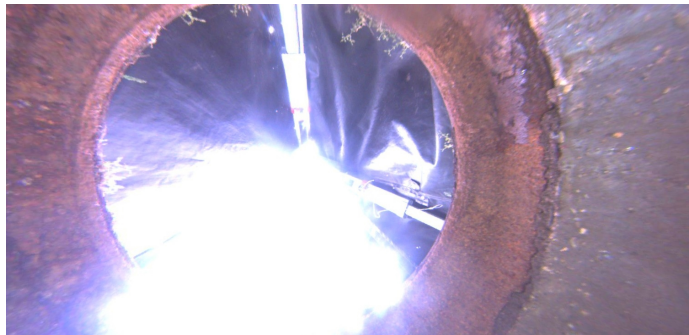
Code: **MGO**
Description: **General Observation**

Distance (ft): **1.3**
Structural Grade: **0**
O&M Grade: **0**
Clock Start/From:
Clock To:
1st Value:
2nd Value:
Value Percent:
Step: **NO**
Remarks: **UNDERSIDE OF FRAME**

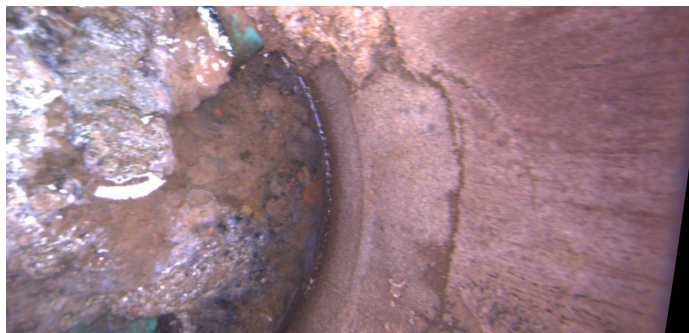
Code: **FC**
Description: **Fracture Circumferential**

Distance (ft): **3.0**
Structural Grade: **2**
O&M Grade: **0**
Clock Start/From: **1**
Clock To: **2**
1st Value:
2nd Value:
Value Percent:
Step: **NO**
Remarks:

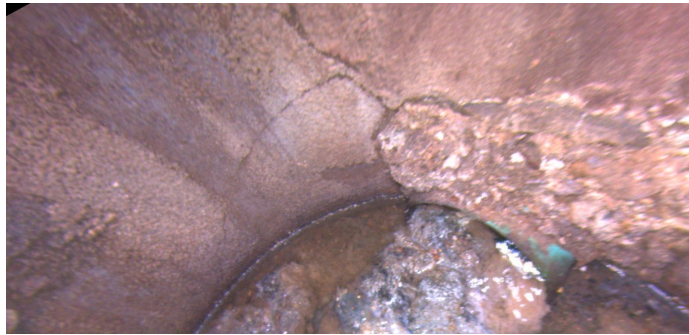
Code:	FM
Description:	Fracture Multiple
Distance (ft):	3.0
Structural Grade:	4
O&M Grade:	0
Clock Start/From:	11
Clock To:	12
1st Value:	
2nd Value:	
Value Percent:	
Step:	NO
Remarks:

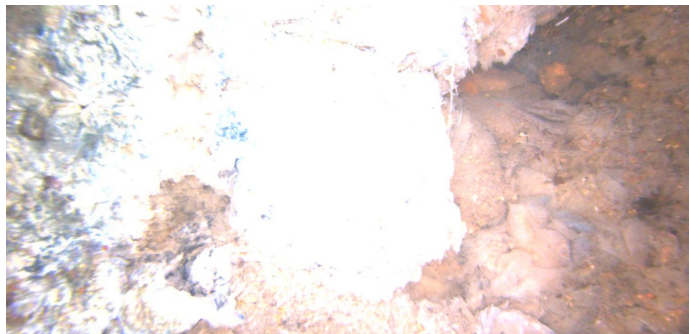
Code:	DSZ
Description:	Deposits Settled Other
Distance (ft):	4.5
Structural Grade:	0
O&M Grade:	2
Clock Start/From:	12
Clock To:	12
1st Value:	
2nd Value:	
Value Percent:	10.000
Step:	NO
Remarks:	MISC
