Manhole Inspection Report

Date:	10/09/2022	Weather:		Coding:	RZMACP
MH#:	M-404-037	Owner:	NA	Len. Surveyed:	3.0
P.O.#:		Surveyor:	Jen Costello	Rim to Invert:	3.7
Customer:		Cert. #:	U-907-5518	Wall Material:	Concrete (cast in place)

Street:	Dearborn St. 707' North of Old Ridg	Project:	Hobart, IN
City:	Hobart, IN	GPS Northing:	2293041.537
Location:	Other	GPS Easting:	2898709.912
Drain Area:	Northwest	GPS Accuracy:	Sub-Meter
Cover Shape:	Circular	Evidence of Surcharge:	No
Cover Size:	24.0	Potential for Runoff:	None
Comments:

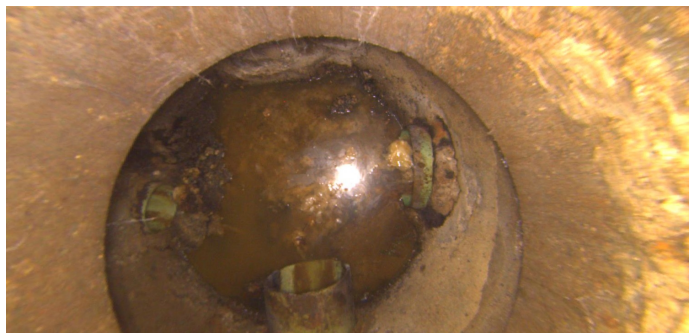
Code: **MGO**
Description: **General Observation**

Distance (ft): **.0**
Structural Grade: **0**
O&M Grade: **0**
Clock Start/From:
Clock To:
1st Value:
2nd Value:
Value Percent:
Step: **NO**
Remarks: **access mh**

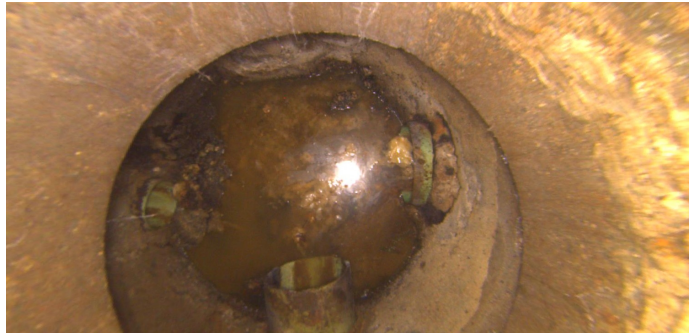
Code:	SAV
Description:	Surface Aggregate Visible
Distance (ft):	.0
Structural Grade:	3
O&M Grade:	0
Clock Start/From:	12
Clock To:	12
1st Value:	
2nd Value:	
Value Percent:	
Step:	NO
Remarks:

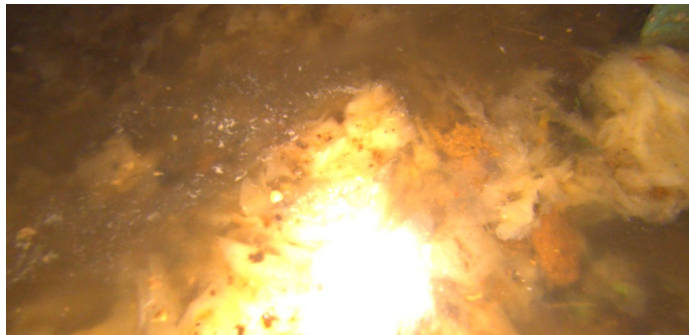
Code:	SAV
Description:	Surface Aggregate Visible
Distance (ft):	2.8
Structural Grade:	3
O&M Grade:	0
Clock Start/From:	12
Clock To:	12
1st Value:	
2nd Value:	
Value Percent:	
Step:	NO
Remarks:

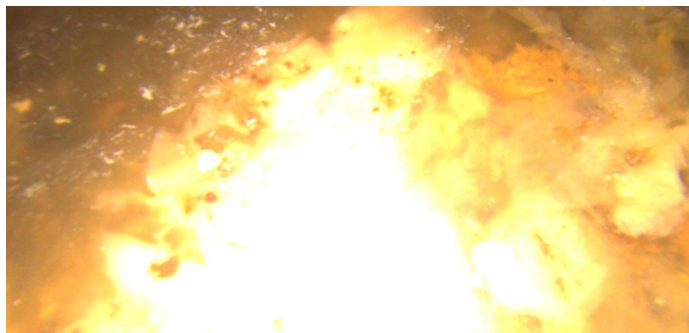
Code:	MGO
Description:	General Observation
Distance (ft):	3.0
Structural Grade:	0
O&M Grade:	0
Clock Start/From:	
Clock To:	
1st Value:	
2nd Value:	
Value Percent:	
Step:	NO
Remarks:	end of survey
