# Manhole Inspection Report

Date:	04/28/2018	Weather:		Coding:	RZMACP
MH#:	M-405-002	Owner:	NA	Len. Surveyed:	8.2
P.O.#:		Surveyor:	Jen Costello	Rim to Invert:	8.0
Customer:		Cert. #:	U-907-5518	Wall Material:	Concrete (reinforced)

Street:	Intersection of Wabash St. and 4th P	Project:	Hobart, IN
City:	Hobart, IN	GPS Northing:	2899105.923
Location:		GPS Easting:	2899105.923
Drain Area:	West	GPS Accuracy:	Sub-Meter
Cover Shape:	Circular	Evidence of Surcharge:	No
Cover Size:	22.5	Potential for Runoff:	None
Comments:

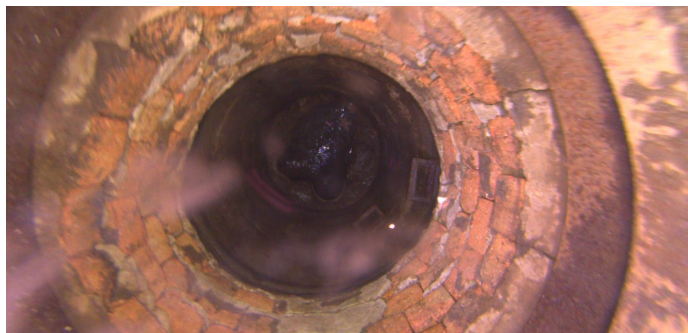
Code: **MGO**  
Description: **General Observation**

Distance (ft): **.0**  
Structural Grade: **0**  
O&M Grade: **0**  
Clock Start/From:  
Clock To:  
1st Value:  
2nd Value:  
Value Percent:  
Step: **NO**  
Remarks: **ACCESS MH**

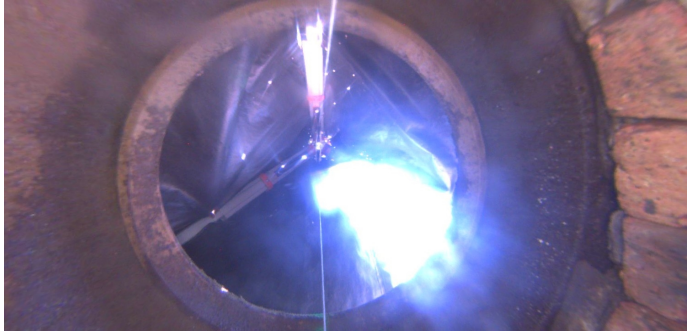
Code:	<b>MGP</b>
Description:	<b>General Photo</b>
Distance (ft):	<b>1.8</b>
Structural Grade:	<b>0</b>
O&M Grade:	<b>0</b>
Clock Start/From:	
Clock To:	
1st Value:	
2nd Value:	
Value Percent:	
Step:	<b>NO</b>
Remarks:	<b>UNDERSIDE OF FRAME</b>

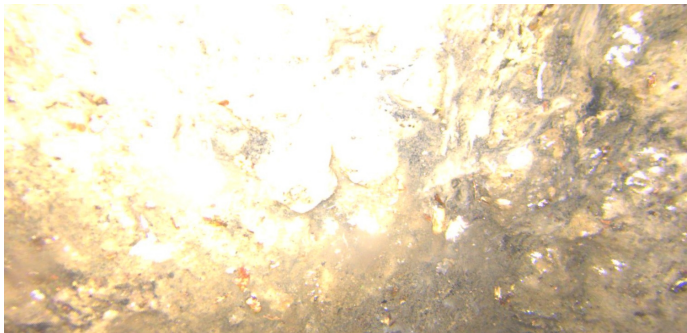
Code:	<b>MGO</b>
Description:	<b>General Observation</b>
Distance (ft):	<b>8.2</b>
Structural Grade:	<b>0</b>
O&M Grade:	<b>0</b>
Clock Start/From:	
Clock To:	
1st Value:	
2nd Value:	
Value Percent:	
Step:	<b>NO</b>
Remarks:	<b>END SURVEY</b>
