# Manhole Inspection Report

Date:	<b>04/28/2018</b>	Weather:		Coding:	<b>RZMACP</b>
MH#:	<b>M-405-003</b>	Owner:	<b>NA</b>	Len. Surveyed:	<b>9.6</b>
P.O.#:		Surveyor:	<b>Jen Costello</b>	Rim to Invert:	<b>9.4</b>
Customer:		Cert. #:	<b>U-907-5518</b>	Wall Material:	<b>Concrete (reinforced)</b>

Street:	<b>Wabash St. 177' South of 4th St.</b>	Project:	<b>Hobart, IN</b>
City:	<b>Hobart, IN</b>	GPS Northing:	<b>2899101.148</b>
Location:		GPS Easting:	<b>2899101.148</b>
Drain Area:	<b>West</b>	GPS Accuracy:	<b>Sub-Meter</b>
Cover Shape:	<b>Circular</b>	Evidence of Surcharge:	<b>No</b>
Cover Size:	<b>24.0</b>	Potential for Runoff:	<b>None</b>
Comments:

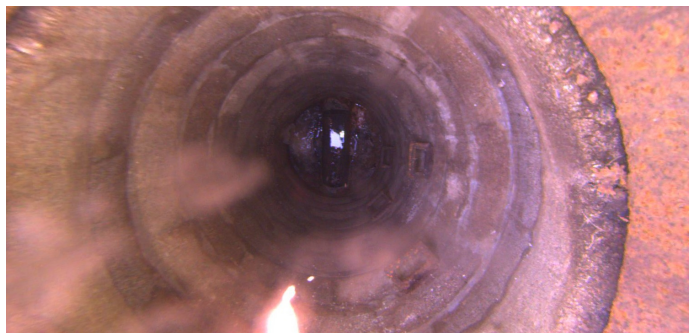
Code: **MGO**  
Description: **General Observation**

Distance (ft): **.0**  
Structural Grade: **0**  
O&M Grade: **0**  
Clock Start/From:  
Clock To:  
1st Value:  
2nd Value:  
Value Percent:  
Step: **NO**  
Remarks: **ACCESS MH**

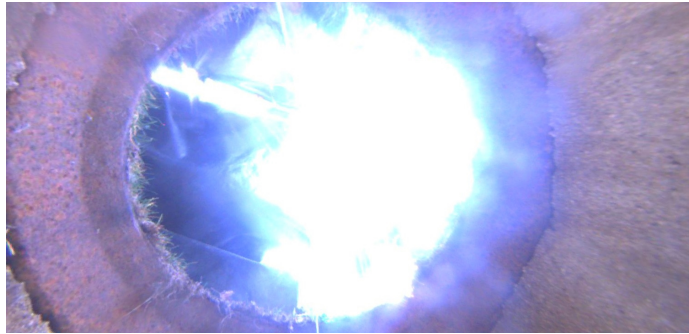
Code:	MGP
Description:	General Photo
Distance (ft):	2.0
Structural Grade:	0
O&M Grade:	0
Clock Start/From:	
Clock To:	
1st Value:	
2nd Value:	
Value Percent:	
Step:	NO
Remarks:	UNDERSIDE OF FRAME

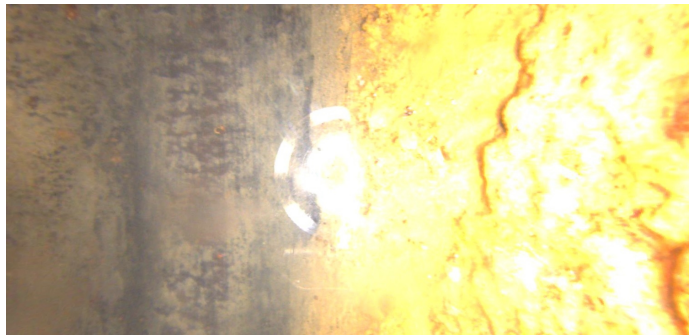
Code:	MGO
Description:	General Observation
Distance (ft):	9.6
Structural Grade:	0
O&M Grade:	0
Clock Start/From:	
Clock To:	
1st Value:	
2nd Value:	
Value Percent:	
Step:	NO
Remarks:	END SURVEY
