Manhole Inspection Report

Date:	04/28/2018	Weather:		Coding:	RZMACP
MH#:	M-405-007	Owner:	NA	Len. Surveyed:	13.5
P.O.#:		Surveyor:	Jen Costello	Rim to Invert:	14.8
Customer:		Cert. #:	U-907-5518	Wall Material:	Concrete (reinforced)

Street:	Wabash St. 181' South of 3rd St.	Project:	Hobart, IN
City:	Hobart, IN	GPS Northing:	2898994.55
Location:		GPS Easting:	2898994.55
Drain Area:	West	GPS Accuracy:	Sub-Meter
Cover Shape:	Circular	Evidence of Surcharge:	No
Cover Size:	24.0	Potential for Runoff:	None
Comments:

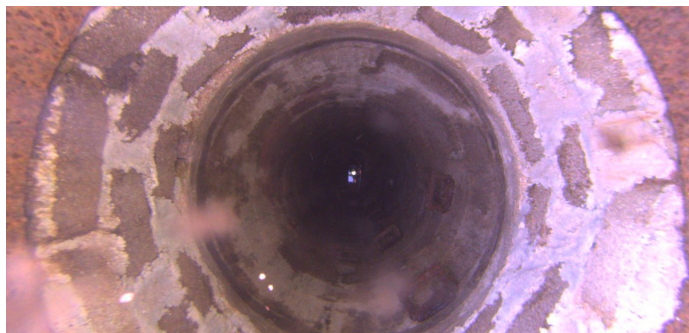
Code: **MGO**
Description: **General Observation**

Distance (ft): **.0**
Structural Grade: **0**
O&M Grade: **0**
Clock Start/From:
Clock To:
1st Value:
2nd Value:
Value Percent:
Step: **NO**
Remarks: **ACCESS MH**

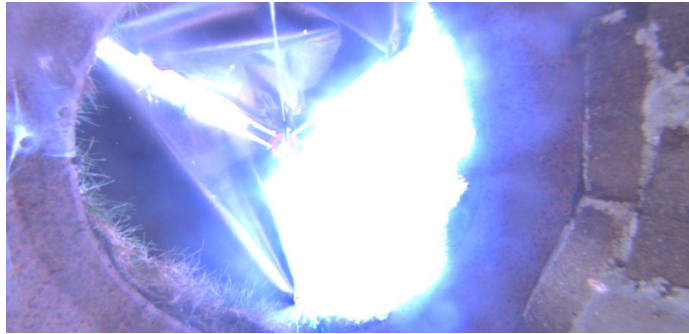
Code:	MGO
Description:	General Observation
Distance (ft):	2.0
Structural Grade:	0
O&M Grade:	0
Clock Start/From:	
Clock To:	
1st Value:	
2nd Value:	
Value Percent:	
Step:	NO
Remarks:	UNDERSIDE OF FRAME

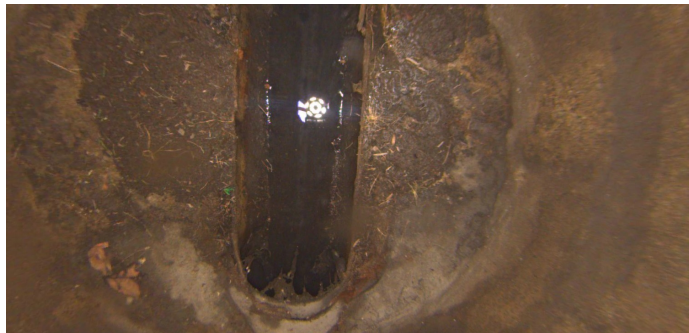
Code:	DSF
Description:	Deposits Settled Fine
Distance (ft):	12.8
Structural Grade:	0
O&M Grade:	2
Clock Start/From:	12
Clock To:	12
1st Value:	
2nd Value:	
Value Percent:	5.000
Step:	NO
Remarks:

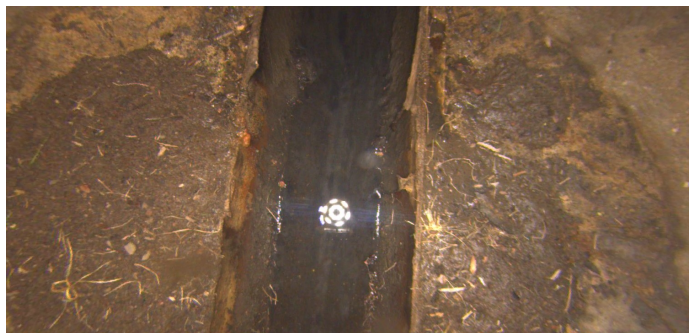
Code:	MGO
Description:	General Observation
Distance (ft):	13.5
Structural Grade:	0
O&M Grade:	0
Clock Start/From:	
Clock To:	
1st Value:	
2nd Value:	
Value Percent:	
Step:	NO
Remarks:	END SURVEY
