# Manhole Inspection Report

Date:	04/20/2018	Weather:		Coding:	RZMACP
MH#:	M-405-012	Owner:	NA	Len. Surveyed:	14.3
P.O.#:		Surveyor:	Jen Costello	Rim to Invert:	17.9
Customer:		Cert. #:	U-907-5518	Wall Material:	Concrete (reinforced)

Street:	3rd St. 162' East of LaSalle St.	Project:	Hobart, IN
City:	Hobart, IN	GPS Northing:	2898237.792
Location:		GPS Easting:	2898237.792
Drain Area:	West	GPS Accuracy:	Sub-Meter
Cover Shape:	Circular	Evidence of Surcharge:	No
Cover Size:	23.0	Potential for Runoff:	None
Comments:

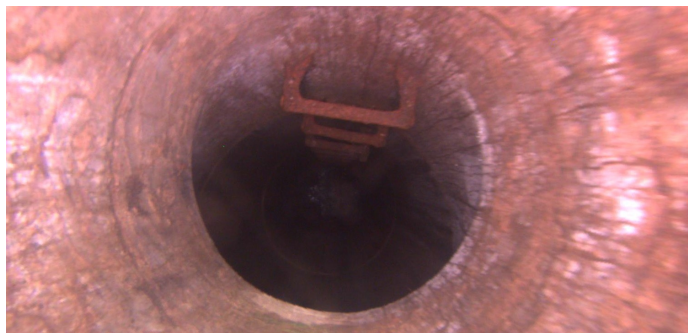
Code: **MGO**  
Description: **General Observation**

Distance (ft): **.0**  
Structural Grade: **0**  
O&M Grade: **0**  
Clock Start/From:  
Clock To:  
1st Value:  
2nd Value:  
Value Percent:  
Step: **NO**  
Remarks: **ACCESS mh**

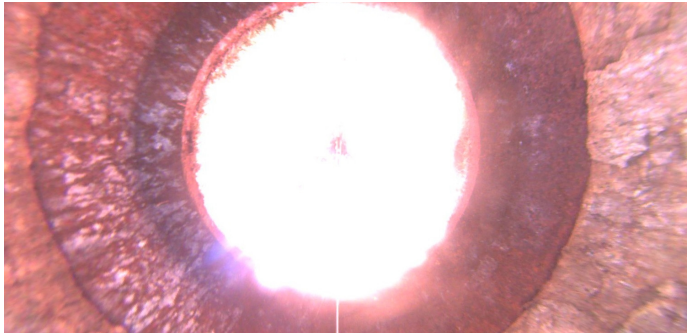
Code:	<b>MGO</b>
Description:	<b>General Observation</b>
Distance (ft):	<b>1.6</b>
Structural Grade:	<b>0</b>
O&M Grade:	<b>0</b>
Clock Start/From:	
Clock To:	
1st Value:	
2nd Value:	
Value Percent:	
Step:	<b>NO</b>
Remarks:	<b>underside of frame</b>

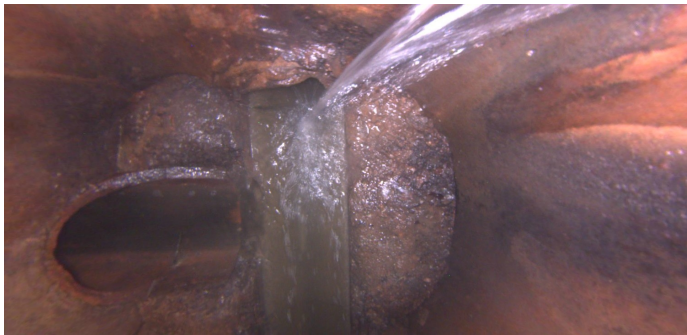
Code:	<b>MGO</b>
Description:	<b>General Observation</b>
Distance (ft):	<b>14.3</b>
Structural Grade:	<b>0</b>
O&M Grade:	<b>0</b>
Clock Start/From:	
Clock To:	
1st Value:	
2nd Value:	
Value Percent:	
Step:	<b>NO</b>
Remarks:	<b>end survey</b>
