Manhole Inspection Report

Date:	05/16/2018	Weather:		Coding:	RZMACP
MH#:	M-405-014	Owner:	NA	Len. Surveyed:	5.9
P.O.#:		Surveyor:	Jen Costello	Rim to Invert:	6.8
Customer:		Cert. #:	U-907-5518	Wall Material:	Concrete (reinforced)

Street:	LaSalle Pl. 383' North of 3rd St.	Project:	Hobart, IN
City:	Hobart, IN	GPS Northing:	41.53390121
Location:		GPS Easting:	-87.28234863
Drain Area:	West	GPS Accuracy:	Nearest Meter
Cover Shape:	Circular	Evidence of Surcharge:	No
Cover Size:	22.5	Potential for Runoff:	None
Comments:

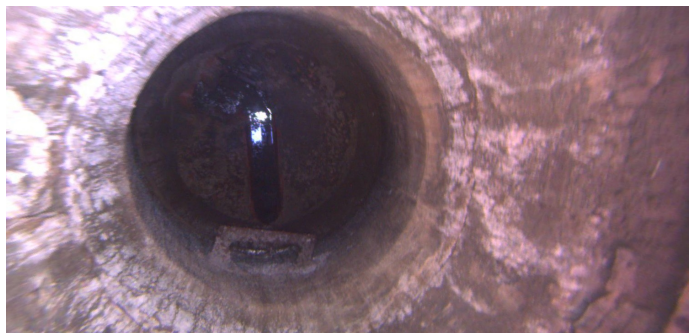
Code: **MGO**
Description: **General Observation**

Distance (ft): **.0**
Structural Grade: **0**
O&M Grade: **0**
Clock Start/From:
Clock To:
1st Value:
2nd Value:
Value Percent:
Step: **NO**
Remarks: **ACCESS MH**

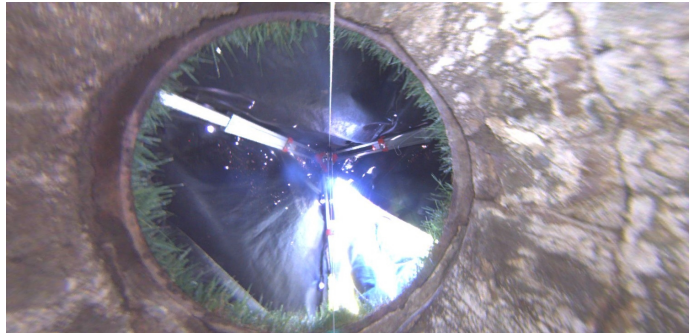
Code:	MGO
Description:	General Observation
Distance (ft):	1.9
Structural Grade:	0
O&M Grade:	0
Clock Start/From:	
Clock To:	
1st Value:	
2nd Value:	
Value Percent:	
Step:	NO
Remarks:	UNDERSIDE OF FRAME

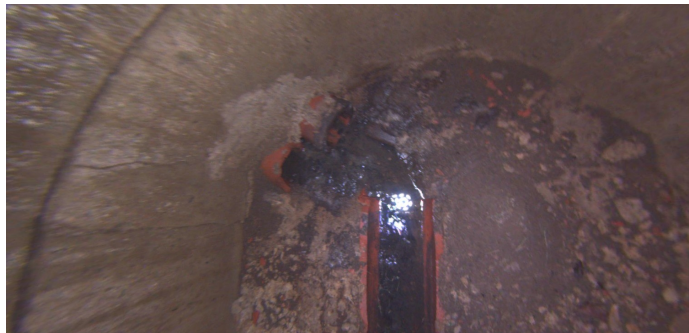
Code:	FM
Description:	Fracture Multiple
Distance (ft):	4.3
Structural Grade:	4
O&M Grade:	0
Clock Start/From:	9
Clock To:	10
1st Value:	
2nd Value:	
Value Percent:	
Step:	NO
Remarks:

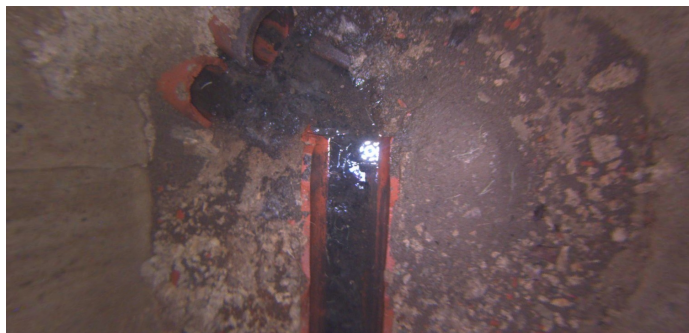
Code:	DSGV
Description:	Deposits Settled Gravel
Distance (ft):	4.9
Structural Grade:	0
O&M Grade:	2
Clock Start/From:	12
Clock To:	12
1st Value:	
2nd Value:	
Value Percent:	5.000
Step:	NO
Remarks:

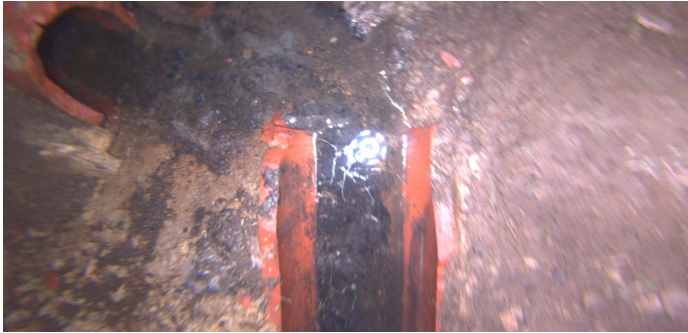
Code: **MGO**
Description: **General Observation**

Distance (ft): **5.9**
Structural Grade: **0**
O&M Grade: **0**
Clock Start/From:
Clock To:
1st Value:
2nd Value:
Value Percent:
Step: **NO**
Remarks: **END SURVEY**
