Manhole Inspection Report

Date:	05/17/2018	Weather:		Coding:	RZMACP
MH#:	M-405-018	Owner:	NA	Len. Surveyed:	13.4
P.O.#:		Surveyor:	Jen Costello	Rim to Invert:	14.0
Customer:		Cert. #:	U-907-5518	Wall Material:	Concrete (reinforced)

Street:	914' South of 3rd St. East of LaSalle	Project:	Hobart, IN
City:	Hobart, IN	GPS Northing:	2898245.426
Location:		GPS Easting:	2898245.426
Drain Area:	West	GPS Accuracy:	Sub-Meter
Cover Shape:	Circular	Evidence of Surcharge:	No
Cover Size:	24.0	Potential for Runoff:	None
Comments:

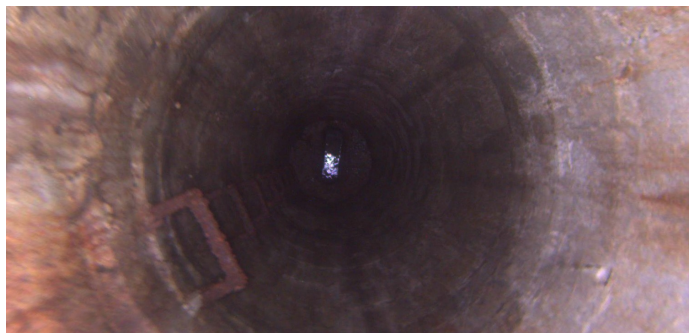
Code: **MGO**
 Description: **General Observation**

Distance (ft): **.0**
 Structural Grade: **0**
 O&M Grade: **0**
 Clock Start/From:
 Clock To:
 1st Value:
 2nd Value:
 Value Percent:
 Step: **NO**
 Remarks: **access MH**

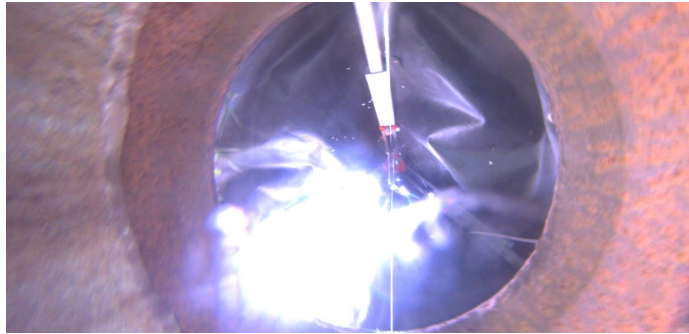
Code:	MGO
Description:	General Observation
Distance (ft):	1.4
Structural Grade:	0
O&M Grade:	0
Clock Start/From:	
Clock To:	
1st Value:	
2nd Value:	
Value Percent:	
Step:	NO
Remarks:	UNDERSIDE OF FRAME

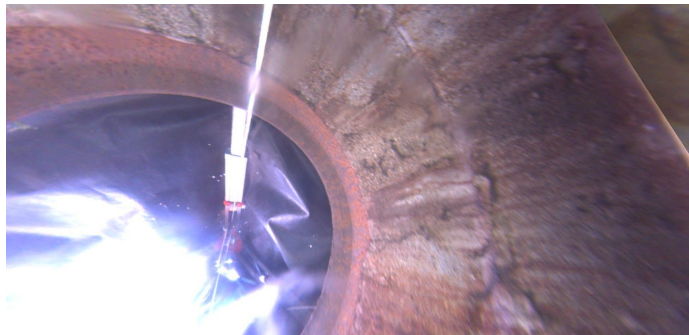
Code:	FM
Description:	Fracture Multiple
Distance (ft):	1.9
Structural Grade:	4
O&M Grade:	0
Clock Start/From:	9
Clock To:	12
1st Value:	
2nd Value:	
Value Percent:	
Step:	NO
Remarks:

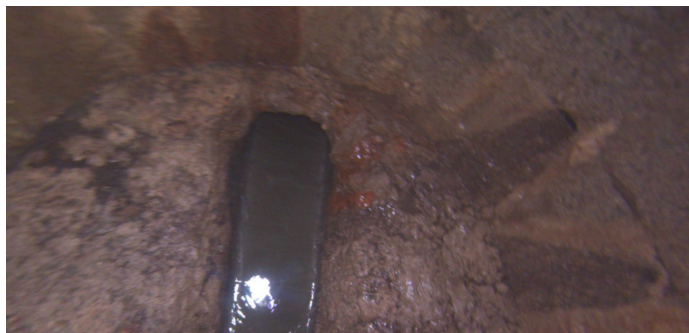
Code:	IW
Description:	Infil Weeper
Distance (ft):	11.9
Structural Grade:	0
O&M Grade:	2
Clock Start/From:	12
Clock To:	3
1st Value:	
2nd Value:	
Value Percent:	
Step:	NO
Remarks:

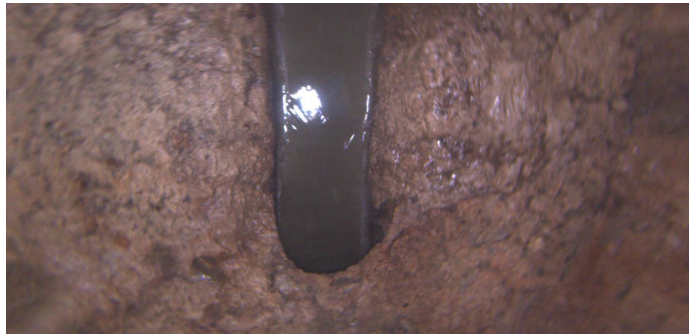
Code: **DSC**
Description: **Deposits Settled Compacted**

Distance (ft): **12.5**
Structural Grade: **0**
O&M Grade: **2**
Clock Start/From: **12**
Clock To: **12**
1st Value:
2nd Value:
Value Percent: **10.000**
Step: **NO**
Remarks:

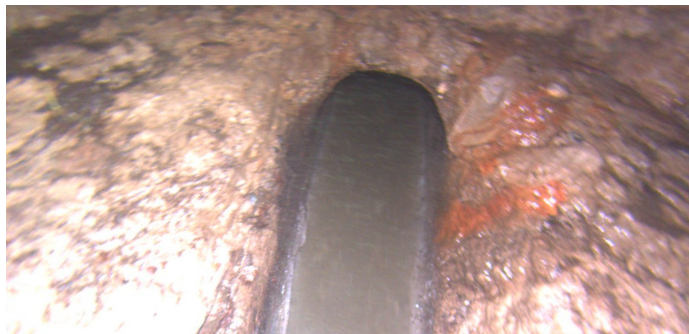
Code: **MGO**
Description: **General Observation**

Distance (ft): **13.4**
Structural Grade: **0**
O&M Grade: **0**
Clock Start/From:
Clock To:
1st Value:
2nd Value:
Value Percent:
Step: **NO**
Remarks: **END SURVEY**
