# Manhole Inspection Report

Date:	05/17/2018	Weather:		Coding:	RZMACP
MH#:	M-405-019	Owner:	NA	Len. Surveyed:	13.3
P.O.#:		Surveyor:	Jen Costello	Rim to Invert:	14.5
Customer:		Cert. #:	U-907-5518	Wall Material:	Concrete (reinforced)

Street:	LaSalle St. and 49th Ave. to the Nort	Project:	Hobart, IN
City:	Hobart, IN	GPS Northing:	2898244.766
Location:		GPS Easting:	2898244.766
Drain Area:	West	GPS Accuracy:	Sub-Meter
Cover Shape:	Circular	Evidence of Surcharge:	No
Cover Size:	22.5	Potential for Runoff:	None
Comments:

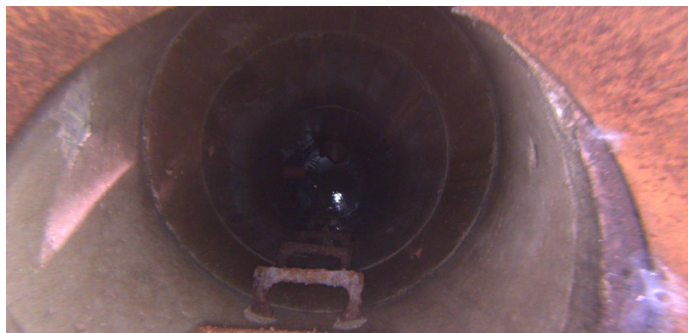
Code: **MGO**  
Description: **General Observation**

Distance (ft): **.0**  
Structural Grade: **0**  
O&M Grade: **0**  
Clock Start/From:  
Clock To:  
1st Value:  
2nd Value:  
Value Percent:  
Step: **NO**  
Remarks: **ACCESS MH**

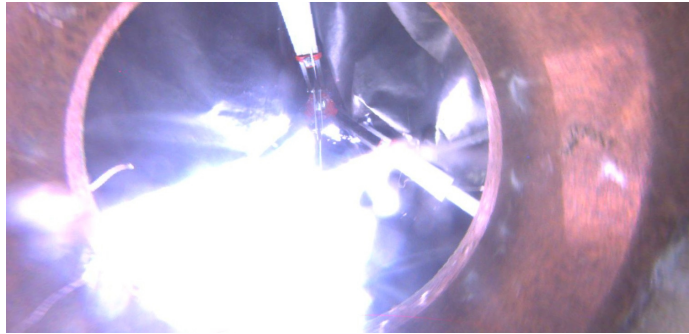
Code:	<b>MGO</b>
Description:	<b>General Observation</b>
Distance (ft):	<b>1.7</b>
Structural Grade:	<b>0</b>
O&M Grade:	<b>0</b>
Clock Start/From:	
Clock To:	
1st Value:	
2nd Value:	
Value Percent:	
Step:	<b>NO</b>
Remarks:	<b>UNDERSIDE OF FRAME</b>

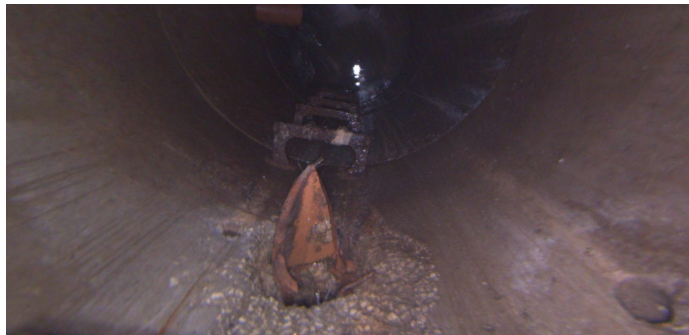
Code:	<b>SAP</b>
Description:	<b>Surface Aggregate Projecting</b>
Distance (ft):	<b>5.6</b>
Structural Grade:	<b>3</b>
O&M Grade:	<b>0</b>
Clock Start/From:	<b>5</b>
Clock To:	<b>7</b>
1st Value:	
2nd Value:	
Value Percent:	
Step:	<b>NO</b>
Remarks:	<b>AROUND TAP</b>

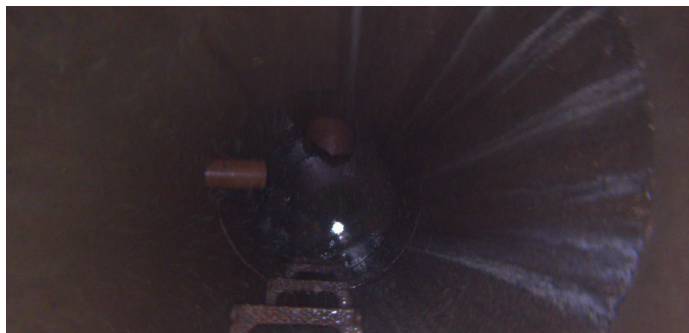
Code:	<b>IW</b>
Description:	<b>Infil Weeper</b>
Distance (ft):	<b>7.5</b>
Structural Grade:	<b>0</b>
O&M Grade:	<b>2</b>
Clock Start/From:	<b>12</b>
Clock To:	<b>12</b>
1st Value:	
2nd Value:	
Value Percent:	
Step:	<b>NO</b>
Remarks:

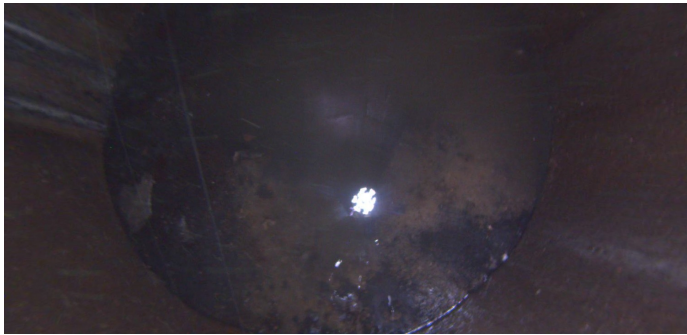
Code:	<b>MSA</b>
Description:	<b>Abandoned Survey</b>
Distance (ft):	<b>13.3</b>
Structural Grade:	<b>0</b>
O&M Grade:	<b>0</b>
Clock Start/From:	
Clock To:	
1st Value:	
2nd Value:	
Value Percent:	
Step:	<b>NO</b>
Remarks:	<b>BENCH IS SUBMERGED</b>
