Manhole Inspection Report

Date:	05/17/2018	Weather:		Coding:	RZMACP
MH#:	M-405-021	Owner:	NA	Len. Surveyed:	13.1
P.O.#:		Surveyor:	Jen Costello	Rim to Invert:	13.5
Customer:		Cert. #:	U-907-5518	Wall Material:	Concrete (reinforced)

Street:	South of 3rd St. 162' West of LaSalle	Project:	Hobart, IN
City:	Hobart, IN	GPS Northing:	2897914.416
Location:		GPS Easting:	2897914.416
Drain Area:	West	GPS Accuracy:	Sub-Meter
Cover Shape:	Circular	Evidence of Surcharge:	No
Cover Size:	22.5	Potential for Runoff:	None
Comments:

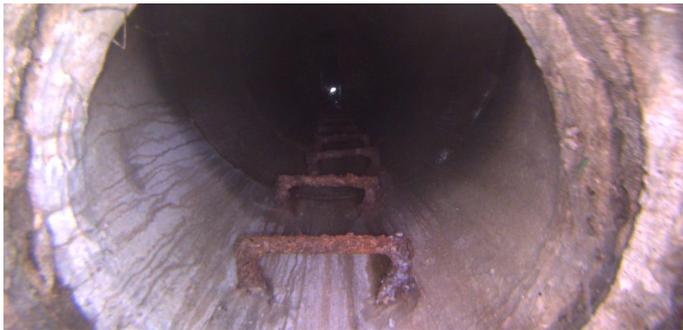
Code: **MGO**
Description: **General Observation**

Distance (ft): **.0**
Structural Grade: **0**
O&M Grade: **0**
Clock Start/From:
Clock To:
1st Value:
2nd Value:
Value Percent:
Step: **NO**
Remarks: **ACCESS MH**

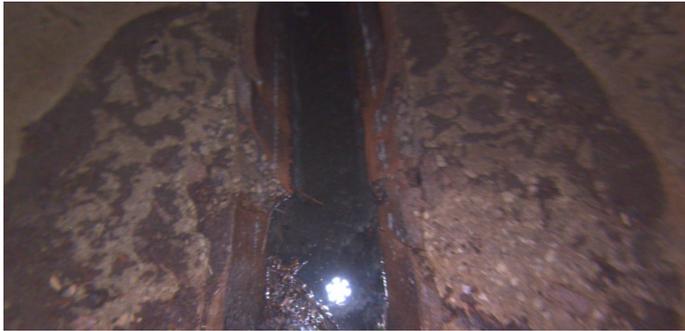
Code: **DSF**
Description: **Deposits Settled Fine**

Distance (ft): **12.4**
Structural Grade: **0**
O&M Grade: **2**
Clock Start/From: **12**
Clock To: **12**
1st Value:
2nd Value:
Value Percent: **5.000**
Step: **NO**
Remarks:

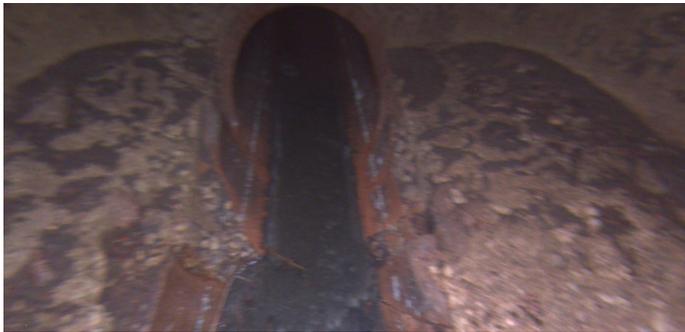
Code: **MGO**
Description: **General Observation**

Distance (ft): **13.1**
Structural Grade: **0**
O&M Grade: **0**
Clock Start/From:
Clock To:
1st Value:
2nd Value:
Value Percent:
Step: **NO**
Remarks: **END SURVEY**
