Manhole Inspection Report

O&M Index:	2.00	O&M Quick:	2100	O&M Rating:	2.00
Structural Index:	0.00	Structural Quick:	0000	Structural Rating:	0.00
Overall Index:	2.00	Overall Quick:	2100	Overall Rating:	2.00

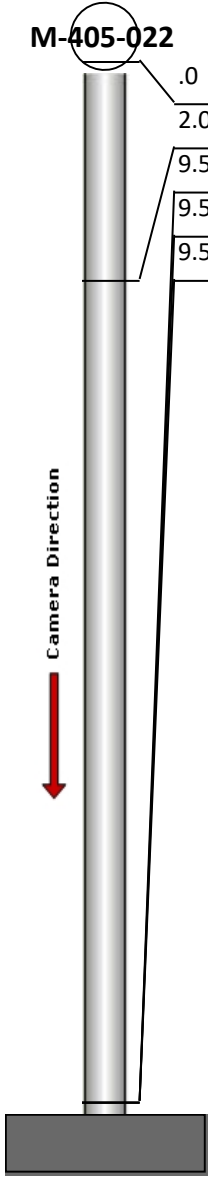
.0	MGO	General Observation	10	NA
	2.0	MGO	General Observation	28	NA
	9.5	DSF	Deposits Settled Fine	57	M 2
	9.5	MGO	General Observation	68	NA
	9.5	RPP	Repair Patch	79	NA

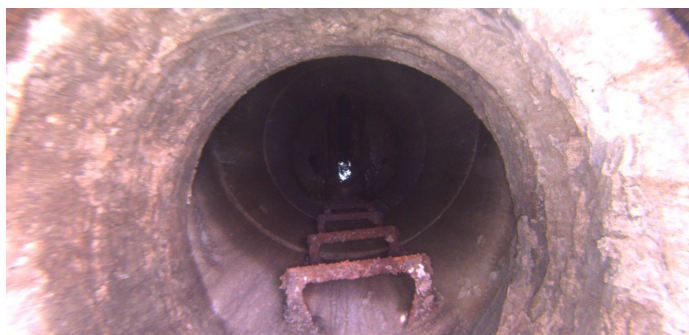
Code: **MGO**
Description: **General Observation**

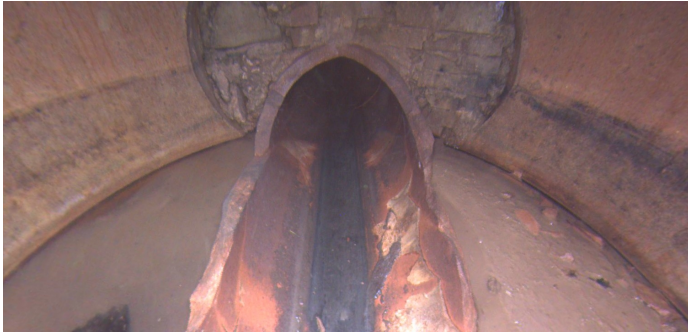
Code:	RPP
Description:	Repair Patch
Distance (ft):	9.5
Structural Grade:	0
O&M Grade:	0
Clock Start/From:	11
Clock To:	1
1st Value:	
2nd Value:	
Value Percent:	
Step:	NO
Remarks:	BRICKS
