Manhole Inspection Report

Date:	05/17/2018	Weather:		Coding:	RZMACP
MH#:	M-405-024	Owner:	NA	Len. Surveyed:	12.1
P.O.#:		Surveyor:	Jen Costello	Rim to Invert:	12.8
Customer:		Cert. #:	U-907-5518	Wall Material:	Brick

Street:	North of 49th Ave. 199' East of Drift	Project:	Hobart, IN
City:	Hobart, IN	GPS Northing:	2897711.959
Location:		GPS Easting:	2897711.959
Drain Area:	West	GPS Accuracy:	Sub-Meter
Cover Shape:	Circular	Evidence of Surcharge:	No
Cover Size:	24.0	Potential for Runoff:	None
Comments:

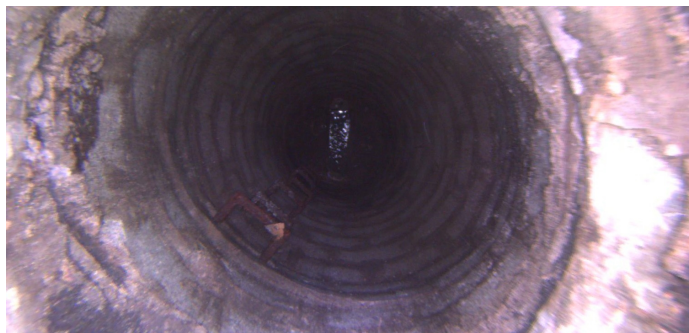
Code: **MGO**
Description: **General Observation**

Distance (ft): **.0**
Structural Grade: **0**
O&M Grade: **0**
Clock Start/From:
Clock To:
1st Value:
2nd Value:
Value Percent:
Step: **NO**
Remarks: **ACCESS MH**

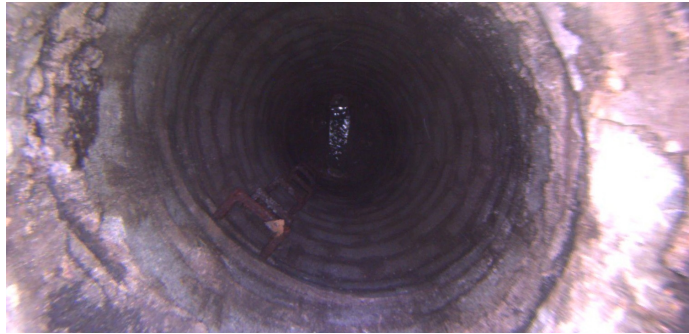
Code:	DAE
Description:	Deposits Attached Encrustation
Distance (ft):	.0
Structural Grade:	0
O&M Grade:	2
Clock Start/From:	12
Clock To:	12
1st Value:	
2nd Value:	
Value Percent:	5.000
Step:	NO
Remarks:

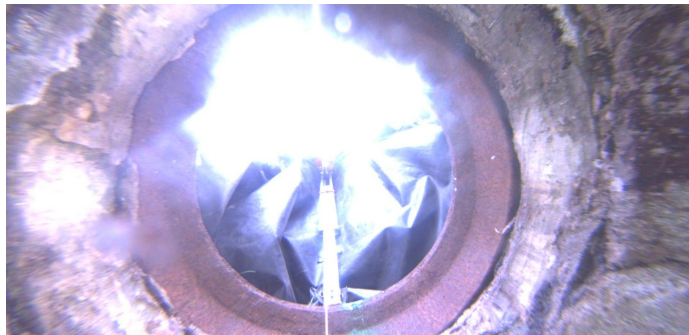
Code:	MGO
Description:	General Observation
Distance (ft):	1.9
Structural Grade:	0
O&M Grade:	0
Clock Start/From:	
Clock To:	
1st Value:	
2nd Value:	
Value Percent:	
Step:	NO
Remarks:	UNDERSIDE OF FRAME

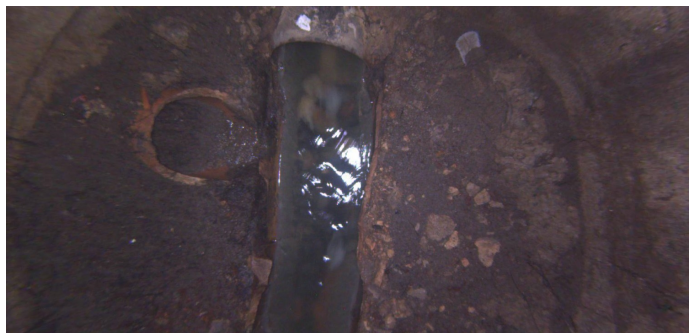
Code:	DSGV
Description:	Deposits Settled Gravel
Distance (ft):	10.9
Structural Grade:	0
O&M Grade:	2
Clock Start/From:	12
Clock To:	12
1st Value:	
2nd Value:	
Value Percent:	5.000
Step:	NO
Remarks:

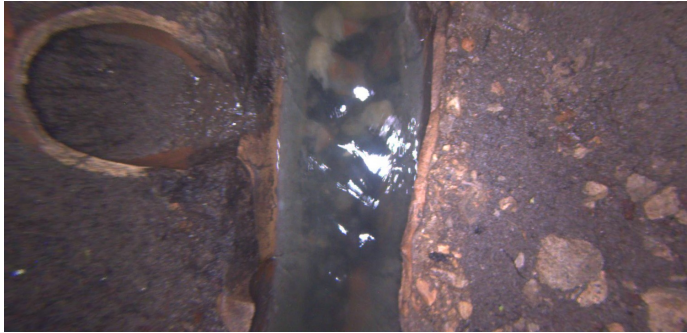
Code: **MGO**
Description: **General Observation**

Distance (ft): **12.1**
Structural Grade: **0**
O&M Grade: **0**
Clock Start/From:
Clock To:
1st Value:
2nd Value:
Value Percent:
Step: **NO**
Remarks: **END SURVE**
