# Manhole Inspection Report

Date:	05/17/2018	Weather:		Coding:	RZMACP
MH#:	M-405-025	Owner:	NA	Len. Surveyed:	12.2
P.O.#:		Surveyor:	Jen Costello	Rim to Invert:	12.8
Customer:		Cert. #:	U-907-5518	Wall Material:	Brick

Street:	North of 49th Ave. 139' East of Drift	Project:	Hobart, IN
City:	Hobart, IN	GPS Northing:	41.52960968
Location:		GPS Easting:	-87.28459167
Drain Area:	West	GPS Accuracy:	Nearest Meter
Cover Shape:	Circular	Evidence of Surcharge:	No
Cover Size:	22.5	Potential for Runoff:	None
Comments:

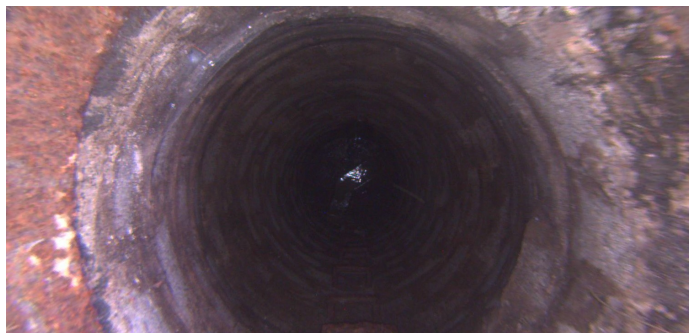
Code: **MGO**  
Description: **General Observation**

Distance (ft): **.0**  
Structural Grade: **0**  
O&M Grade: **0**  
Clock Start/From:  
Clock To:  
1st Value:  
2nd Value:  
Value Percent:  
Step: **NO**  
Remarks: **access mh**

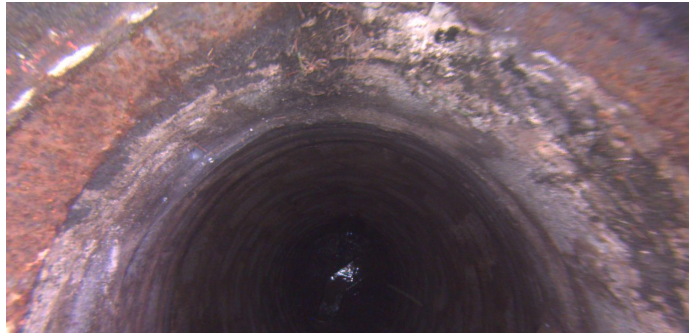
Code: **RFJ**  
Description: **Roots Fine Joint**

Distance (ft): **.0**  
Structural Grade: **0**  
O&M Grade: **1**  
Clock Start/From: **12**  
Clock To: **12**  
1st Value:  
2nd Value:  
Value Percent:  
Step: **NO**  
Remarks:

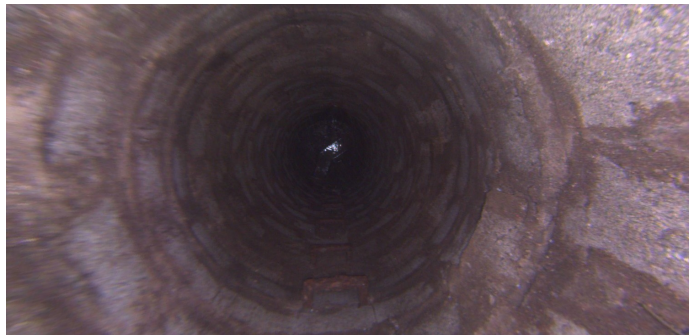
Code: **SAV**  
Description: **Surface Aggregate Visible**

Distance (ft): **.8**  
Structural Grade: **3**  
O&M Grade: **0**  
Clock Start/From: **12**  
Clock To: **12**  
1st Value:  
2nd Value:  
Value Percent:  
Step: **NO**  
Remarks:

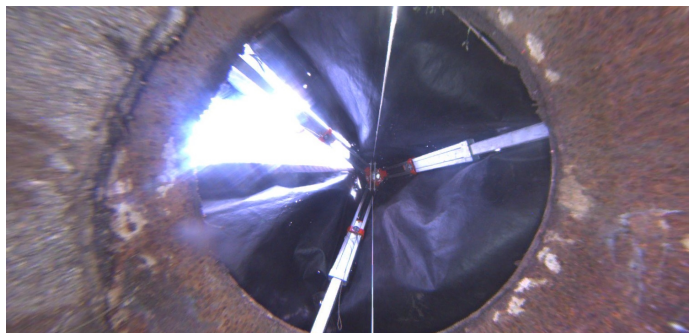
Code: **MGO**  
Description: **General Observation**

Distance (ft): **1.6**  
Structural Grade: **0**  
O&M Grade: **0**  
Clock Start/From:  
Clock To:  
1st Value:  
2nd Value:  
Value Percent:  
Step: **NO**  
Remarks: **underside of frame**

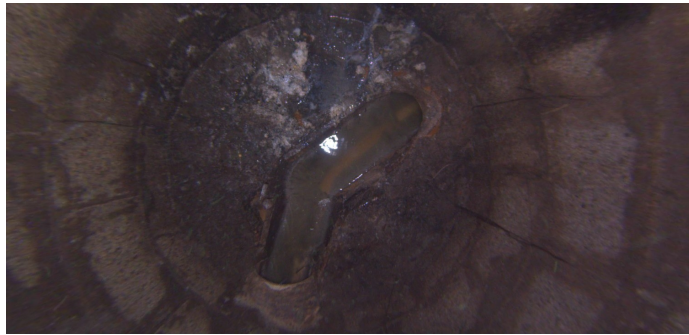
Code: **RFB**  
Description: **Roots Fine Barrel**

Distance (ft): **10.3**  
Structural Grade: **0**  
O&M Grade: **2**  
Clock Start/From: **12**  
Clock To: **12**  
1st Value:  
2nd Value:  
Value Percent:  
Step: **NO**  
Remarks:

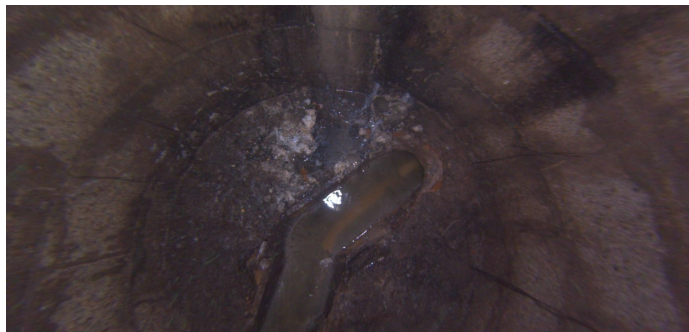
Code: **IS**  
Description: **Infil Stain**

Distance (ft): **10.3**  
Structural Grade: **0**  
O&M Grade: **0**  
Clock Start/From: **12**  
Clock To: **1**  
1st Value:  
2nd Value:  
Value Percent:  
Step: **NO**  
Remarks:

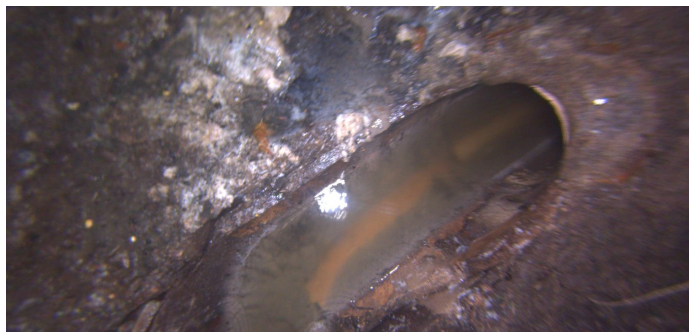
Code: **DSGV**  
Description: **Deposits Settled Gravel**

Distance (ft): **11.9**  
Structural Grade: **0**  
O&M Grade: **2**  
Clock Start/From: **12**  
Clock To: **12**  
1st Value:  
2nd Value:  
Value Percent: **5.000**  
Step: **NO**  
Remarks:

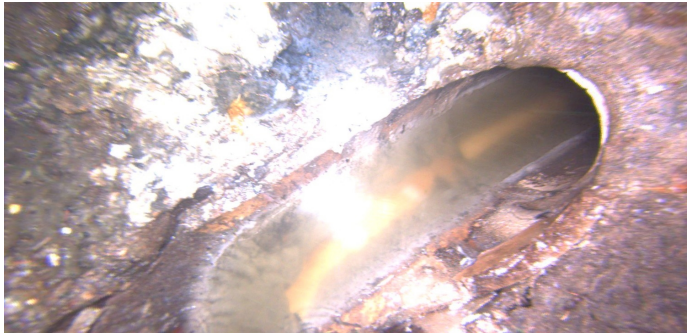
Code:	<b>MGO</b>
Description:	<b>General Observation</b>
Distance (ft):	<b>12.2</b>
Structural Grade:	<b>0</b>
O&M Grade:	<b>0</b>
Clock Start/From:	
Clock To:	
1st Value:	
2nd Value:	
Value Percent:	
Step:	<b>NO</b>
Remarks:	<b>end survey</b>

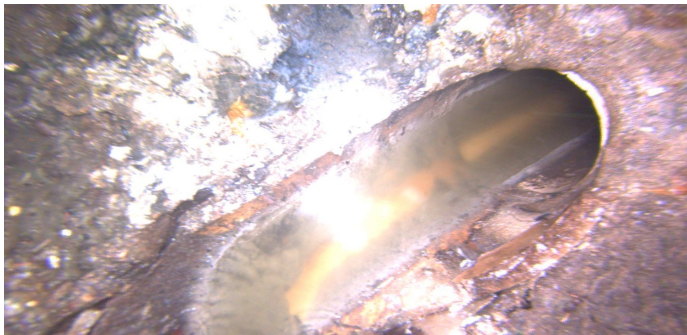
Code:	<b>SAV</b>
Description:	<b>Surface Aggregate Visible</b>
Distance (ft):	<b>12.2</b>
Structural Grade:	<b>3</b>
O&M Grade:	<b>0</b>
Clock Start/From:	<b>12</b>
Clock To:	<b>12</b>
1st Value:	
2nd Value:	
Value Percent:	
Step:	<b>NO</b>
Remarks:
