Manhole Inspection Report

Date:	05/17/2018	Weather:		Coding:	RZMACP
MH#:	M-405-036	Owner:	NA	Len. Surveyed:	8.5
P.O.#:		Surveyor:	Jen Costello	Rim to Invert:	9.5
Customer:		Cert. #:	U-907-5518	Wall Material:	Concrete (reinforced)

Street:	West 3rd Pl. 146' East of Crestwood	Project:	Hobart, IN
City:	Hobart, IN	GPS Northing:	2897065.355
Location:		GPS Easting:	2897065.355
Drain Area:	West	GPS Accuracy:	Sub-Meter
Cover Shape:	Circular	Evidence of Surcharge:	No
Cover Size:	22.5	Potential for Runoff:	None
Comments:

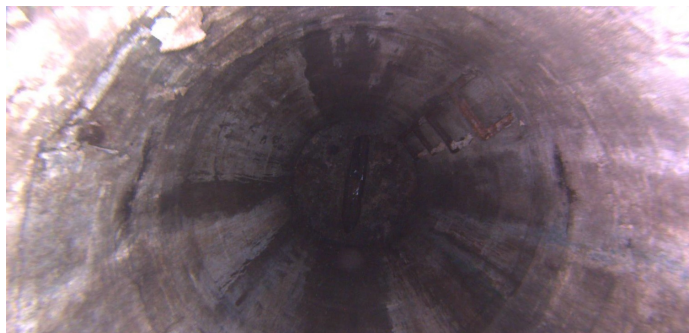
Code: **MGO**
Description: **General Observation**

Distance (ft): **.0**
Structural Grade: **0**
O&M Grade: **0**
Clock Start/From:
Clock To:
1st Value:
2nd Value:
Value Percent:
Step: **NO**
Remarks: **access mh**

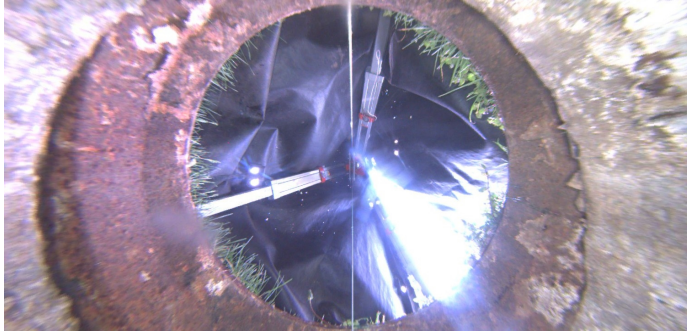
Code: **MGO**
Description: **General Observation**

Distance (ft): **1.6**
Structural Grade: **0**
O&M Grade: **0**
Clock Start/From:
Clock To:
1st Value:
2nd Value:
Value Percent:
Step: **NO**
Remarks: **underside of frame**

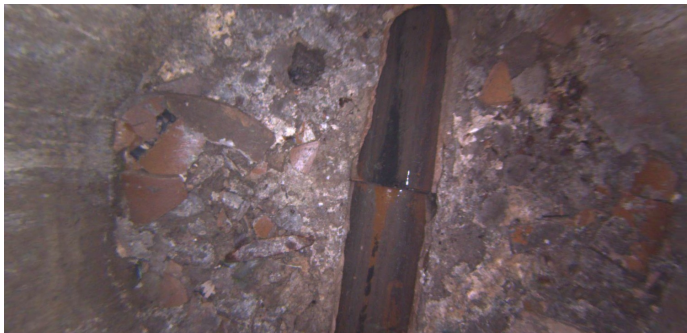
Code: **OBM**
Description: **Obstacle Pipe Material**

Distance (ft): **7.2**
Structural Grade: **0**
O&M Grade: **2**
Clock Start/From: **12**
Clock To: **12**
1st Value:
2nd Value:
Value Percent: **5.000**
Step: **NO**
Remarks:

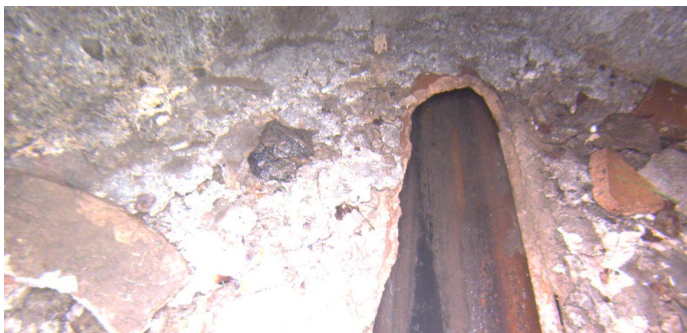
Code: **MGO**
Description: **General Observation**

Distance (ft): **8.5**
Structural Grade: **0**
O&M Grade: **0**
Clock Start/From:
Clock To:
1st Value:
2nd Value:
Value Percent:
Step: **NO**
Remarks: **end survey**
