# Manhole Inspection Report

Date:	05/17/2018	Weather:		Coding:	RZMACP
MH#:	M-405-041	Owner:	NA	Len. Surveyed:	9.0
P.O.#:		Surveyor:	Jen Costello	Rim to Invert:	8.8
Customer:		Cert. #:	U-907-5518	Wall Material:	Concrete (reinforced)

Street:	South of 3rd St. 127' East of Softwoo	Project:	Hobart, IN
City:	Hobart, IN	GPS Northing:	2897331.315
Location:		GPS Easting:	2897331.315
Drain Area:	West	GPS Accuracy:	Sub-Meter
Cover Shape:	Circular	Evidence of Surcharge:	No
Cover Size:	24.0	Potential for Runoff:	None
Comments:

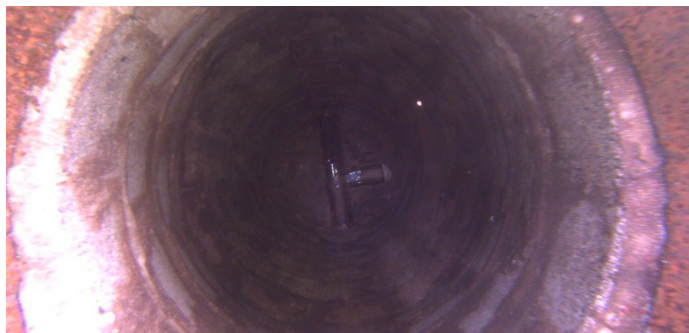
Code: **MGO**  
Description: **General Observation**

Distance (ft): **.0**  
Structural Grade: **0**  
O&M Grade: **0**  
Clock Start/From:  
Clock To:  
1st Value:  
2nd Value:  
Value Percent:  
Step: **NO**  
Remarks: **ACCESS MH**

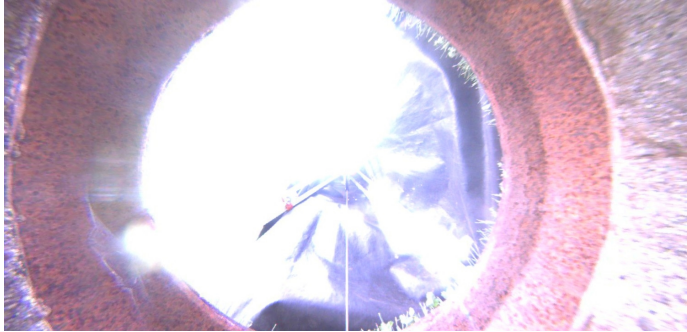
Code: **MGO**  
Description: **General Observation**

Distance (ft): **1.9**  
Structural Grade: **0**  
O&M Grade: **0**  
Clock Start/From:  
Clock To:  
1st Value:  
2nd Value:  
Value Percent:  
Step: **NO**  
Remarks: **END SURVEY**

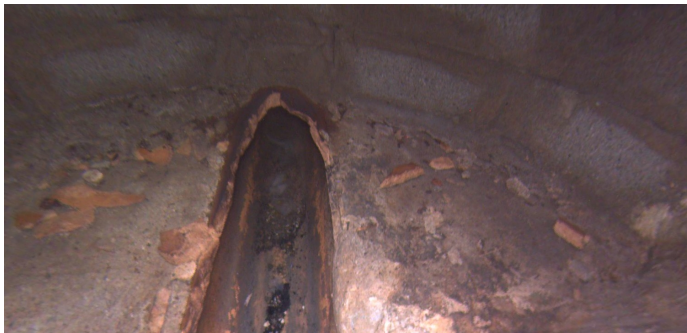
Code: **OBM**  
Description: **Obstacle Pipe Material**

Distance (ft): **7.7**  
Structural Grade: **0**  
O&M Grade: **2**  
Clock Start/From: **9**  
Clock To: **3**  
1st Value:  
2nd Value:  
Value Percent: **5.000**  
Step: **NO**  
Remarks:

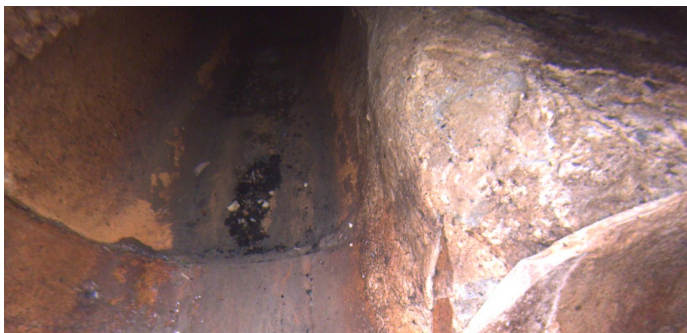
Code: **MGO**  
Description: **General Observation**

Distance (ft): **8.9**  
Structural Grade: **0**  
O&M Grade: **0**  
Clock Start/From:  
Clock To:  
1st Value:  
2nd Value:  
Value Percent:  
Step: **NO**  
Remarks: **END SURVEY**
