Manhole Inspection Report

Date:	04/20/2018	Weather:		Coding:	RZMACP
MH#:	M-405-044	Owner:	NA	Len. Surveyed:	15.3
P.O.#:		Surveyor:	Jen Costello	Rim to Invert:	18.5
Customer:		Cert. #:	U-907-5518	Wall Material:	Brick

Street:	3rd St. 128' East of Softwood Dr.	Project:	Hobart, IN
City:	Hobart, IN	GPS Northing:	0.0
Location:		GPS Easting:	0.0
Drain Area:	West	GPS Accuracy:	Nearest Meter
Cover Shape:	Square	Evidence of Surcharge:	No
Cover Size:	23.0	Potential for Runoff:	None
Comments:

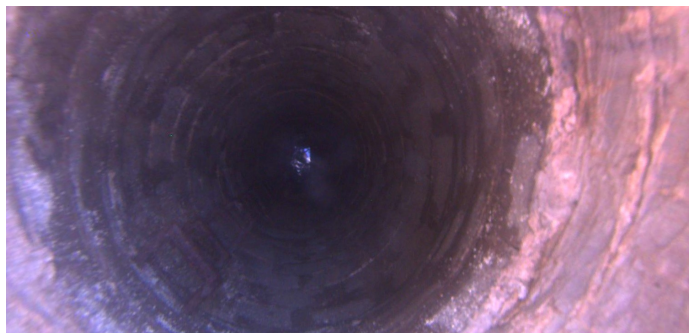
Code: **MGO**
Description: **General Observation**

Distance (ft): **.0**
Structural Grade: **0**
O&M Grade: **0**
Clock Start/From:
Clock To:
1st Value:
2nd Value:
Value Percent:
Step: **NO**
Remarks: **access MH**

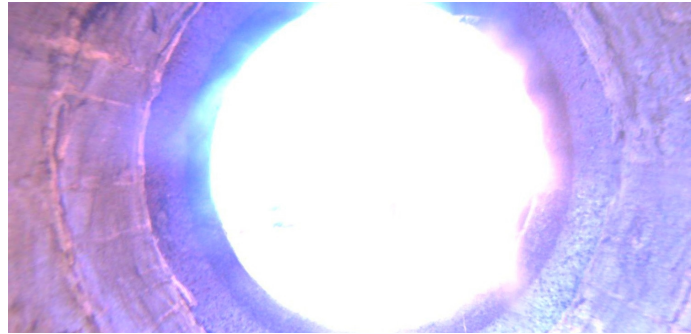
Code:	MGP
Description:	General Photo
Distance (ft):	1.9
Structural Grade:	0
O&M Grade:	0
Clock Start/From:	
Clock To:	
1st Value:	
2nd Value:	
Value Percent:	
Step:	NO
Remarks:	UNDERSIDE OF FRAME

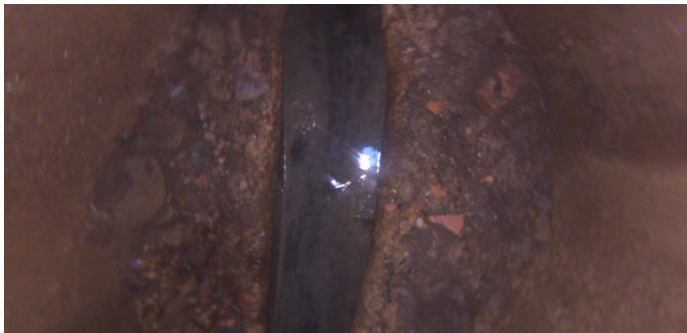
Code:	OBR
Description:	Obstacle Rocks
Distance (ft):	14.5
Structural Grade:	0
O&M Grade:	2
Clock Start/From:	12
Clock To:	12
1st Value:	
2nd Value:	
Value Percent:	10.000
Step:	NO
Remarks:

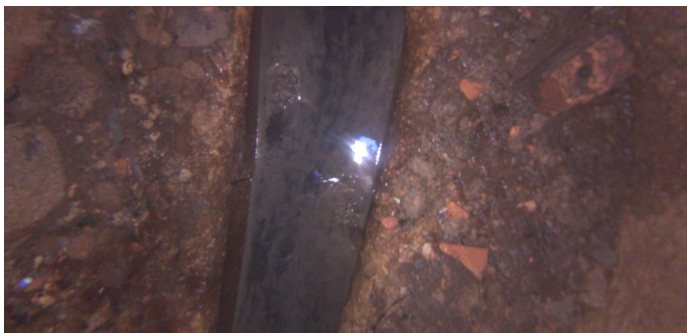
Code:	MGO
Description:	General Observation
Distance (ft):	15.3
Structural Grade:	0
O&M Grade:	0
Clock Start/From:	
Clock To:	
1st Value:	
2nd Value:	
Value Percent:	
Step:	NO
Remarks:	END SURVEY
