Manhole Inspection Report

Date:	05/17/2018	Weather:		Coding:	RZMACP
MH#:	M-405-049	Owner:	NA	Len. Surveyed:	6.7
P.O.#:		Surveyor:	Jen Costello	Rim to Invert:	7.3
Customer:		Cert. #:	U-907-5518	Wall Material:	Concrete (reinforced)

Street:	Driftwood Dr. 153' North of 3rd St.	Project:	Hobart, IN
City:	Hobart, IN	GPS Northing:	2897934.146
Location:		GPS Easting:	2897934.146
Drain Area:	West	GPS Accuracy:	Sub-Meter
Cover Shape:	Circular	Evidence of Surcharge:	No
Cover Size:	22.5	Potential for Runoff:	None
Comments:

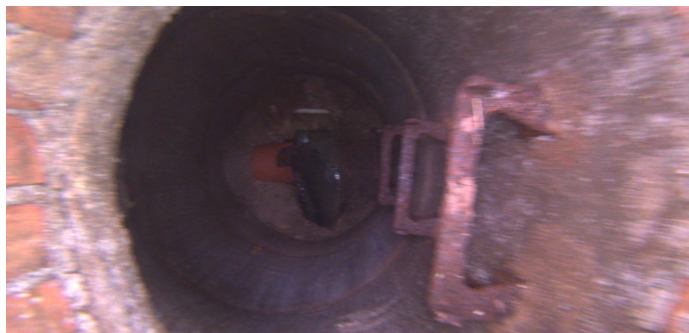
Code: **MGO**
Description: **General Observation**

Distance (ft): **.0**
Structural Grade: **0**
O&M Grade: **0**
Clock Start/From:
Clock To:
1st Value:
2nd Value:
Value Percent:
Step: **NO**
Remarks: **ACCESS MH**

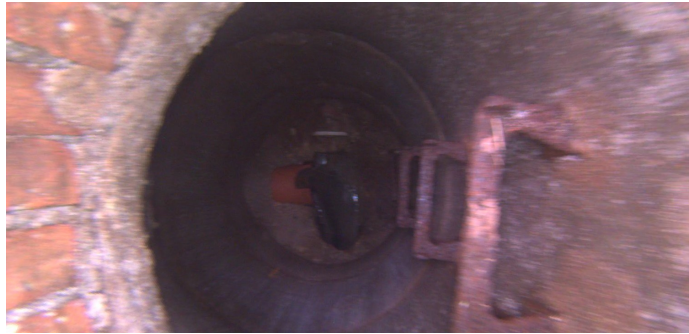
Code:	MGP
Description:	General Photo
Distance (ft):	.0
Structural Grade:	0
O&M Grade:	0
Clock Start/From:	
Clock To:	
1st Value:	
2nd Value:	
Value Percent:	
Step:	NO
Remarks:

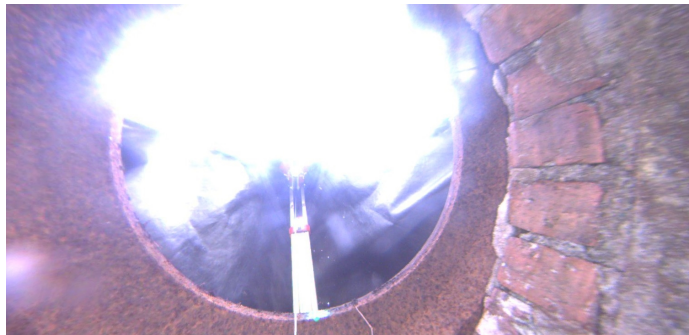
Code:	MGO
Description:	General Observation
Distance (ft):	1.5
Structural Grade:	0
O&M Grade:	0
Clock Start/From:	
Clock To:	
1st Value:	
2nd Value:	
Value Percent:	
Step:	NO
Remarks:	UNDERSIDE OF FRAME

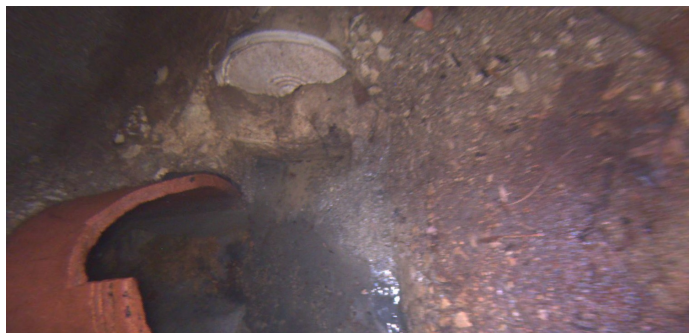
Code:	DSGV
Description:	Deposits Settled Gravel
Distance (ft):	6.1
Structural Grade:	0
O&M Grade:	2
Clock Start/From:	12
Clock To:	12
1st Value:	
2nd Value:	
Value Percent:	5.000
Step:	NO
Remarks:

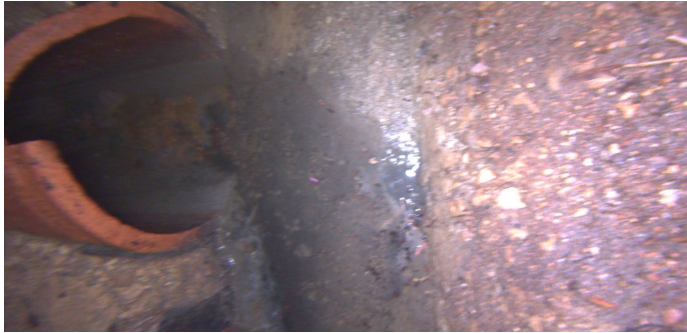
Code: **MGO**
Description: **General Observation**

Distance (ft): **6.7**
Structural Grade: **0**
O&M Grade: **0**
Clock Start/From:
Clock To:
1st Value:
2nd Value:
Value Percent:
Step: **NO**
Remarks: **END SURVEY**
