# Manhole Inspection Report

Date:	09/29/2022	Weather:		Coding:	RZMACP
MH#:	M-405-050	Owner:	NA	Len. Surveyed:	7.6
P.O.#:		Surveyor:	Jen Costello	Rim to Invert:	8.8
Customer:		Cert. #:	U-907-5518	Wall Material:	Concrete (cast in place)

Street:	150' North of 3rd St. West of Driftw	Project:	Hobart, IN
City:	Hobart, IN	GPS Northing:	2289364.978
Location:	Local Rural Streets	GPS Easting:	2897755.294
Drain Area:	West	GPS Accuracy:	Sub-Meter
Cover Shape:	Circular	Evidence of Surcharge:	No
Cover Size:	24.0	Potential for Runoff:	None
Comments:

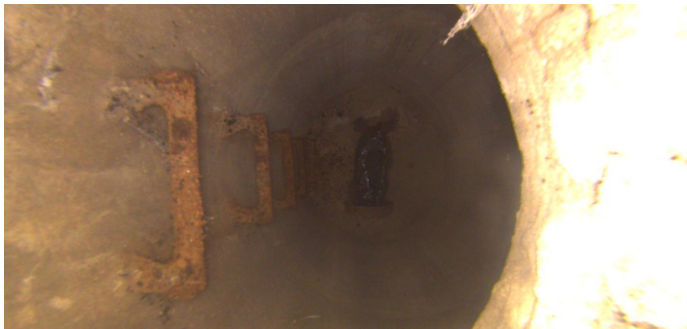
Code: **MGO**  
Description: **General Observation**

Distance (ft): **.0**  
Structural Grade: **0**  
O&M Grade: **0**  
Clock Start/From:  
Clock To:  
1st Value:  
2nd Value:  
Value Percent:  
Step: **NO**  
Remarks: **access mh**

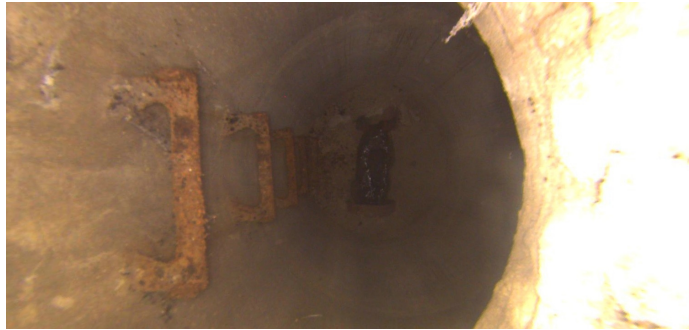
Code:	<b>SRI</b>
Description:	<b>Surface Roughness Increased</b>
Distance (ft):	<b>.0</b>
Structural Grade:	<b>1</b>
O&M Grade:	<b>0</b>
Clock Start/From:	<b>12</b>
Clock To:	<b>12</b>
1st Value:	
2nd Value:	
Value Percent:	
Step:	<b>NO</b>
Remarks:

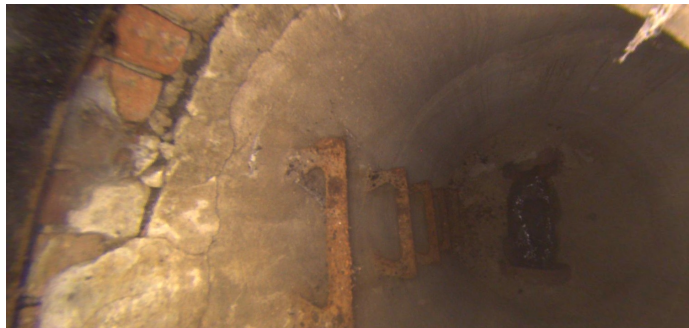
Code:	<b>B</b>
Description:	<b>Broken</b>
Distance (ft):	<b>.1</b>
Structural Grade:	<b>5</b>
O&M Grade:	<b>0</b>
Clock Start/From:	<b>6</b>
Clock To:	<b>12</b>
1st Value:	
2nd Value:	
Value Percent:	
Step:	<b>NO</b>
Remarks:

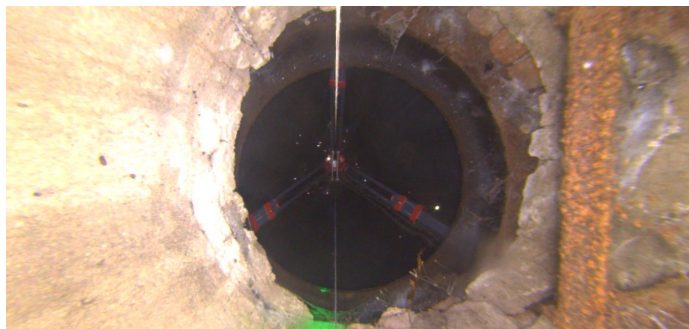
Code:	<b>MGO</b>
Description:	<b>General Observation</b>
Distance (ft):	<b>2.3</b>
Structural Grade:	<b>0</b>
O&M Grade:	<b>0</b>
Clock Start/From:	
Clock To:	
1st Value:	
2nd Value:	
Value Percent:	
Step:	<b>NO</b>
Remarks:	<b>underside of frame</b>

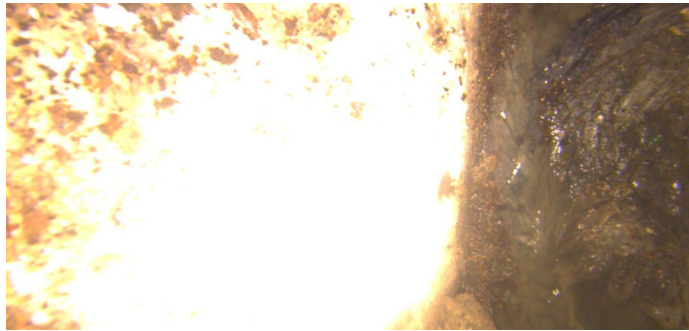
Code: **DSF**  
Description: **Deposits Settled Fine**

Distance (ft): **7.6**  
Structural Grade: **0**  
O&M Grade: **2**  
Clock Start/From: **12**  
Clock To: **12**  
1st Value:  
2nd Value:  
Value Percent: **5.000**  
Step: **NO**  
Remarks:

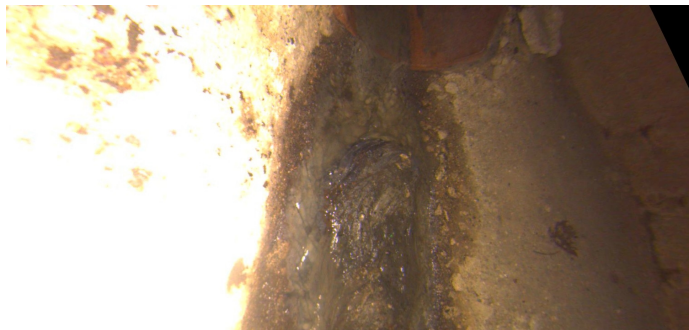
Code: **SAV**  
Description: **Surface Aggregate Visible**

Distance (ft): **7.6**  
Structural Grade: **3**  
O&M Grade: **0**  
Clock Start/From: **3**  
Clock To: **9**  
1st Value:  
2nd Value:  
Value Percent:  
Step: **NO**  
Remarks:

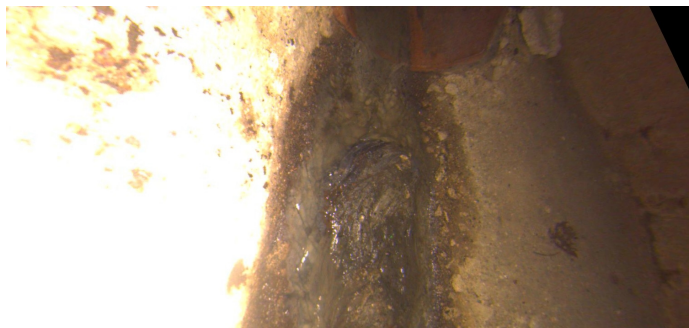
Code: **DSF**  
Description: **Deposits Settled Fine**

Distance (ft): **7.6**  
Structural Grade: **0**  
O&M Grade: **2**  
Clock Start/From: **5**  
Clock To: **7**  
1st Value:  
2nd Value:  
Value Percent: **10.000**  
Step: **NO**  
Remarks:

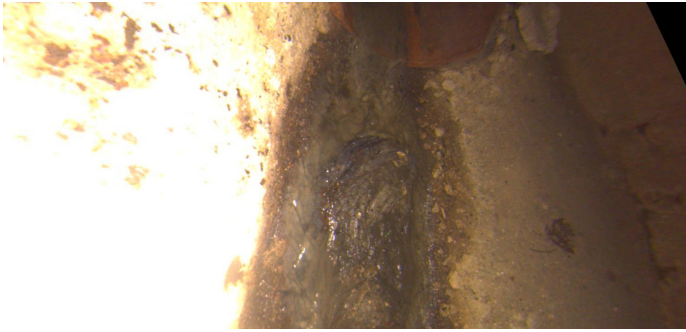
Code: **MGO**  
Description: **General Observation**

Distance (ft): **7.6**  
Structural Grade: **0**  
O&M Grade: **0**  
Clock Start/From:  
Clock To:  
1st Value:  
2nd Value:  
Value Percent:  
Step: **NO**  
Remarks: **end of survey**

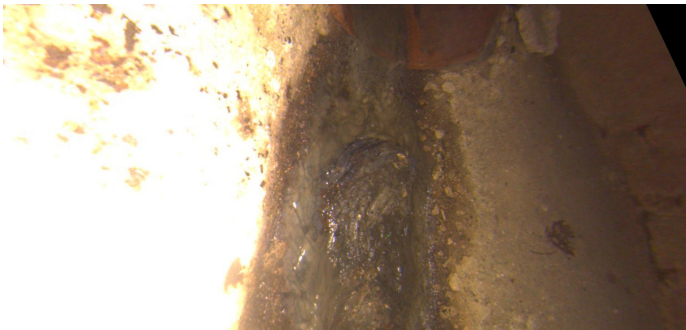
Code: **SRI**  
Description: **Surface Roughness Increased**

Distance (ft): **7.6**  
Structural Grade: **1**  
O&M Grade: **0**  
Clock Start/From: **12**  
Clock To: **12**  
1st Value:  
2nd Value:  
Value Percent:  
Step: **NO**  
Remarks:
