Manhole Inspection Report

Date:	05/17/2018	Weather:		Coding:	RZMACP
MH#:	M-405-051	Owner:	NA	Len. Surveyed:	7.9
P.O.#:		Surveyor:	Jen Costello	Rim to Invert:	8.2
Customer:		Cert. #:	U-907-5518	Wall Material:	Concrete (reinforced)

Street:	150' North of 3rd St. West of Oakwo	Project:	Hobart, IN
City:	Hobart, IN	GPS Northing:	41.5332756
Location:		GPS Easting:	-87.28543091
Drain Area:	West	GPS Accuracy:	Nearest Meter
Cover Shape:	Circular	Evidence of Surcharge:	No
Cover Size:	22.5	Potential for Runoff:	None
Comments:

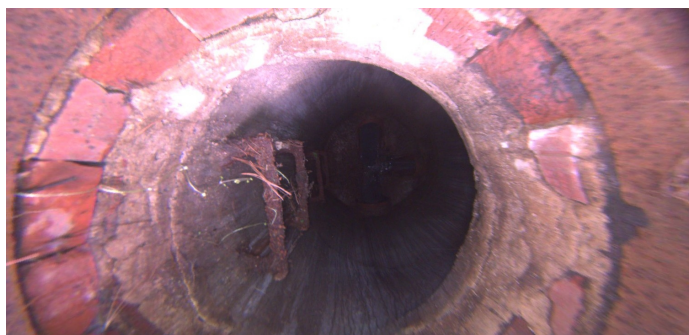
Code: **MGO**
Description: **General Observation**

Distance (ft): **.0**
Structural Grade: **0**
O&M Grade: **0**
Clock Start/From:
Clock To:
1st Value:
2nd Value:
Value Percent:
Step: **NO**
Remarks: **ACCESS MH**

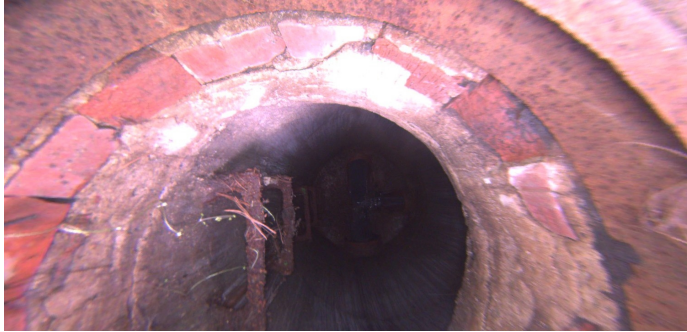
Code: **FM**
Description: **Fracture Multiple**

Distance (ft): **.0**
Structural Grade: **4**
O&M Grade: **0**
Clock Start/From: **11**
Clock To: **12**
1st Value:
2nd Value:
Value Percent:
Step: **NO**
Remarks:

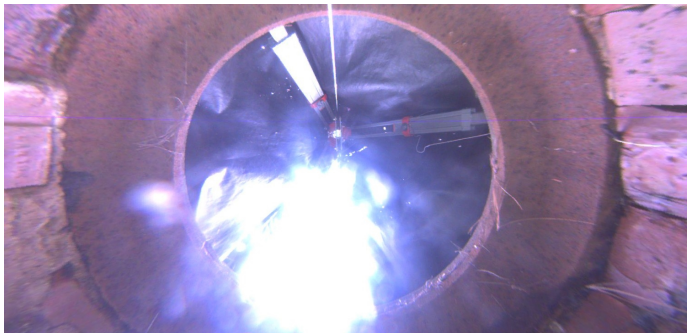
Code: **MGO**
Description: **General Observation**

Distance (ft): **1.3**
Structural Grade: **0**
O&M Grade: **0**
Clock Start/From:
Clock To:
1st Value:
2nd Value:
Value Percent:
Step: **NO**
Remarks: **UNDERSIDE OF FRAME**

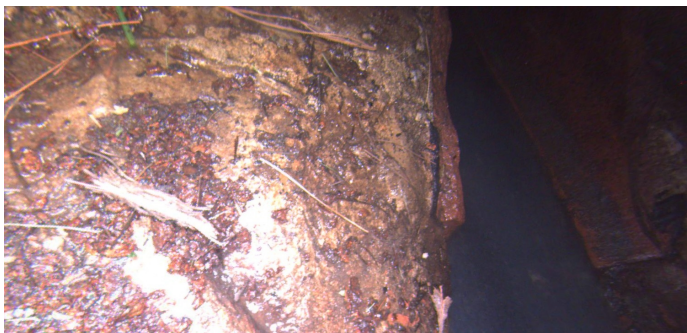
Code: **DSGV**
Description: **Deposits Settled Gravel**

Distance (ft): **7.9**
Structural Grade: **0**
O&M Grade: **2**
Clock Start/From: **12**
Clock To: **12**
1st Value:
2nd Value:
Value Percent: **5.000**
Step: **NO**
Remarks:
