Manhole Inspection Report

Date:	05/17/2018	Weather:		Coding:	RZMACP
MH#:	M-405-051	Owner:	NA	Len. Surveyed:	7.9
P.O.#:		Surveyor:	Jen Costello	Rim to Invert:	8.5
Customer:		Cert. #:	U-907-5518	Wall Material:	Concrete (reinforced)

Street:	150' North of 3rd St. West of Oakwo	Project:	Hobart, IN
City:	Hobart, IN	GPS Northing:	41.53325272
Location:		GPS Easting:	-87.28412628
Drain Area:	West	GPS Accuracy:	Nearest Meter
Cover Shape:	Circular	Evidence of Surcharge:	No
Cover Size:	22.5	Potential for Runoff:	None
Comments:

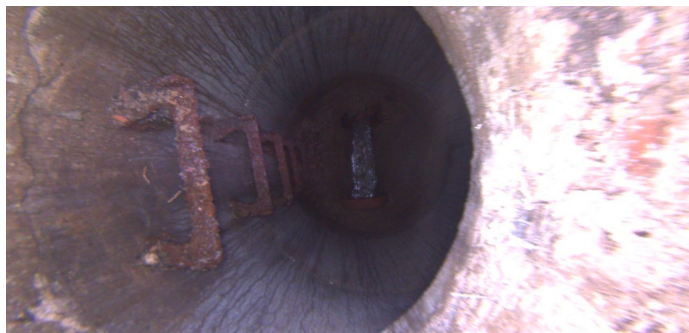
Code: **MGO**
Description: **General Observation**

Distance (ft): **.0**
Structural Grade: **0**
O&M Grade: **0**
Clock Start/From:
Clock To:
1st Value:
2nd Value:
Value Percent:
Step: **NO**
Remarks: **ACCESS MH**

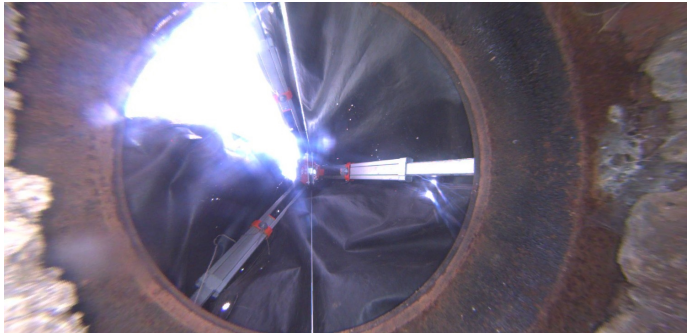
Code: **MGO**
Description: **General Observation**

Distance (ft): **1.4**
Structural Grade: **0**
O&M Grade: **0**
Clock Start/From:
Clock To:
1st Value:
2nd Value:
Value Percent:
Step: **NO**
Remarks: **UNDERSIDE OF FRAME**

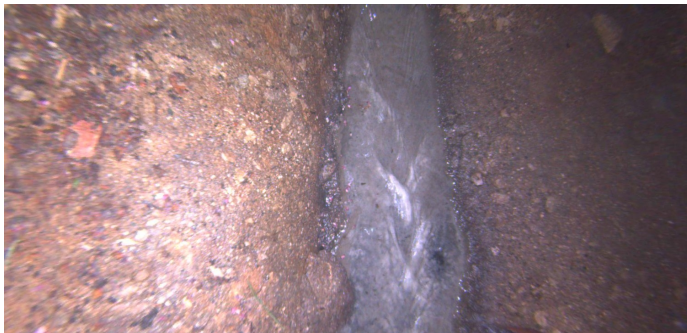
Code: **DSF**
Description: **Deposits Settled Fine**

Distance (ft): **7.4**
Structural Grade: **0**
O&M Grade: **2**
Clock Start/From: **12**
Clock To: **12**
1st Value:
2nd Value:
Value Percent: **5.000**
Step: **NO**
Remarks:

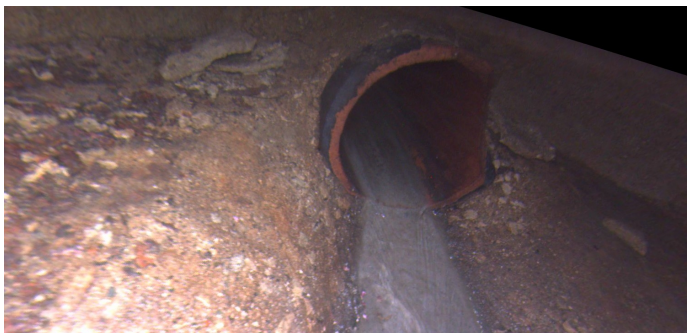
Code: **MGO**
Description: **General Observation**

Distance (ft): **7.9**
Structural Grade: **0**
O&M Grade: **0**
Clock Start/From:
Clock To:
1st Value:
2nd Value:
Value Percent:
Step: **NO**
Remarks: **END SURVEY**
