Manhole Inspection Report

Date:	05/16/2018	Weather:		Coding:	RZMACP
MH#:	M-405-053	Owner:	NA	Len. Surveyed:	4.8
P.O.#:		Surveyor:	Jen Costello	Rim to Invert:	5.5
Customer:		Cert. #:	U-907-5518	Wall Material:	Concrete (reinforced)

Street:	South of West 2nd Pl. 92' West of O	Project:	Hobart, IN
City:	Hobart, IN	GPS Northing:	41.53434372
Location:		GPS Easting:	-87.28517151
Drain Area:	West	GPS Accuracy:	Nearest Meter
Cover Shape:	Circular	Evidence of Surcharge:	No
Cover Size:	22.5	Potential for Runoff:	None
Comments:

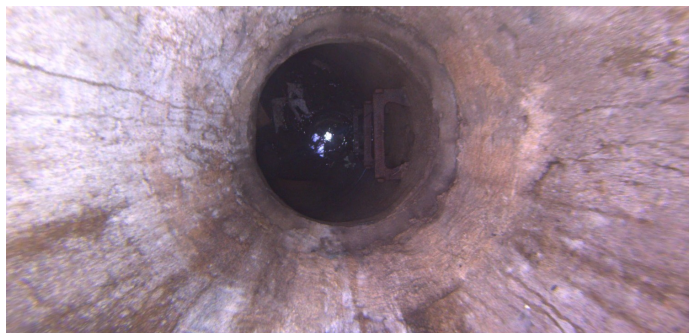
Code: **MGO**
Description: **General Observation**

Distance (ft): **.0**
Structural Grade: **0**
O&M Grade: **0**
Clock Start/From:
Clock To:
1st Value:
2nd Value:
Value Percent:
Step: **NO**
Remarks: **ACCESS MH**

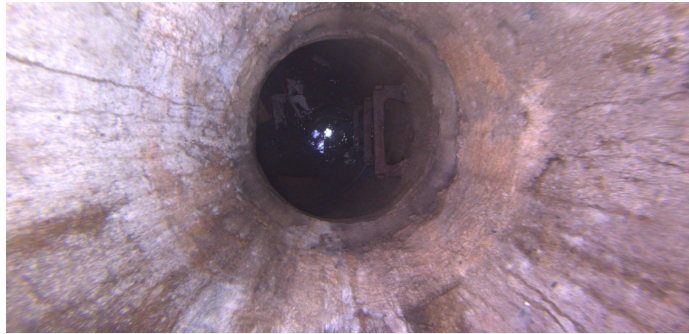
Code: **CM**
Description: **Crack Multiple**

Distance (ft): **.0**
Structural Grade: **3**
O&M Grade: **0**
Clock Start/From: **12**
Clock To: **12**
1st Value:
2nd Value:
Value Percent:
Step: **NO**
Remarks:

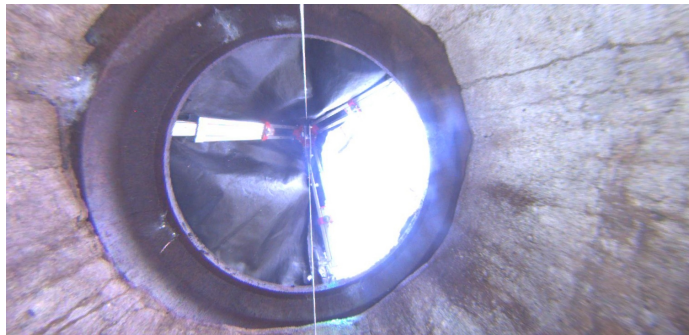
Code: **MGO**
Description: **General Observation**

Distance (ft): **1.6**
Structural Grade: **0**
O&M Grade: **0**
Clock Start/From:
Clock To:
1st Value:
2nd Value:
Value Percent:
Step: **NO**
Remarks: **UNDERSIDE OF FRAME**

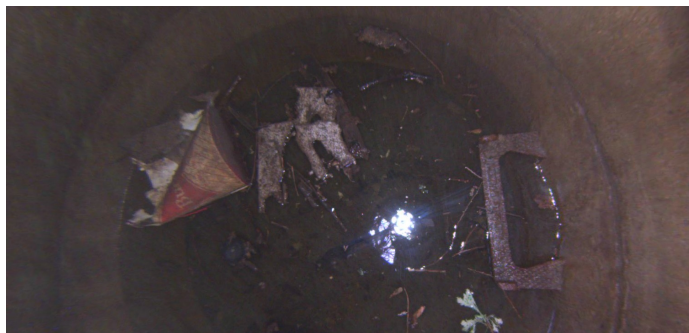
Code: **OBZ**
Description: **Obstacle Other**

Distance (ft): **3.3**
Structural Grade: **0**
O&M Grade: **2**
Clock Start/From: **9**
Clock To: **12**
1st Value:
2nd Value:
Value Percent: **5.000**
Step: **NO**
Remarks: **GARBAGE**

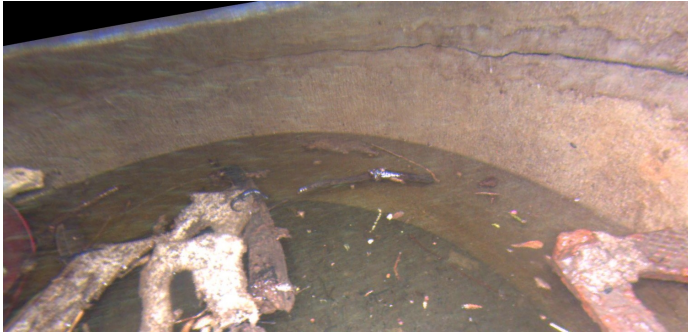
Code:	MGO
Description:	General Observation
Distance (ft):	4.8
Structural Grade:	0
O&M Grade:	0
Clock Start/From:	
Clock To:	
1st Value:	
2nd Value:	
Value Percent:	
Step:	NO
Remarks:	END SURVEY BENCH IS SUBMERGED
