Manhole Inspection Report

| MH#: | M-405-054 | Owner: | NA | Len. Surveyed: | 8.2 |

| Street: | South of West 2nd Pl. 166' West of | Project: | Hobart, IN |

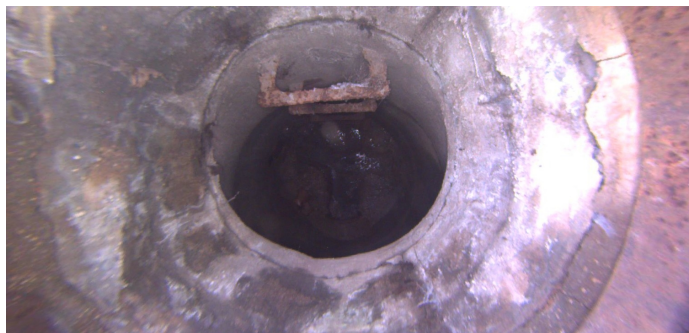
Code: **MGO**
Description: **General Observation**

Distance (ft): **.0**
Structural Grade: **0**
O&M Grade: **0**
Clock Start/From:
Clock To:
1st Value:
2nd Value:
Value Percent:
Step: **NO**
Remarks: **ACCESS MH**

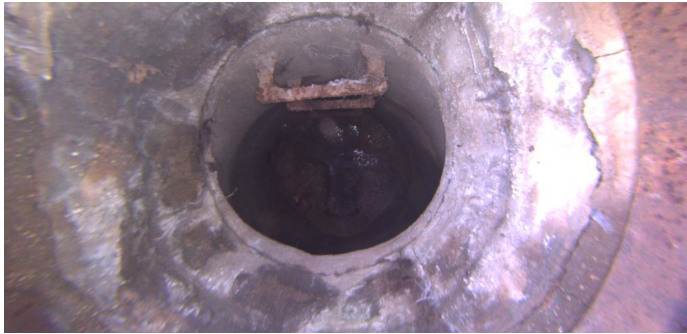
Code: **FL**
Description: **Fracture Longitudinal**

Distance (ft): **.0**
Structural Grade: **3**
O&M Grade: **0**
Clock Start/From: **2**
Clock To:
1st Value:
2nd Value:
Value Percent:
Step: **NO**
Remarks:

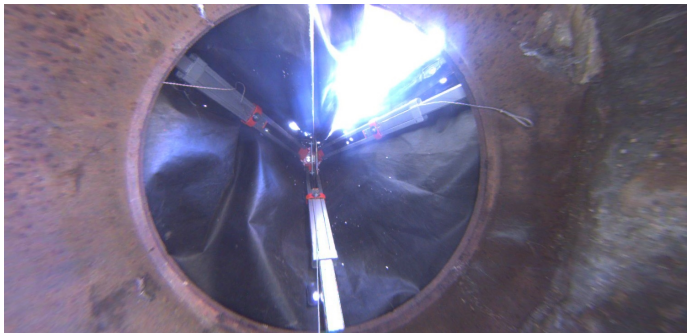
Code: **MGO**
Description: **General Observation**

Distance (ft): **1.4**
Structural Grade: **0**
O&M Grade: **0**
Clock Start/From:
Clock To:
1st Value:
2nd Value:
Value Percent:
Step: **NO**
Remarks: **UNDERSIDE OF FRAME**

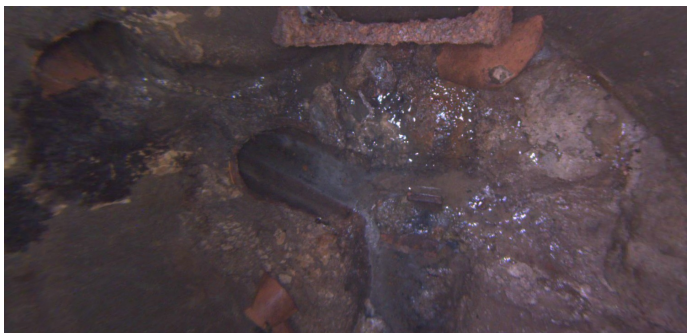
Code: **OBM**
Description: **Obstacle Pipe Material**

Distance (ft): **5.8**
Structural Grade: **0**
O&M Grade: **2**
Clock Start/From: **8**
Clock To: **1**
1st Value:
2nd Value:
Value Percent: **5.000**
Step: **NO**
Remarks:

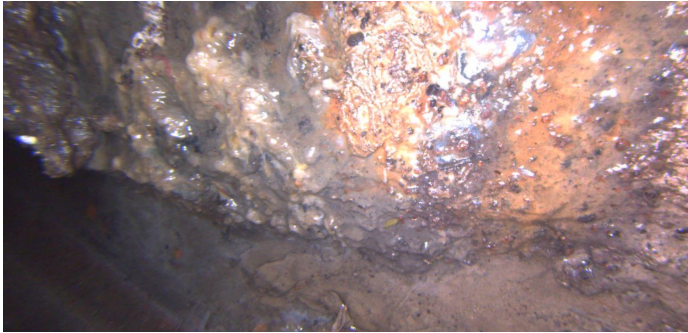
| Code: | MGO |
| Description: | General Observation |
| Distance (ft): | 8.2 |
| Remarks: | END SURVEY |
