Manhole Inspection Report

Date:	05/13/2018	Weather:		Coding:	RZMACP
MH#:	M-405-065	Owner:	NA	Len. Surveyed:	2.7
P.O.#:		Surveyor:	Jen Costello	Rim to Invert:	2.6
Customer:		Cert. #:	U-907-5518	Wall Material:	Concrete (reinforced)

Street:	2nd St. 72' West of Wilson St.	Project:	Hobart, IN
City:	Hobart, IN	GPS Northing:	41.53478622
Location:		GPS Easting:	-87.27848053
Drain Area:	West	GPS Accuracy:	Nearest Meter
Cover Shape:	Circular	Evidence of Surcharge:	No
Cover Size:	22.5	Potential for Runoff:	None
Comments:

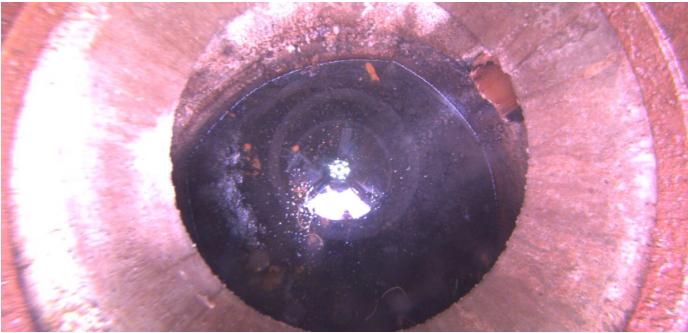
Code:

MGO

Description:

General Observation

Distance (ft):

.0

Remarks:

ACCESS MH

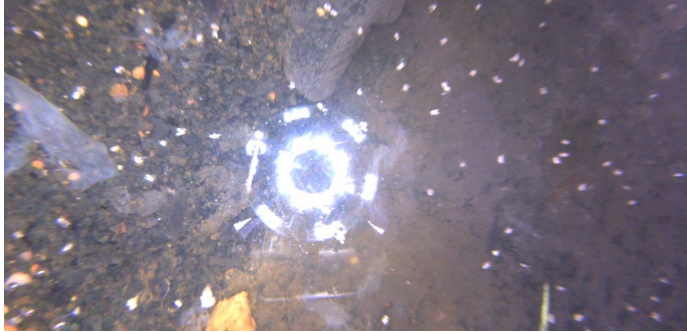
Code:	MGO
Description:	General Observation
Distance (ft):	2.4
Structural Grade:	0
O&M Grade:	0
Clock Start/From:	
Clock To:	
1st Value:	
2nd Value:	
Value Percent:	
Step:	NO
Remarks:	BENCH IS SUBMERGED
