# Manhole Inspection Report

Date:	04/30/2018	Weather:		Coding:	RZMACP
MH#:	M-405-069	Owner:	NA	Len. Surveyed:	11.0
P.O.#:		Surveyor:	Jen Costello	Rim to Invert:	11.3
Customer:		Cert. #:	U-907-5518	Wall Material:	Concrete (reinforced)

Street:	3rd St. and 327' East of Wabash St.	Project:	Hobart, IN
City:	Hobart, IN	GPS Northing:	2899293.43
Location:		GPS Easting:	2899293.43
Drain Area:	West	GPS Accuracy:	Sub-Meter
Cover Shape:	Circular	Evidence of Surcharge:	No
Cover Size:	22.5	Potential for Runoff:	None
Comments:

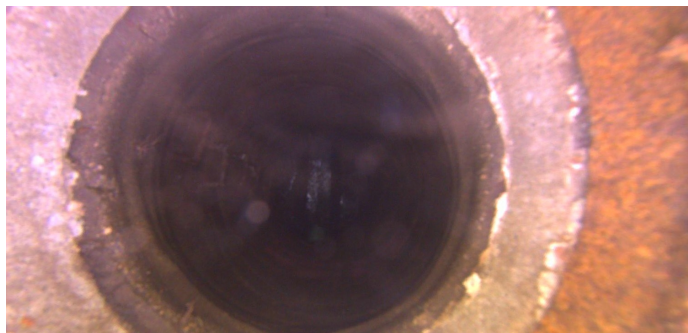
Code: **MGP**  
Description: **General Photo**

Distance (ft): **.0**  
Structural Grade: **0**  
O&M Grade: **0**  
Clock Start/From:  
Clock To:  
1st Value:  
2nd Value:  
Value Percent:  
Step: **NO**  
Remarks: **access MH**

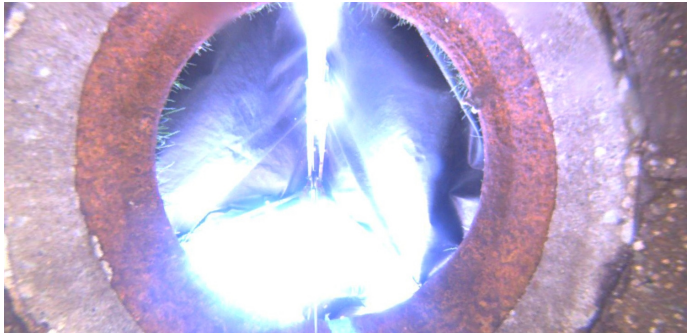
Code:	<b>MGO</b>
Description:	<b>General Observation</b>
Distance (ft):	<b>2.2</b>
Structural Grade:	<b>0</b>
O&M Grade:	<b>0</b>
Clock Start/From:	
Clock To:	
1st Value:	
2nd Value:	
Value Percent:	
Step:	<b>NO</b>
Remarks:	<b>UNDERSIDE OF FRAME</b>

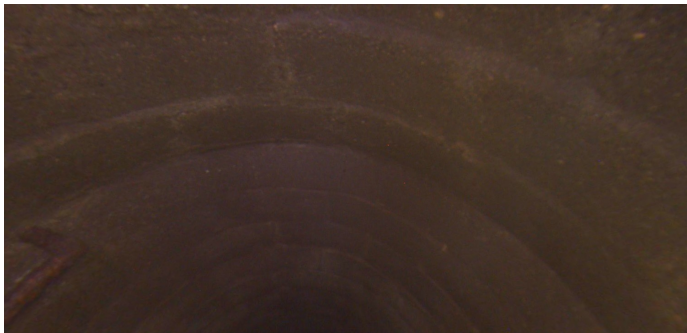
Code:	<b>SAV</b>
Description:	<b>Surface Aggregate Visible</b>
Distance (ft):	<b>2.2</b>
Structural Grade:	<b>3</b>
O&M Grade:	<b>0</b>
Clock Start/From:	<b>12</b>
Clock To:	<b>12</b>
1st Value:	
2nd Value:	
Value Percent:	
Step:	<b>NO</b>
Remarks:

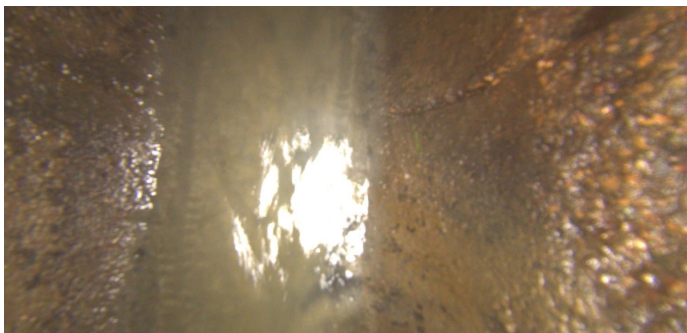
Code:	<b>MGO</b>
Description:	<b>General Observation</b>
Distance (ft):	<b>11.0</b>
Structural Grade:	<b>0</b>
O&M Grade:	<b>0</b>
Clock Start/From:	
Clock To:	
1st Value:	
2nd Value:	
Value Percent:	
Step:	<b>NO</b>
Remarks:	<b>END SURVEY</b>
