Manhole Inspection Report

Date:	04/24/2018	Weather:		Coding:	RZMACP
MH#:	M-406-001	Owner:	NA	Len. Surveyed:	5.8
P.O.#:		Surveyor:	Jen Costello	Rim to Invert:	5.4
Customer:		Cert. #:	U-907-5518	Wall Material:	Concrete (reinforced)

Street:	Wabash Pl. The Middle of the Cul D	Project:	Hobart, IN
City:	Hobart, IN	GPS Northing:	2899310.88
Location:		GPS Easting:	2899310.88
Drain Area:	West	GPS Accuracy:	Sub-Meter
Cover Shape:	Circular	Evidence of Surcharge:	No
Cover Size:	22.5	Potential for Runoff:	None
Comments:

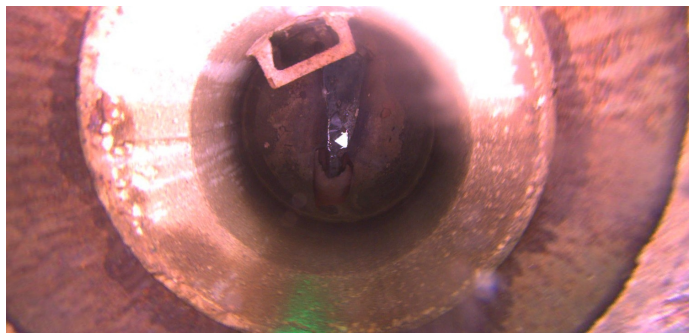
Code: **MGO**
Description: **General Observation**

Distance (ft): **.0**
Structural Grade: **0**
O&M Grade: **0**
Clock Start/From:
Clock To:
1st Value:
2nd Value:
Value Percent:
Step: **NO**
Remarks: **ACCESS MH**

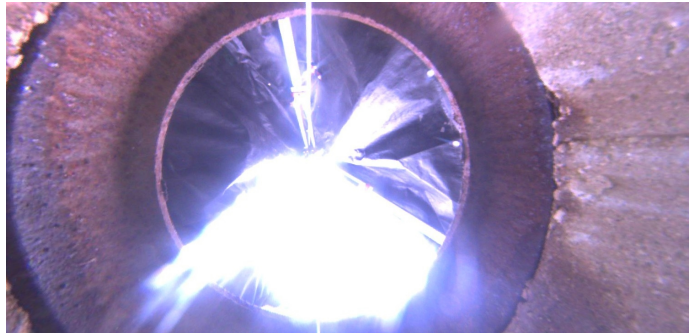
Code:	MGO
Description:	General Observation
Distance (ft):	1.8
Structural Grade:	0
O&M Grade:	0
Clock Start/From:	
Clock To:	
1st Value:	
2nd Value:	
Value Percent:	
Step:	NO
Remarks:	UNDERSIDE OF FRAME

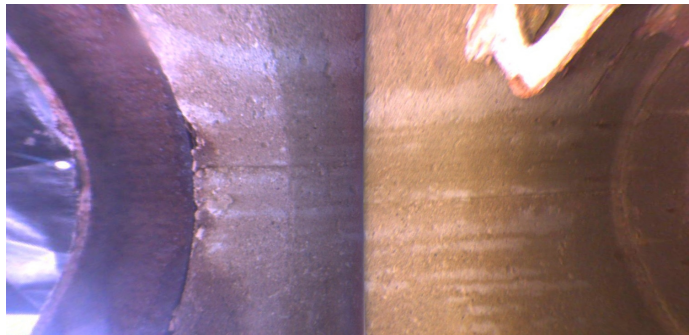
Code:	FL
Description:	Fracture Longitudinal
Distance (ft):	1.8
Structural Grade:	3
O&M Grade:	0
Clock Start/From:	9
Clock To:	
1st Value:	
2nd Value:	
Value Percent:	
Step:	NO
Remarks:

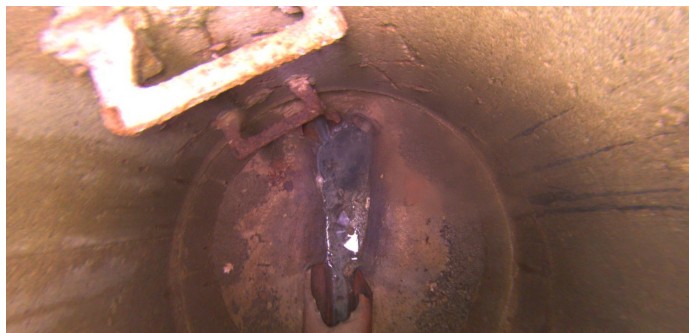
Code:	SAV
Description:	Surface Aggregate Visible
Distance (ft):	1.8
Structural Grade:	3
O&M Grade:	0
Clock Start/From:	12
Clock To:	12
1st Value:	
2nd Value:	
Value Percent:	
Step:	NO
Remarks:

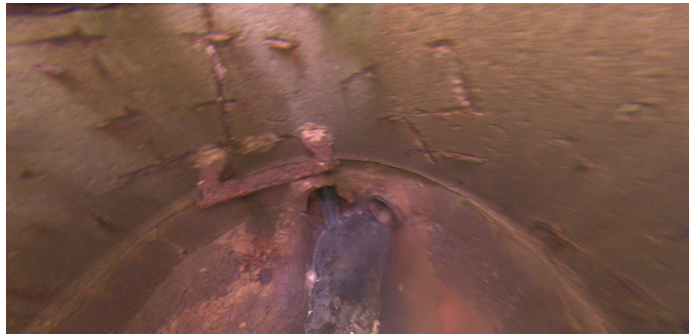
Code:	SRV
Description:	Surface Reinforcement Visible
Distance (ft):	2.8
Structural Grade:	5
O&M Grade:	0
Clock Start/From:	12
Clock To:	12
1st Value:	
2nd Value:	
Value Percent:	
Step:	NO
Remarks:

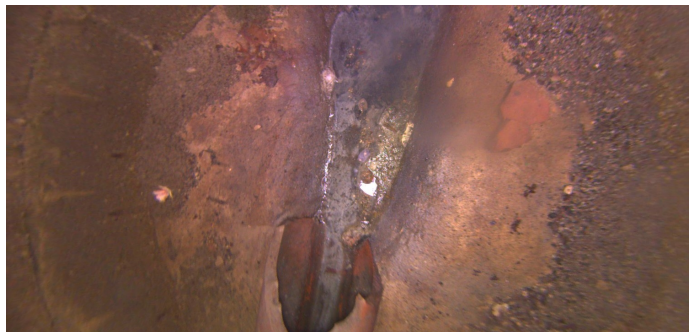
Code:	DSF
Description:	Deposits Settled Fine
Distance (ft):	3.6
Structural Grade:	0
O&M Grade:	2
Clock Start/From:	12
Clock To:	12
1st Value:	
2nd Value:	
Value Percent:	5.000
Step:	NO
Remarks:

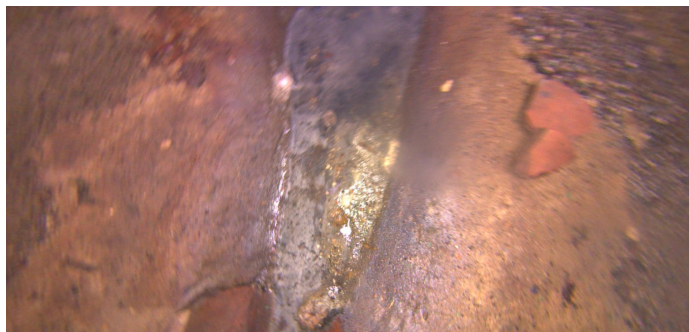
Code:	OBM
Description:	Obstacle Pipe Material
Distance (ft):	4.2
Structural Grade:	0
O&M Grade:	2
Clock Start/From:	1
Clock To:	
1st Value:	
2nd Value:	
Value Percent:	5.000
Step:	NO
Remarks:

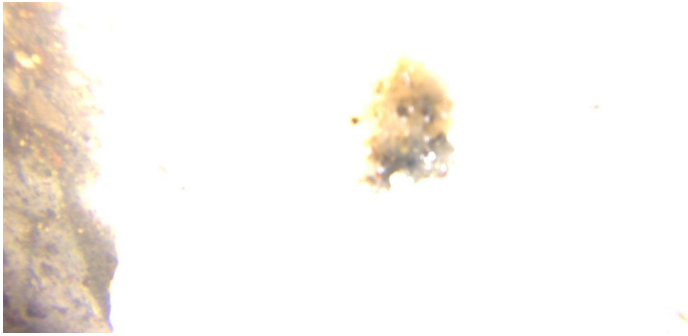
Code:	MGO
Description:	General Observation
Distance (ft):	5.8
Structural Grade:	0
O&M Grade:	0
Clock Start/From:	
Clock To:	
1st Value:	
2nd Value:	
Value Percent:	
Step:	NO
Remarks:	end survey
