Manhole Inspection Report

Date:	04/24/2018	Weather:		Coding:	RZMACP
MH#:	M-407-002	Owner:	NA	Len. Surveyed:	5.2
P.O.#:		Surveyor:	John Kuglmaier	Rim to Invert:	4.9
Customer:		Cert. #:	U-1215-07002349	Wall Material:	Concrete (reinforced)

Street:	On Lake View Dr. South of 10th St.	Project:	Hobart, IN
City:	Hobart, IN	GPS Northing:	2898999.954
Location:		GPS Easting:	2898999.954
Drain Area:	Southwest	GPS Accuracy:	Sub-Meter
Cover Shape:	Circular	Evidence of Surcharge:	No
Cover Size:	22.5	Potential for Runoff:	None
Comments:

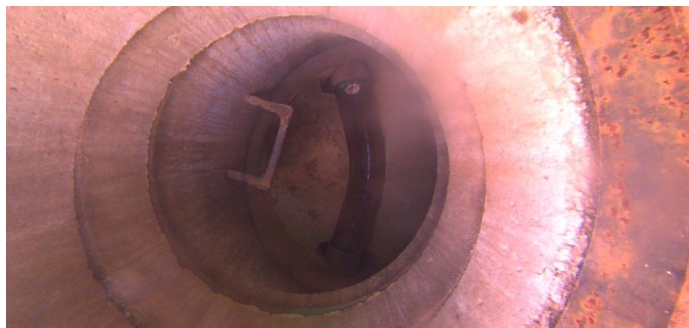
Code: **MGP**
Description: **General Photo**

Distance (ft): **.0**
Structural Grade: **0**
O&M Grade: **0**
Clock Start/From:
Clock To:
1st Value:
2nd Value:
Value Percent:
Step: **NO**
Remarks:

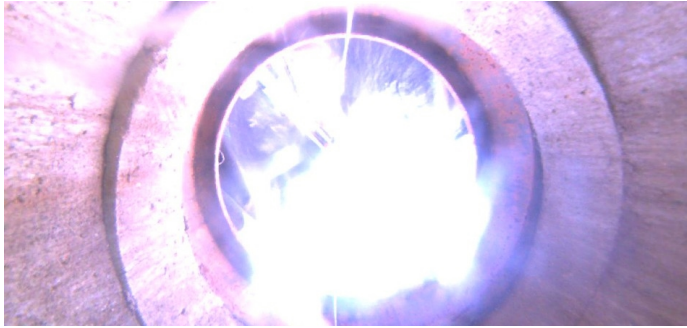
Code: **MGP**
Description: **General Photo**

Distance (ft): **2.6**
Structural Grade: **0**
O&M Grade: **0**
Clock Start/From:
Clock To:
1st Value:
2nd Value:
Value Percent:
Step: **NO**
Remarks:

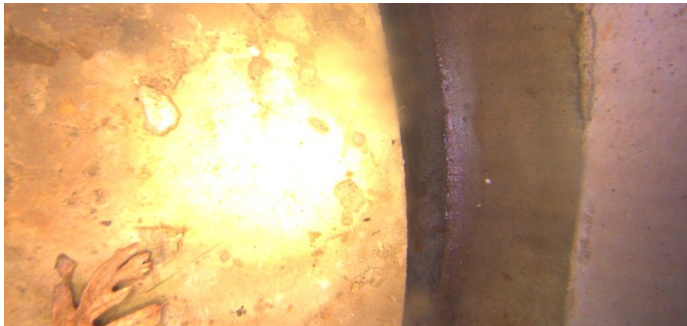
Code: **MGO**
Description: **General Observation**

Distance (ft): **4.6**
Structural Grade: **0**
O&M Grade: **0**
Clock Start/From:
Clock To:
1st Value:
2nd Value:
Value Percent:
Step: **NO**
Remarks: **Ins. Comp.**
