Manhole Inspection Report

Date:	04/24/2018	Weather:		Coding:	RZMACP
MH#:	M-407-004	Owner:	NA	Len. Surveyed:	4.8
P.O.#:		Surveyor:	John Kuglmaier	Rim to Invert:	5.3
Customer:		Cert. #:	U-1215-07002349	Wall Material:	Concrete (reinforced)

Street:	On Lake View Dr. South of 10th St.	Project:	Hobart, IN
City:	Hobart, IN	GPS Northing:	2898773.08
Location:		GPS Easting:	2898773.08
Drain Area:	Southwest	GPS Accuracy:	Sub-Meter
Cover Shape:	Circular	Evidence of Surcharge:	No
Cover Size:	22.5	Potential for Runoff:	None
Comments:

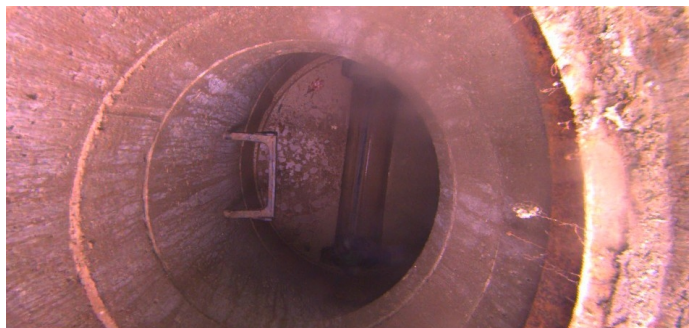
Code: **MGP**
Description: **General Photo**

Distance (ft): **.0**
Structural Grade: **0**
O&M Grade: **0**
Clock Start/From:
Clock To:
1st Value:
2nd Value:
Value Percent:
Step: **NO**
Remarks:

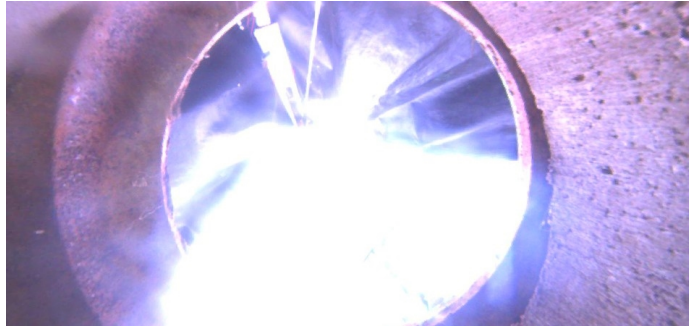
Code: **MGP**
Description: **General Photo**

Distance (ft): **2.0**
Structural Grade: **0**
O&M Grade: **0**
Clock Start/From:
Clock To:
1st Value:
2nd Value:
Value Percent:
Step: **NO**
Remarks:

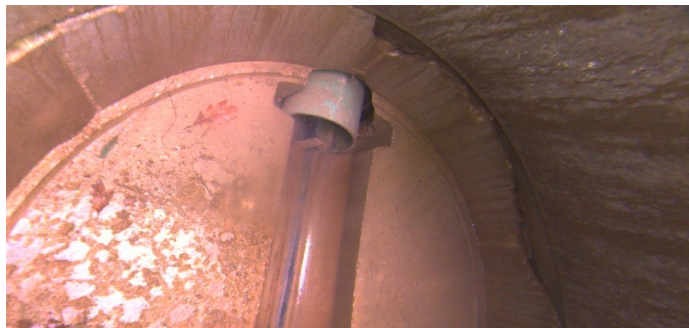
Code: **SSS**
Description: **Surface Spalling**

Distance (ft): **2.7**
Structural Grade: **2**
O&M Grade: **0**
Clock Start/From: **1**
Clock To: **4**
1st Value:
2nd Value:
Value Percent:
Step: **NO**
Remarks:

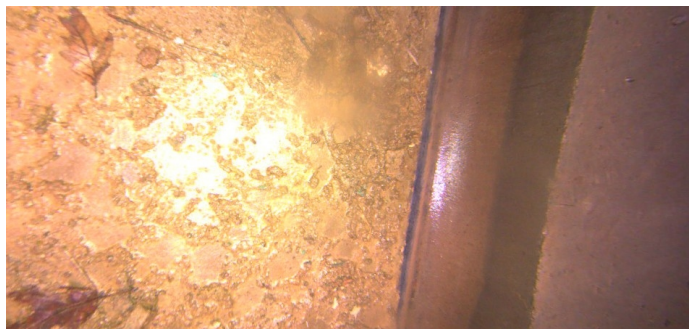
Code: **MGO**
Description: **General Observation**

Distance (ft): **4.0**
Structural Grade: **0**
O&M Grade: **0**
Clock Start/From:
Clock To:
1st Value:
2nd Value:
Value Percent:
Step: **NO**
Remarks: **Ins. Comp.**
