Manhole Inspection Report

Date:	04/24/2018	Weather:		Coding:	RZMACP
MH#:	M-407-005	Owner:	NA	Len. Surveyed:	6.5
P.O.#:		Surveyor:	John Kuglmaier	Rim to Invert:	6.8
Customer:		Cert. #:	U-1215-07002349	Wall Material:	Concrete (reinforced)

Street:	On Lake View Dr. South of 10th St.	Project:	Hobart, IN
City:	Hobart, IN	GPS Northing:	2898881.243
Location:		GPS Easting:	2898881.243
Drain Area:	Southwest	GPS Accuracy:	Sub-Meter
Cover Shape:	Circular	Evidence of Surcharge:	No
Cover Size:	22.5	Potential for Runoff:	None
Comments:

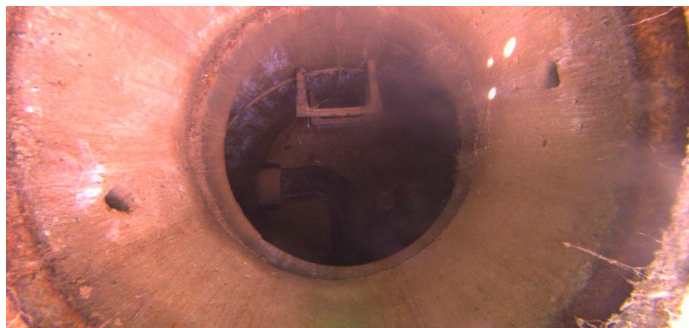
Code: **MGP**
Description: **General Photo**

Distance (ft): **.0**
Structural Grade: **0**
O&M Grade: **0**
Clock Start/From:
Clock To:
1st Value:
2nd Value:
Value Percent:
Step: **NO**
Remarks:

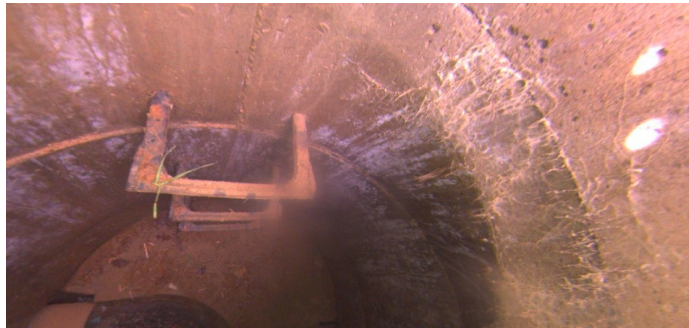
Code: **RFJ**
Description: **Roots Fine Joint**

Distance (ft): **1.5**
Structural Grade: **0**
O&M Grade: **1**
Clock Start/From: **2**
Clock To: **5**
1st Value:
2nd Value:
Value Percent:
Step: **NO**
Remarks:

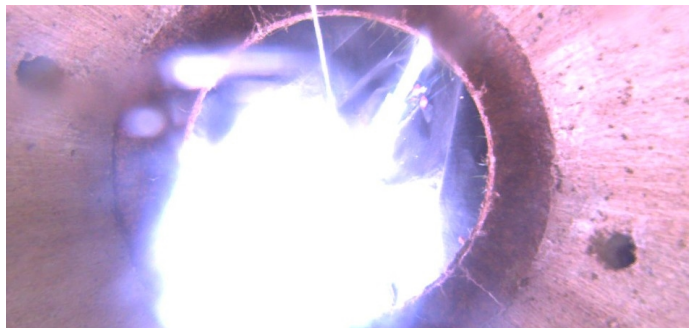
Code: **MGP**
Description: **General Photo**

Distance (ft): **2.2**
Structural Grade: **0**
O&M Grade: **0**
Clock Start/From:
Clock To:
1st Value:
2nd Value:
Value Percent:
Step: **NO**
Remarks:

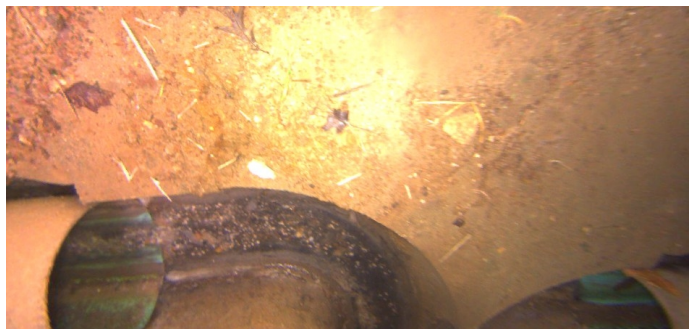
Code: **MGO**
Description: **General Observation**

Distance (ft): **5.4**
Structural Grade: **0**
O&M Grade: **0**
Clock Start/From:
Clock To:
1st Value:
2nd Value:
Value Percent:
Step: **NO**
Remarks: **Ins. Comp.**
