# Manhole Inspection Report

Date:	<b>04/24/2018</b>	Weather:		Coding:	<b>RZMACP</b>
MH#:	<b>M-407-006</b>	Owner:	<b>NA</b>	Len. Surveyed:	<b>6.1</b>
P.O.#:		Surveyor:	<b>John Kuglmaier</b>	Rim to Invert:	<b>7.0</b>
Customer:		Cert. #:	<b>U-1215-07002349</b>	Wall Material:	<b>Concrete (reinforced)</b>

Street:	<b>On Lake Side Dr. South of 10th St.</b>	Project:	<b>Hobart, IN</b>
City:	<b>Hobart, IN</b>	GPS Northing:	<b>2899009.637</b>
Location:		GPS Easting:	<b>2899009.637</b>
Drain Area:	<b>Southwest</b>	GPS Accuracy:	<b>Sub-Meter</b>
Cover Shape:	<b>Circular</b>	Evidence of Surcharge:	<b>No</b>
Cover Size:	<b>22.5</b>	Potential for Runoff:	<b>None</b>
Comments:

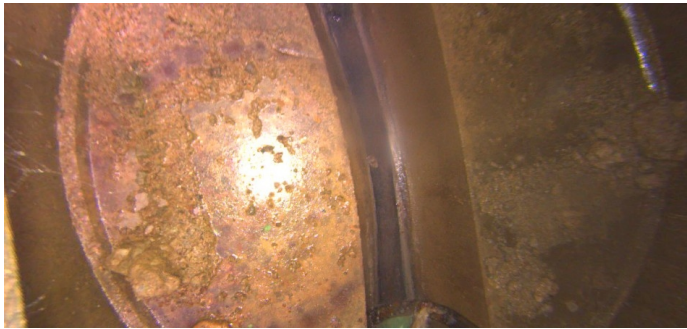
Code:	<b>MGO</b>
Description:	<b>General Observation</b>
Distance (ft):	<b>4.9</b>
Structural Grade:	<b>0</b>
O&M Grade:	<b>0</b>
Clock Start/From:	
Clock To:	
1st Value:	
2nd Value:	
Value Percent:	
Step:	<b>NO</b>
Remarks:	<b>Ins. Comp.</b>
