Manhole Inspection Report

Date:	04/24/2018	Weather:		Coding:	RZMACP
MH#:	M-407-007	Owner:	NA	Len. Surveyed:	6.1
P.O.#:		Surveyor:	John Kuglmaier	Rim to Invert:	6.9
Customer:		Cert. #:	U-1215-07002349	Wall Material:	Concrete (reinforced)

Street:	On Lake Side Dr. South of 10th St.	Project:	Hobart, IN
City:	Hobart, IN	GPS Northing:	2899111.123
Location:		GPS Easting:	2899111.123
Drain Area:	Southwest	GPS Accuracy:	Sub-Meter
Cover Shape:	Circular	Evidence of Surcharge:	No
Cover Size:	22.5	Potential for Runoff:	None
Comments:

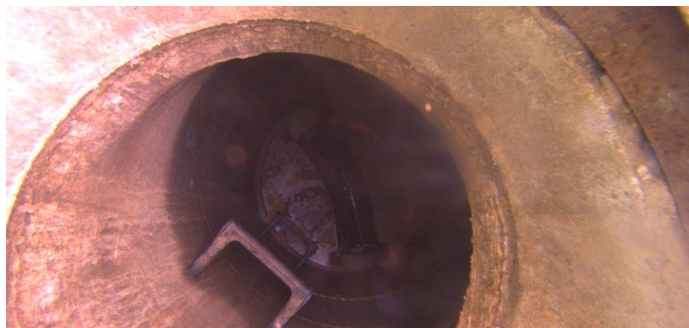
Code: **MGP**
Description: **General Photo**

Distance (ft): **.0**
Structural Grade: **0**
O&M Grade: **0**
Clock Start/From:
Clock To:
1st Value:
2nd Value:
Value Percent:
Step: **NO**
Remarks:

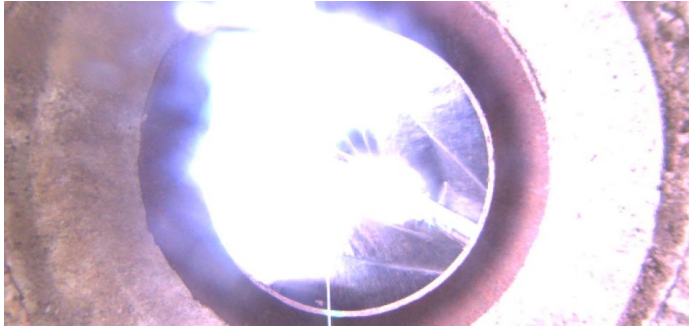
Code: **MGP**
Description: **General Photo**

Distance (ft): **2.2**
Structural Grade: **0**
O&M Grade: **0**
Clock Start/From:
Clock To:
1st Value:
2nd Value:
Value Percent:
Step: **NO**
Remarks:

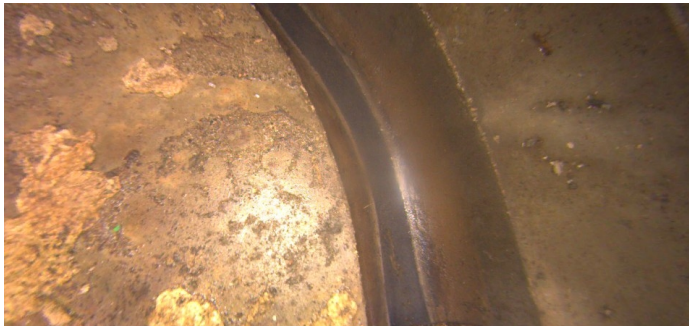
Code: **MGO**
Description: **General Observation**

Distance (ft): **5.1**
Structural Grade: **0**
O&M Grade: **0**
Clock Start/From:
Clock To:
1st Value:
2nd Value:
Value Percent:
Step: **NO**
Remarks: **Ins. Comp.**
