# Manhole Inspection Report

Date:	<b>04/24/2018</b>	Weather:		Coding:	<b>RZMACP</b>
MH#:	<b>M-407-008</b>	Owner:	<b>NA</b>	Len. Surveyed:	<b>5.7</b>
P.O.#:		Surveyor:	<b>John Kuglmaier</b>	Rim to Invert:	<b>6.6</b>
Customer:		Cert. #:	<b>U-1215-07002349</b>	Wall Material:	<b>Concrete (reinforced)</b>

Street:	<b>On Lake Side Dr. South of 10th St.</b>	Project:	<b>Hobart, IN</b>
City:	<b>Hobart, IN</b>	GPS Northing:	<b>2899178.859</b>
Location:		GPS Easting:	<b>2899178.859</b>
Drain Area:	<b>Southwest</b>	GPS Accuracy:	<b>Sub-Meter</b>
Cover Shape:	<b>Circular</b>	Evidence of Surcharge:	<b>No</b>
Cover Size:	<b>22.5</b>	Potential for Runoff:	<b>None</b>
Comments:

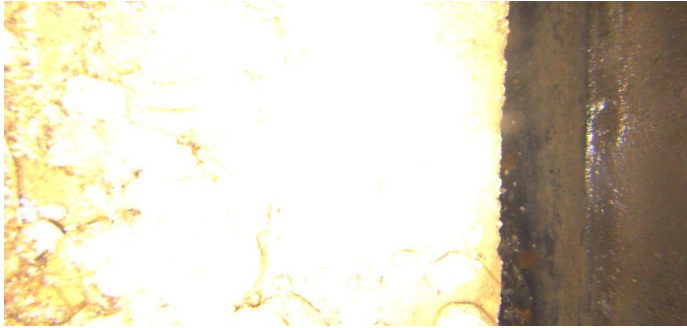
Code:	<b>MGO</b>
Description:	<b>General Observation</b>
Distance (ft):	<b>5.1</b>
Structural Grade:	<b>0</b>
O&M Grade:	<b>0</b>
Clock Start/From:	
Clock To:	
1st Value:	
2nd Value:	
Value Percent:	
Step:	<b>NO</b>
Remarks:	<b>Ins. Comp.</b>
